# NATIONAL TRANSPORTATION SAFETY BOARD

## SAFETY REPORT

GENERAL AVIATION CRASHWORTHINESS  
PROJECT: PHASE III - -  
ACCELERATION LOADS AND  
VELOCITY CHANGES OF SURVIVABLE  
GENERAL AVIATION ACCIDENTS

NTSB/SR-85/02

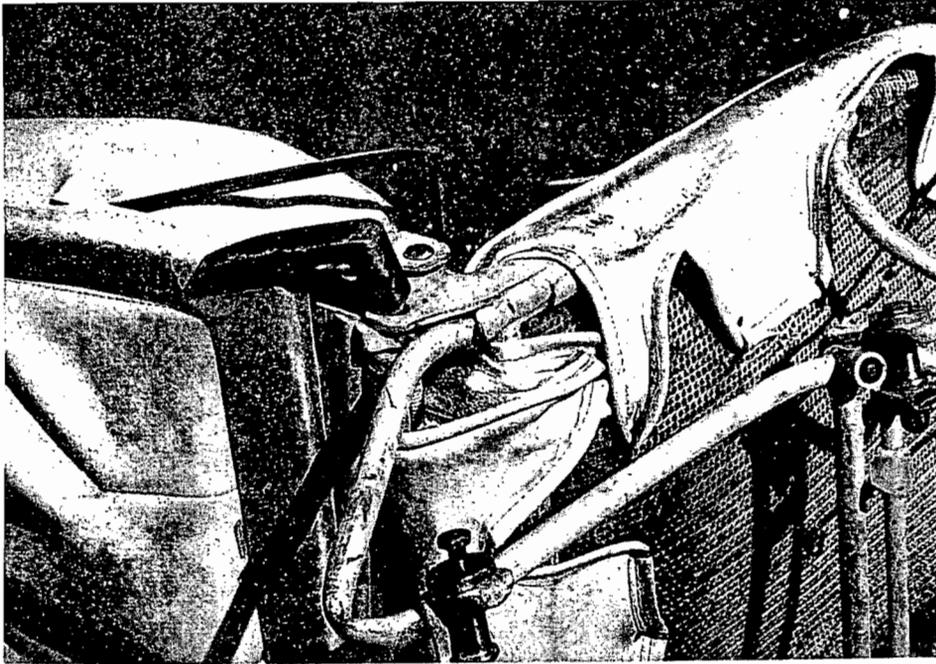
Photograph 3.-- Washers added to help the retention of the seat feet. The front foot is still spread.

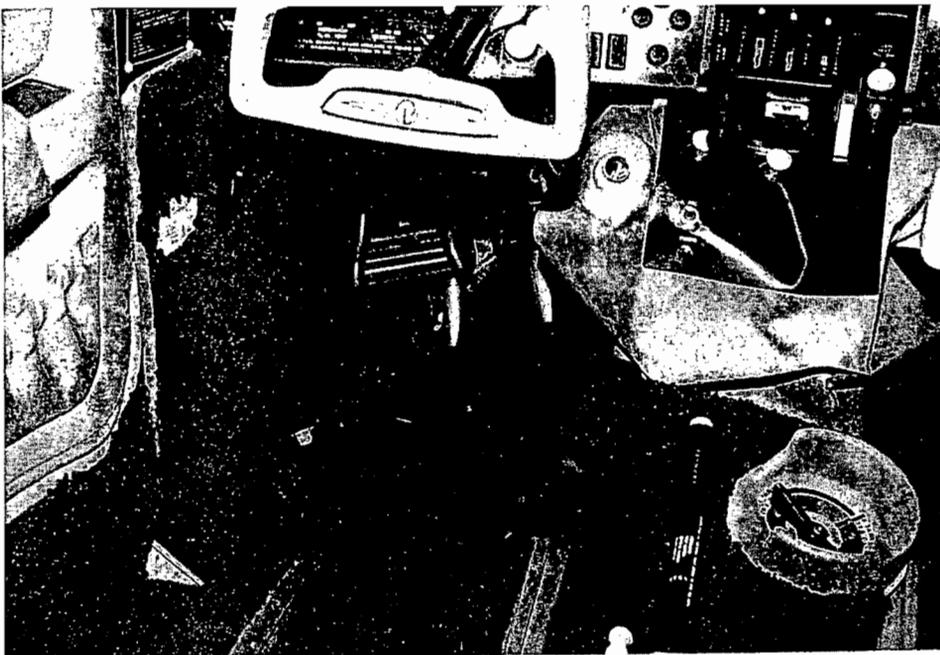
Floor warping can cause seats to fail. Photograph 4 shows warping of the floor area because the bottom of the fuselage contacted the nose gear. As a floor warps, extra stresses can be placed on the seat feet as the seat resists changing its original shape to accommodate the floor warp. Several seats in Case 33 separated because floor warping placed additional stresses on the seat feet (other cases 1, 3, and 12).

Photograph 4.-- Warped floor in minor accident.

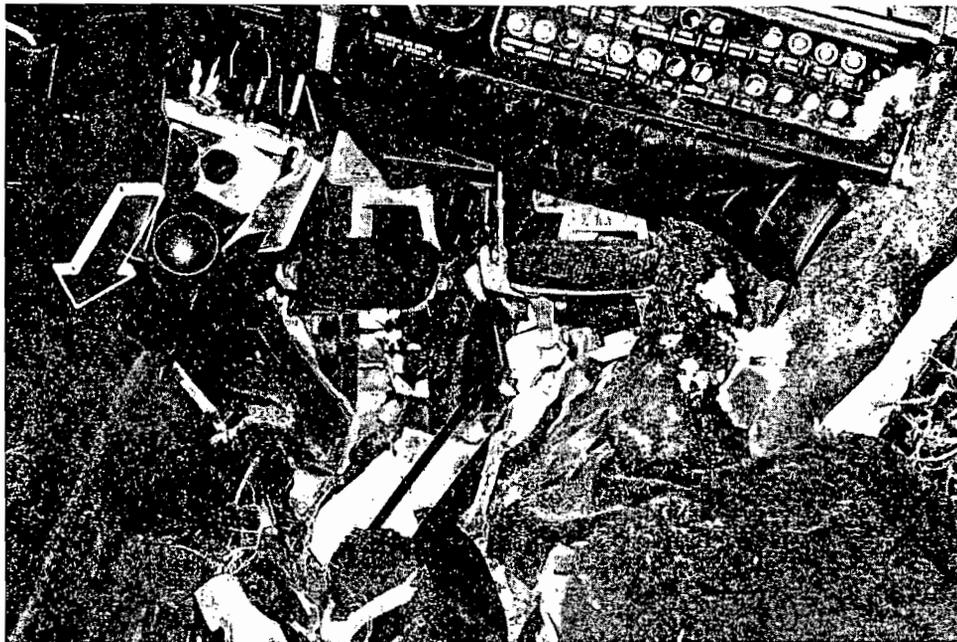
Piper designed an energy-absorbing seat that is flexible in several directions. The seat can stroke vertically, which absorbs energy, but it can distort and twist also without much resistance. With that built-in flexibility the Piper "S" tube seat (photograph 5) can deform to the contour of the floor warp without causing excessive stress on the seat feet.

Photograph 5.--Warped floor with flexible seat.  
The left seat conformed to the warped floor and stayed in place.

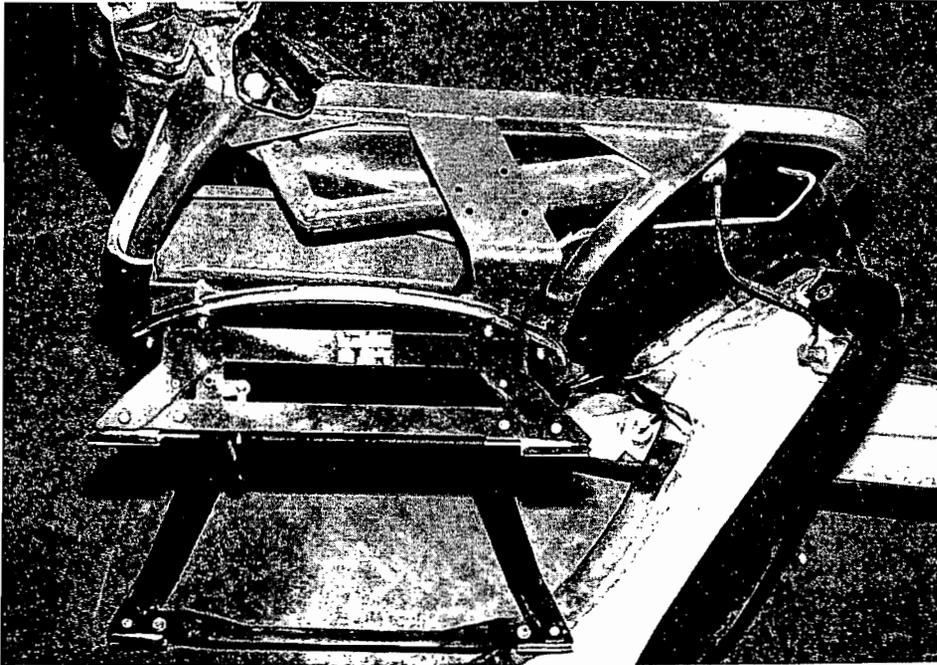
The front seats in Case 36 are a good example of seatpans that separated incrementally, absorbing energy in the process. (See photograph 7.) The crew seatpans in this airplane consist of formed aluminum sheets that are attached to the steel tube seat frames by rivets. As the pilot and copilot moved downward, the aluminum seatpans began to tear away from the rivets sequentially. Although the seats did not stroke, the tearing seatpans increased the stopping distance of the crewmembers in a relatively controlled manner, which resulted in less severe acceleration loads on their spines. In contrast, the rear seats in this airplane did not have an actual seatpan. Instead, they had a lower surface made of plastic which is not structural. Below that surface is a plastic book compartment and a steel ring mechanism that allows the seat to swivel. (See photograph 8.)

Photograph 8.--Steel ring and plastic seatpan.

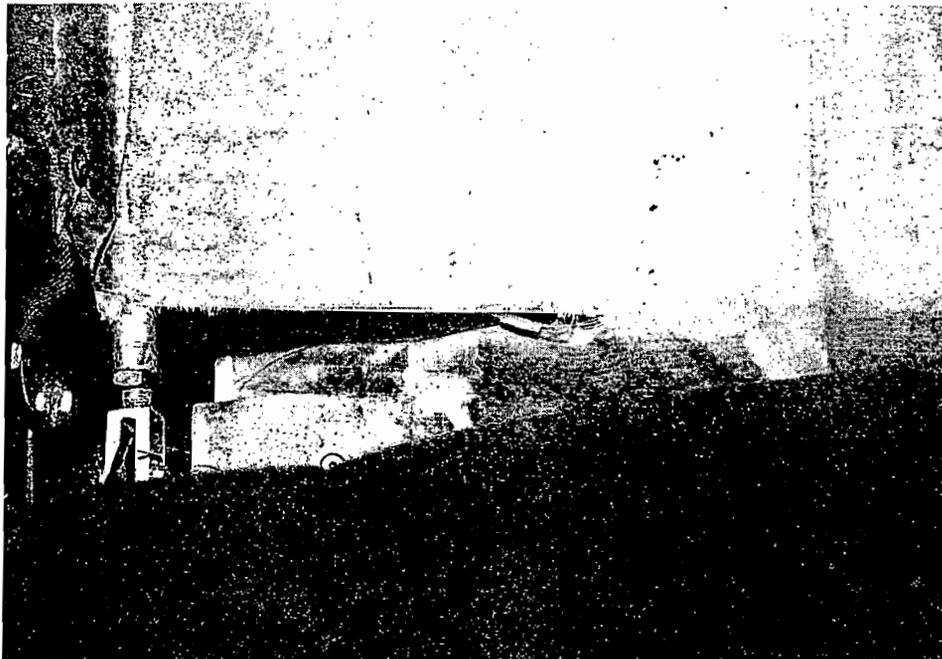
By pulling at the tear with one finger, the tear was propagated along one side of the seatpan (photograph 10). The material appeared to be strong, but the tear resistance was minimal while the material was under tension, acting as a diaphragm. Once the material was torn enough to ease the tension, it could no longer be torn by hand. It is believed that the loads on the occupied seat were high and that a tear started in the pan and propagated with little resistance.

Photograph 10.--Seatpan torn by pulling.

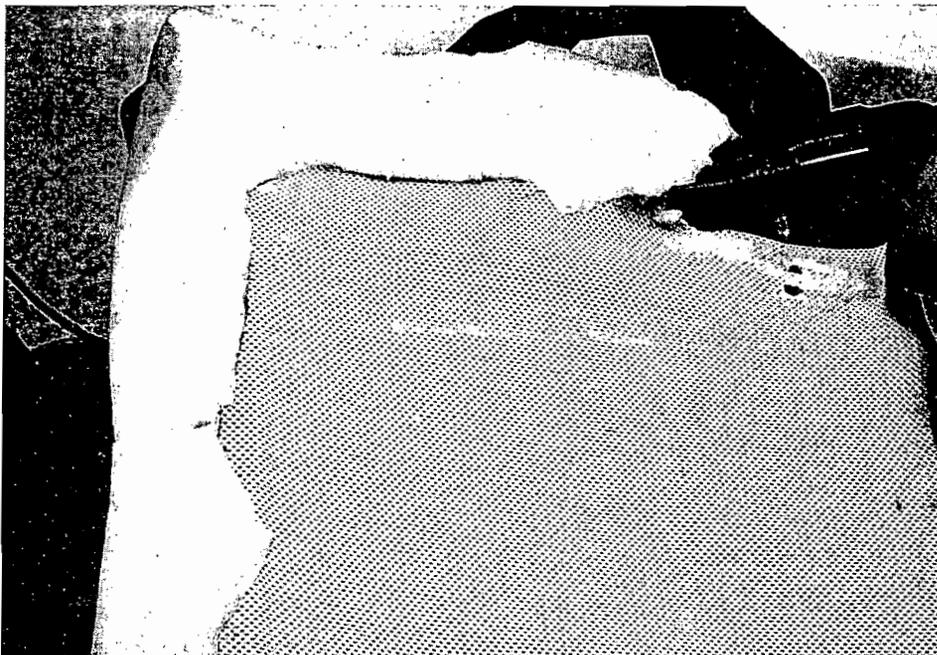
In Case 14, a seatpan exhibited characteristics similar to the ones discussed above. The seat was over air conditioning ducting which limited vertical movement. However, there were two small holes in the nylon mesh seatpan (photograph 11). During the investigation, the seatpan was torn by pulling at the holes with a finger. The pan could be torn in that manner until it no longer was in tension.

Photograph 11.--Seatpan before being torn by hand.

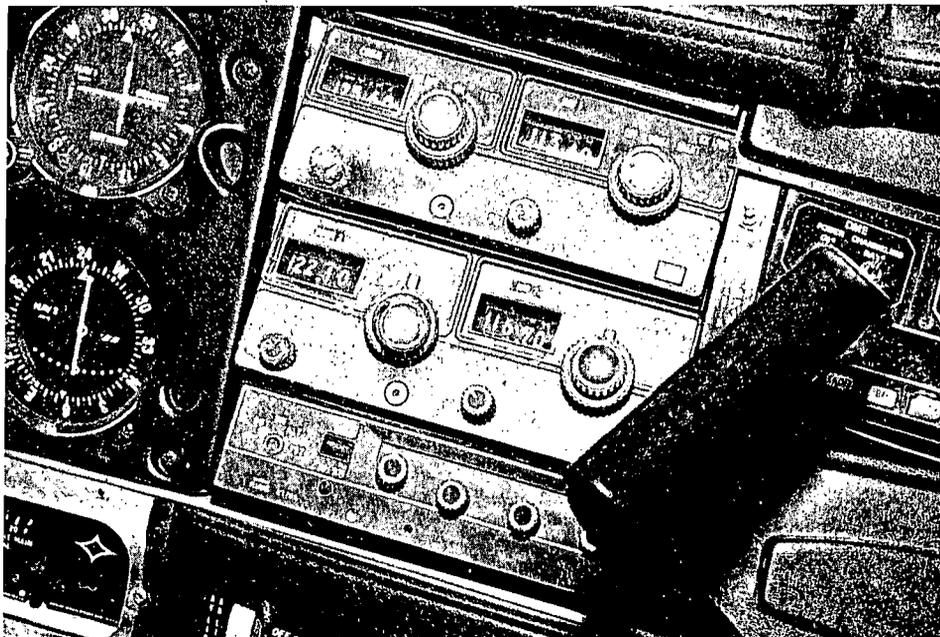
1-3 Passenger's head contact area.

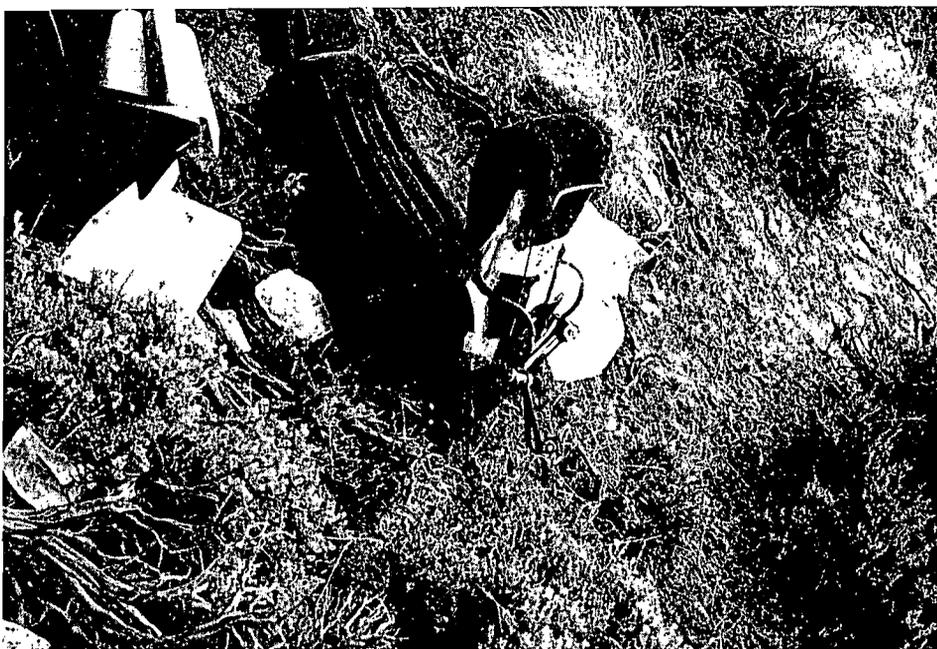
1-4 Stroked energy absorbing seat; note that legs separated.

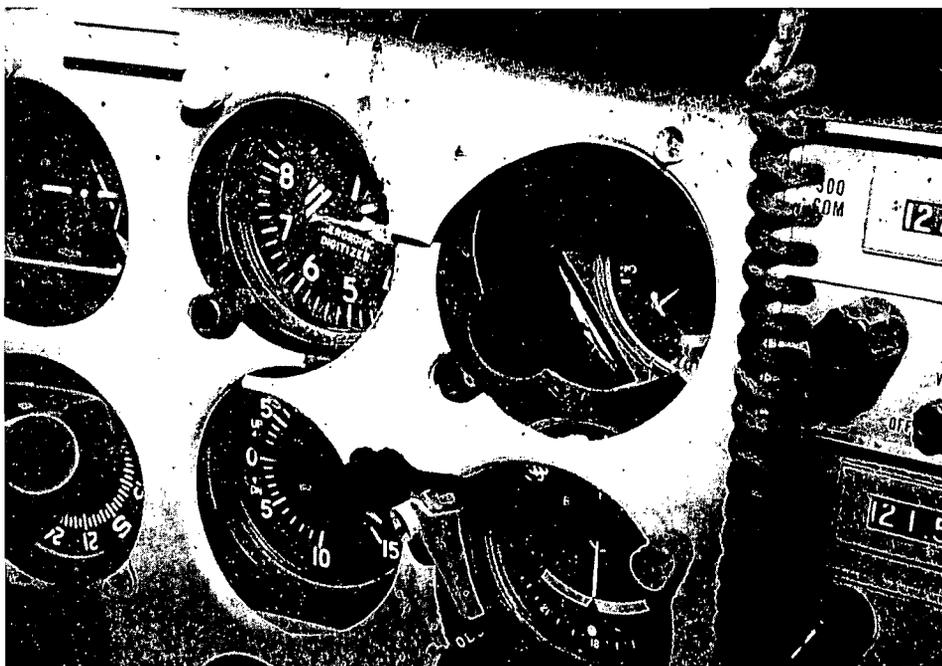
2-5. Pilot's head impact area.

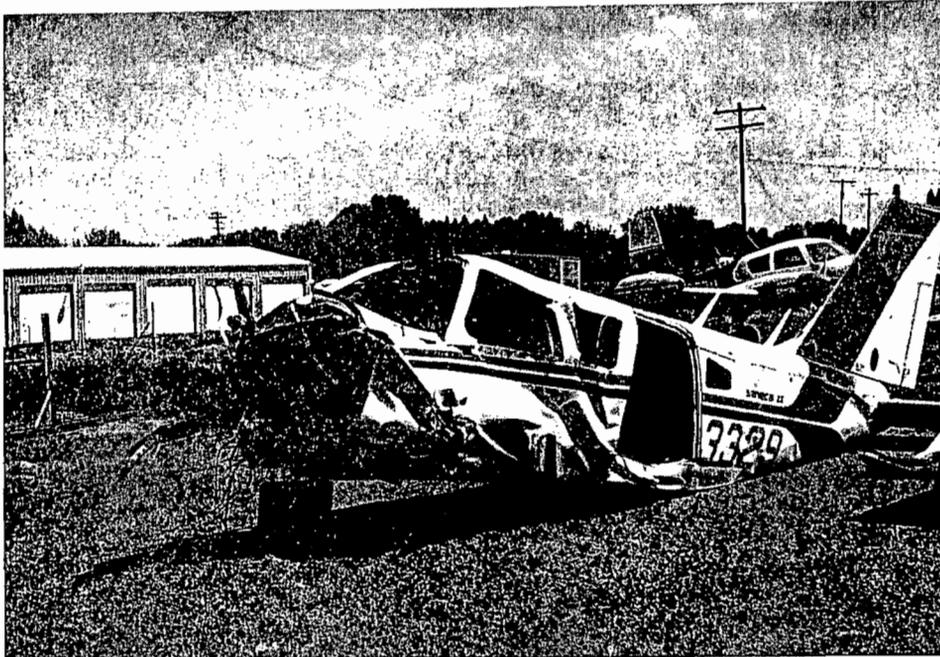
3-3. Wreckage and crush line.

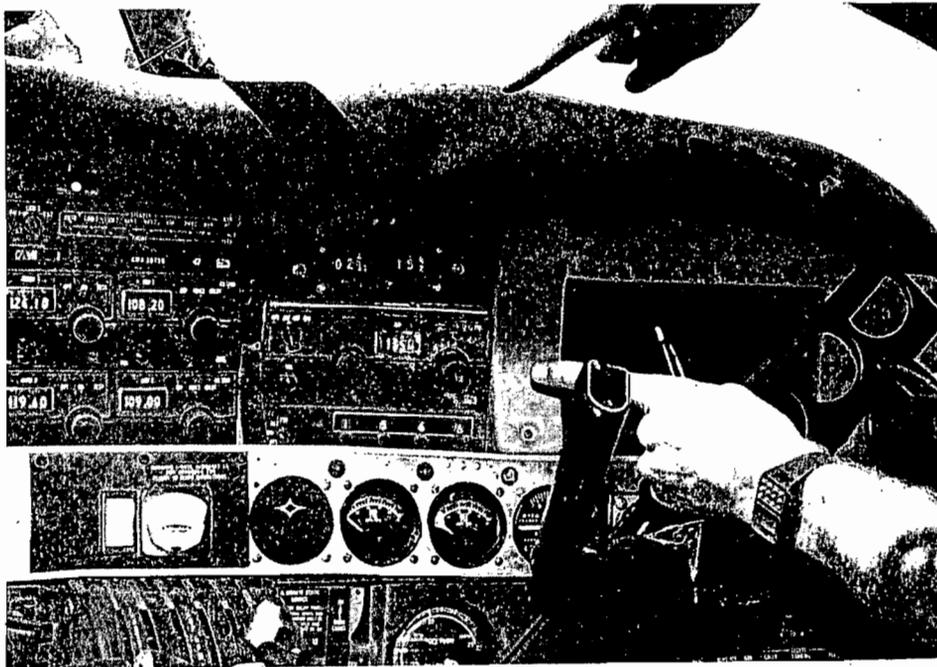
3-4. Area where right front occupant contacted panel.

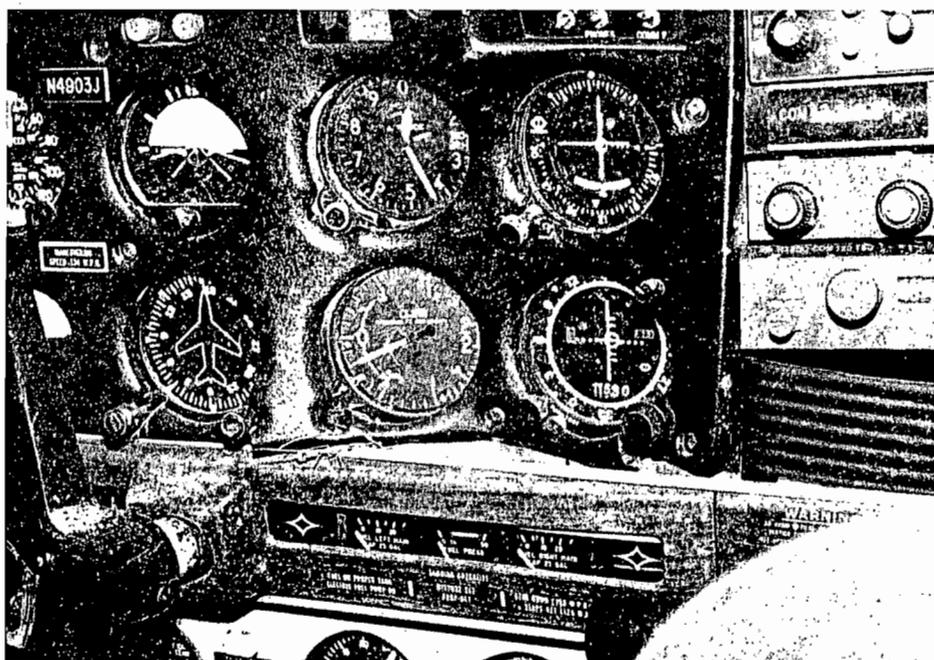
4-5. Pilot's head impact area.

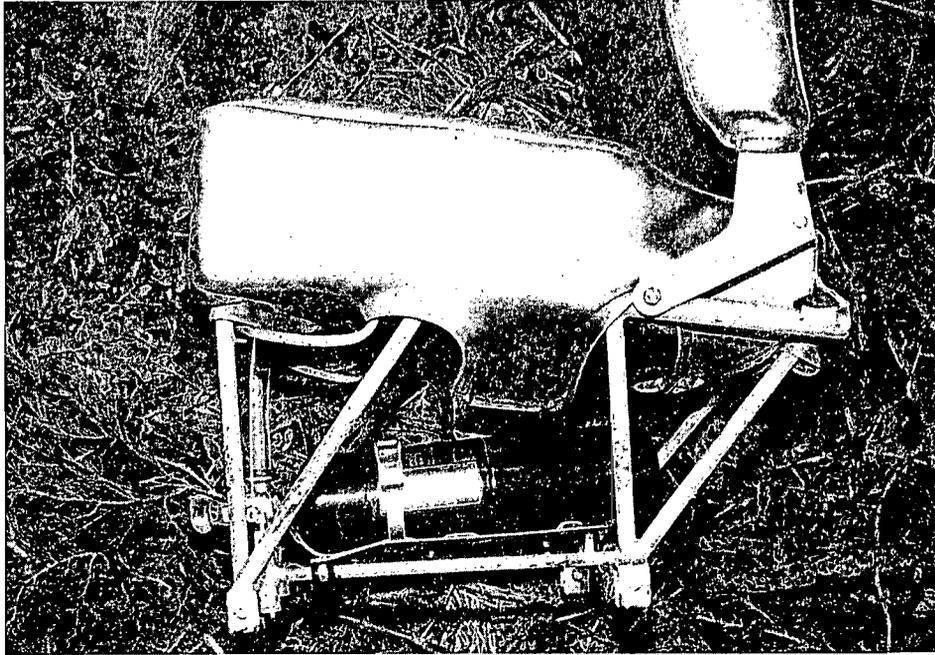
4-6. Fire extinguisher was added to seat, but seat was not certificated for extra weight. Stabilizing bar is located between front and rear legs.

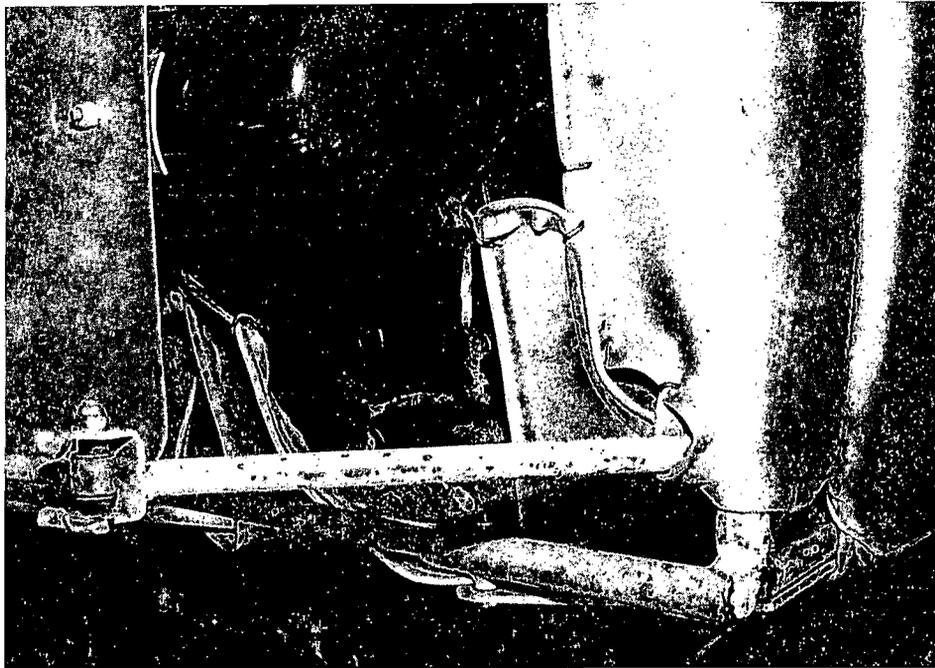
4-7. Rotten seat pan and typical seat foot.

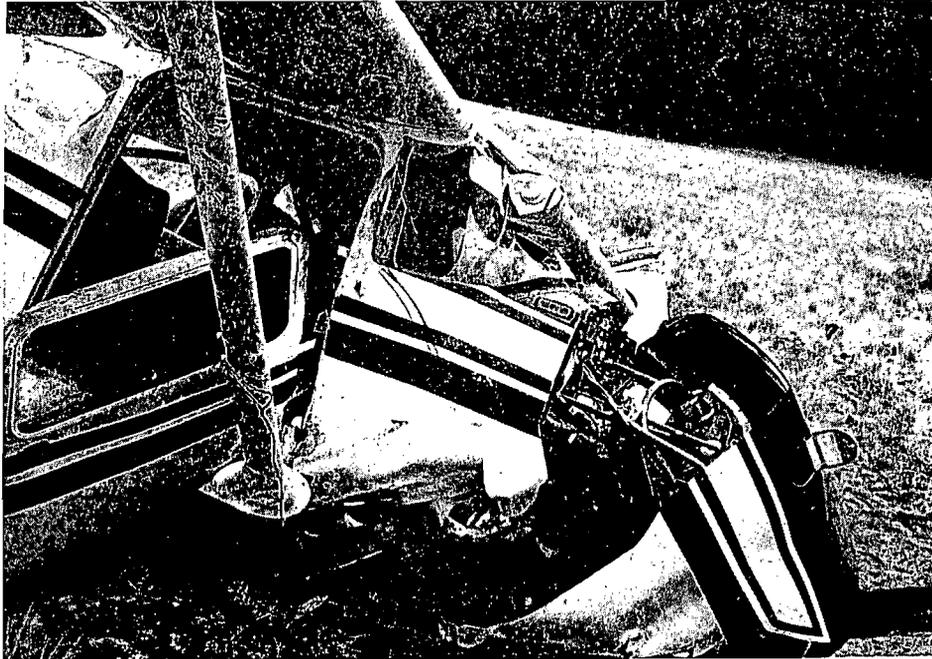
5-3. Wreckage - crush line.

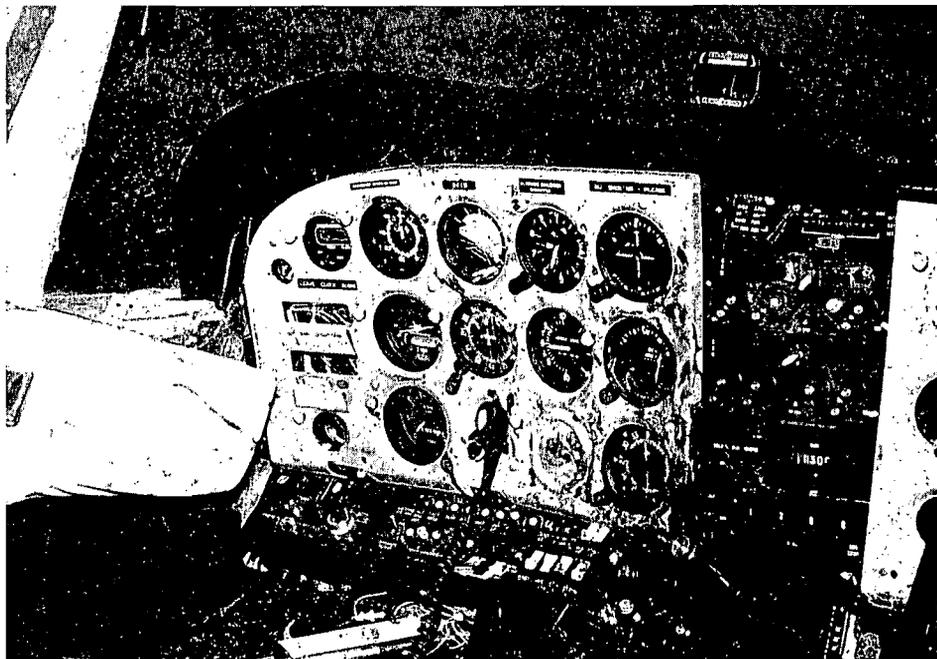
5-4. Pilot's head contact area.

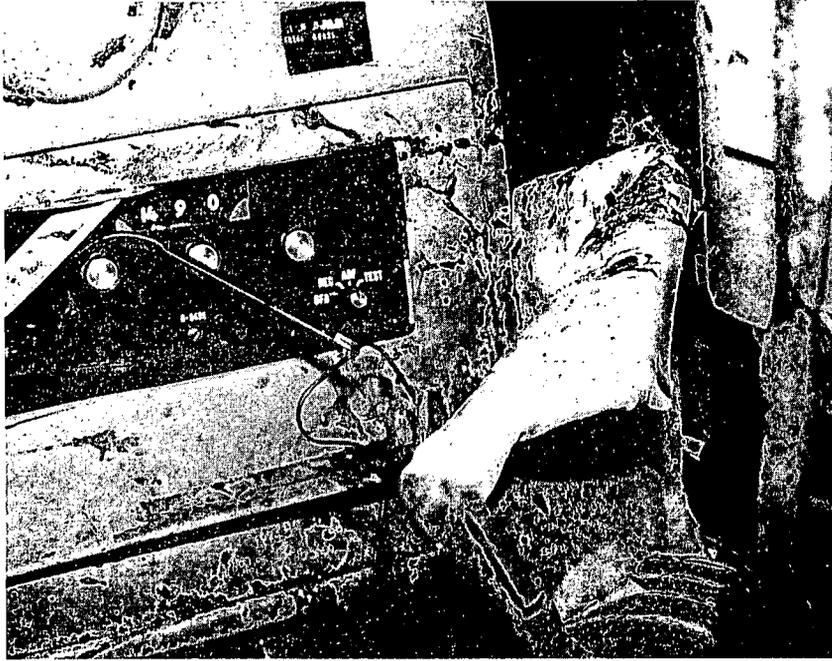
5-5. Right front passenger's head contact area.

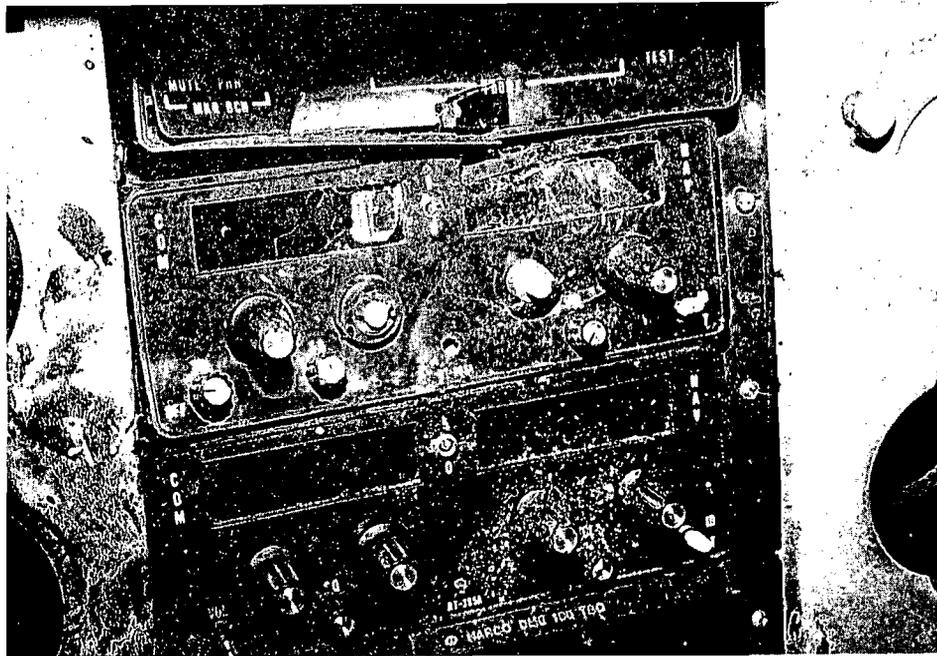
5-6. Pilot's head contact area.

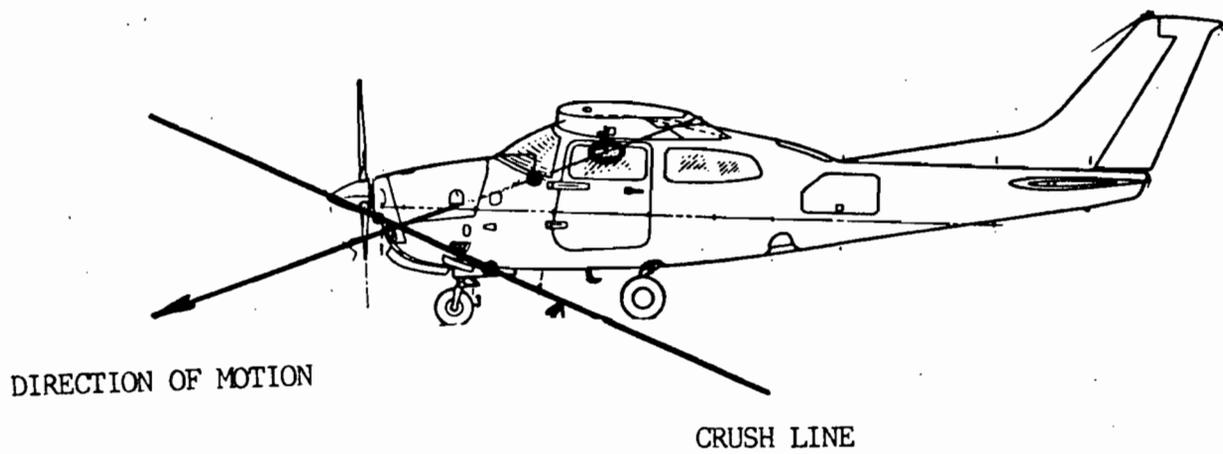
6-2. Side view depiction of airplane at impact.

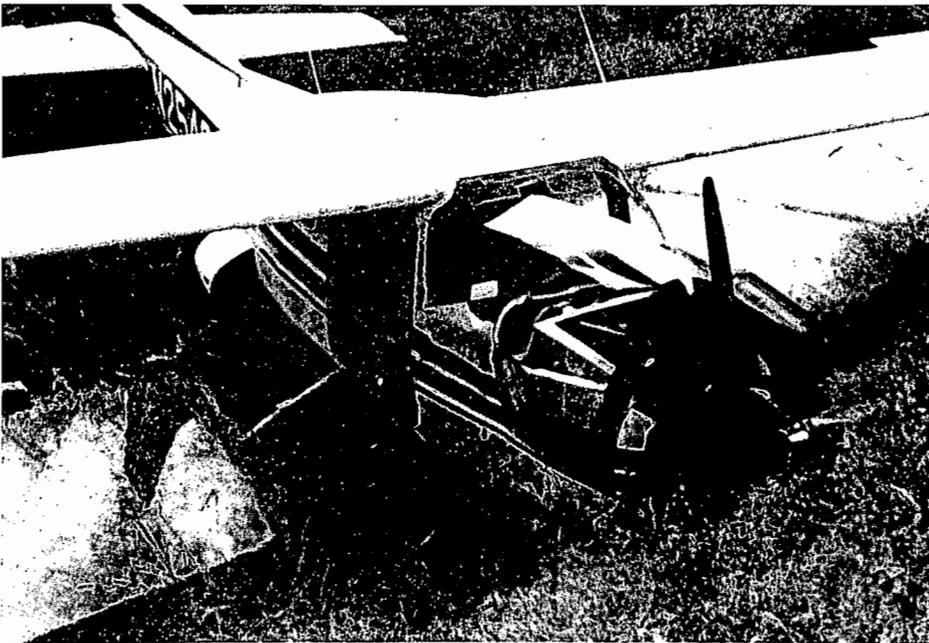
The passenger seated in the right front seat was wearing a lapbelt. She sustained a severe blow to her face when she impacted the top edge and front of the instrument panel. (See photograph 6-3.) Her injuries included several large and disfiguring facial lacerations, a fractured nose and a fractured rib. These injuries would have been prevented or would have been much less severe had she worn a shoulder harness. The seat tracks of her seat were badly deformed and the seat legs were bent and buckled (photograph 6-4).

6-4. View of aircraft.

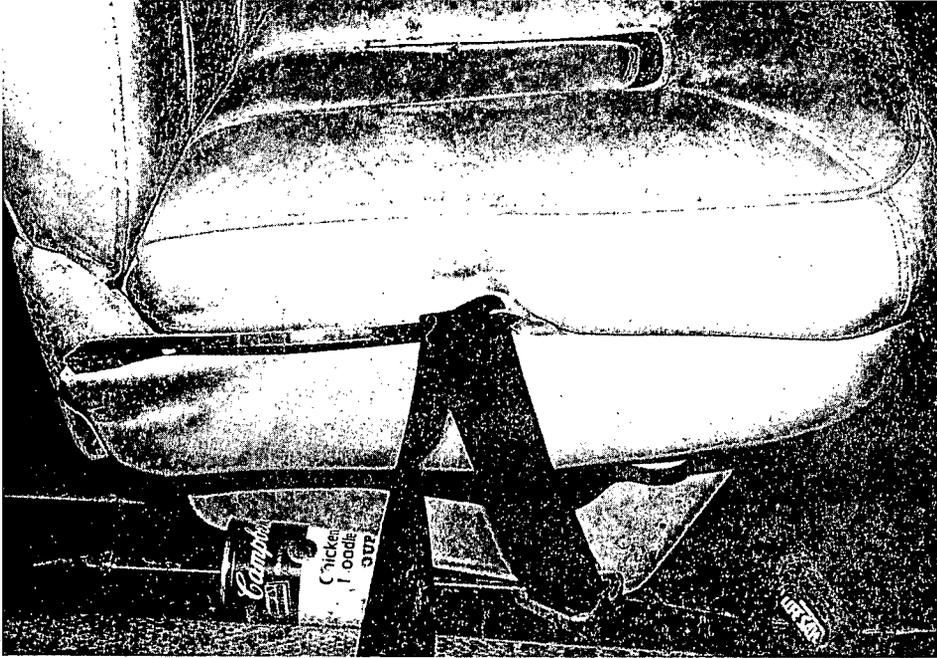
The passenger in the left rear seat also was wearing a lapbelt but not a shoulder harness. She received minor facial lacerations. The side brackets on the right front seat had started to score or weaken the outboard portion of the lapbelt.

6-7. Lapbelt holder that started scoring lapbelt.

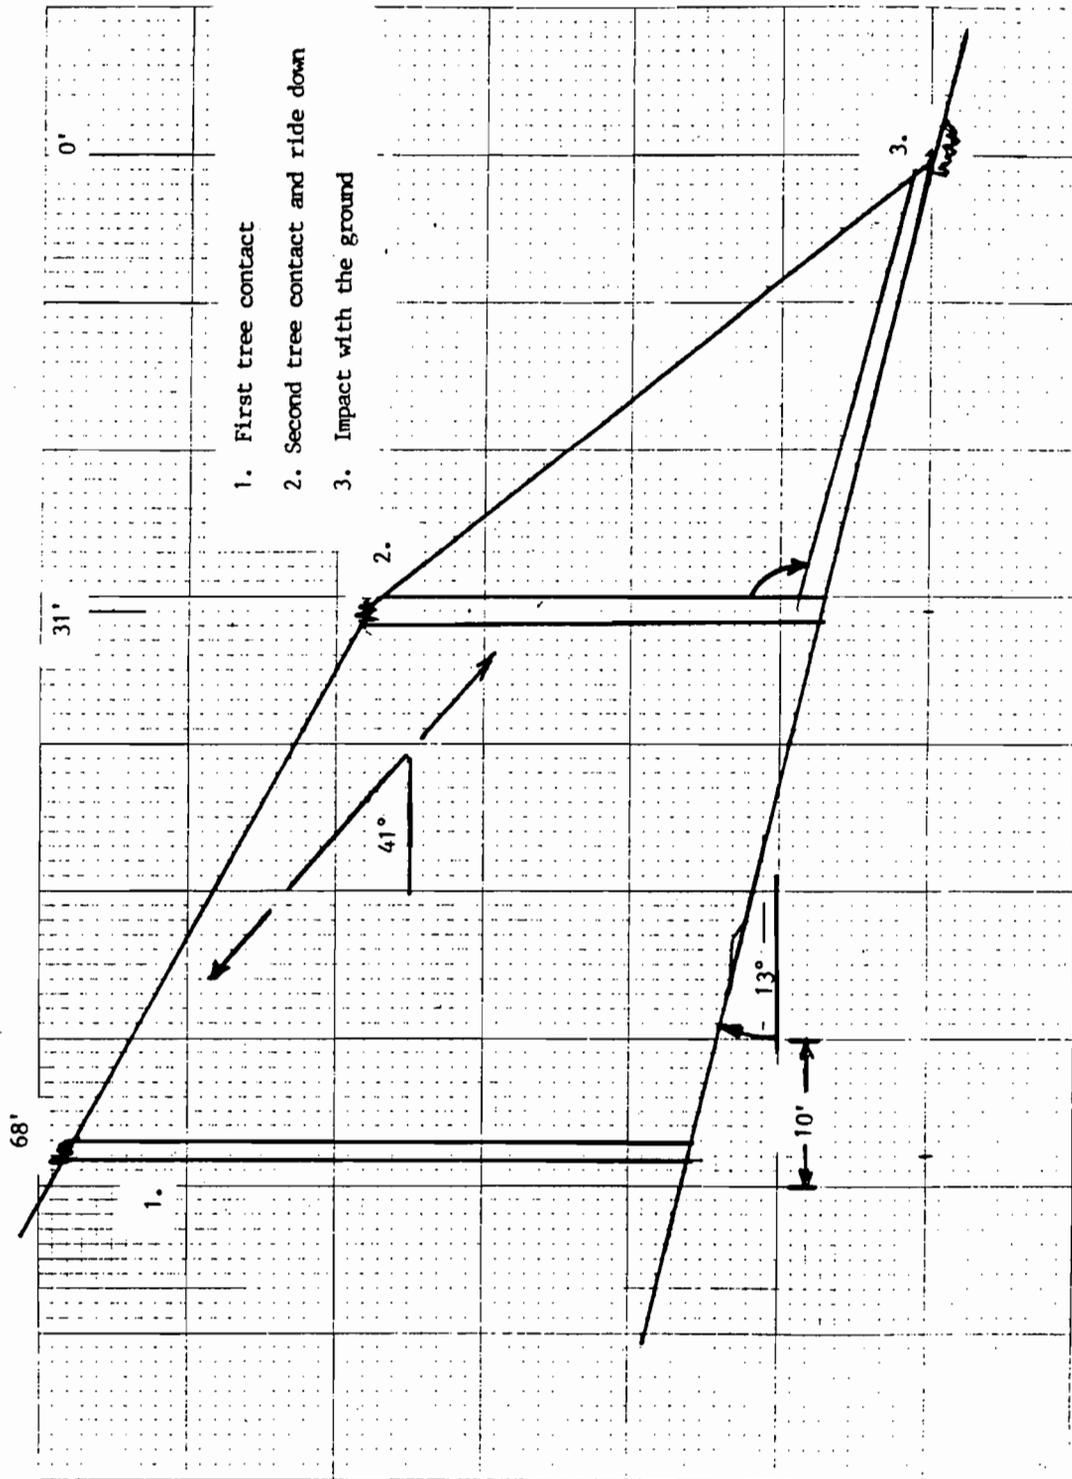
No acceleration loads could be calculated because the impact speed with the ground could not be estimated. At point 2 on the diagram (7-1), the airplane hit a tree and it remained with the tree until reaching the ground.

7-1. Airplane's final approach before impact.

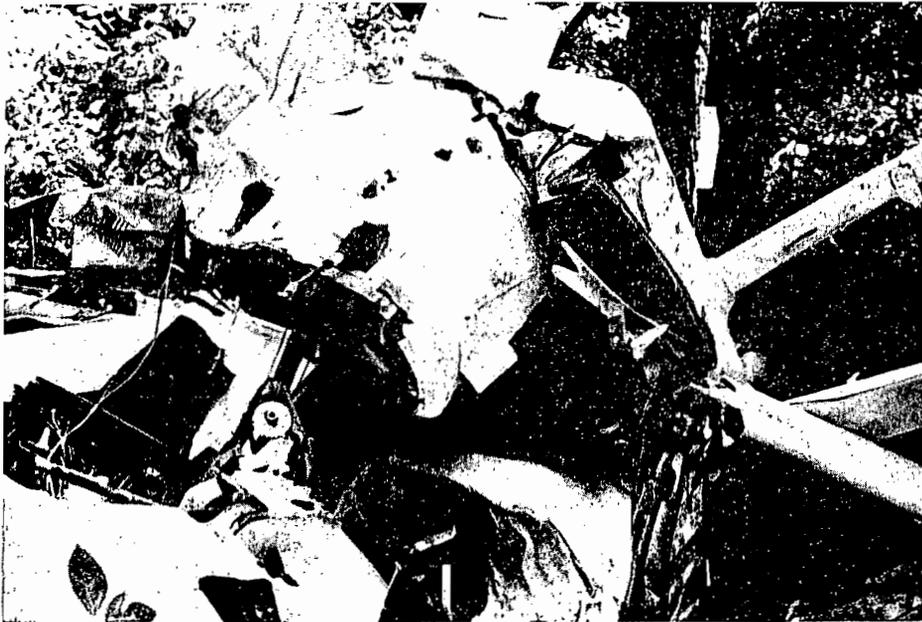
7-2. Airplane is inverted. Seat back top is pointing towards camera, and passenger seat is in view.

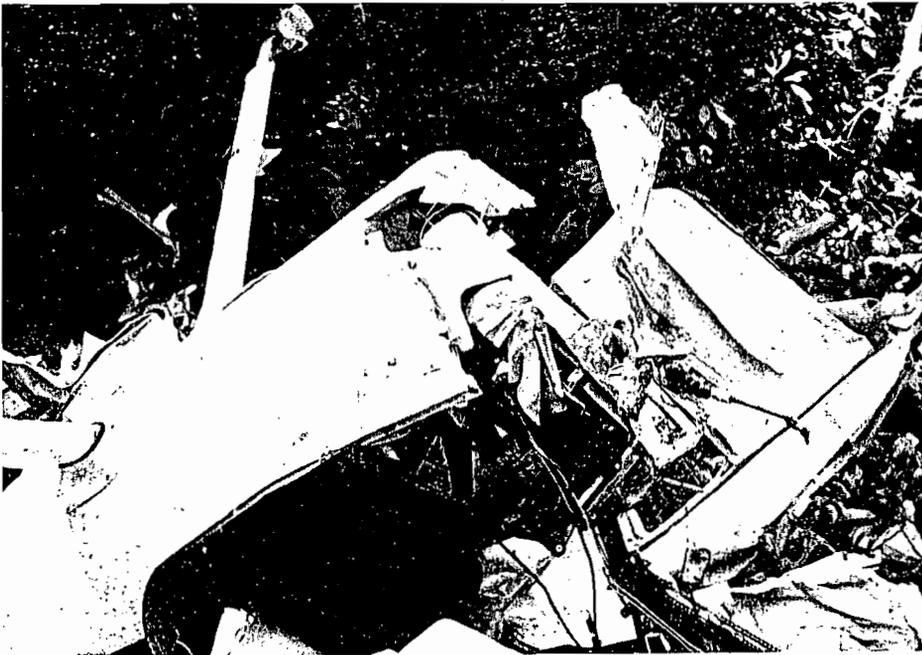
The pilot was fatally injured by the impact, although he was wearing a lapbelt and a shoulder harness. His injuries included numerous contusions, abrasions, and lacerations as well as hemorrhage within the brain structures. These were the result of pilot impact with the windshield and instrument panel and the control yoke. The legs of his seat and the seat track were bent and buckled as a result of the impact.

7-3. Pilot seat inverted.

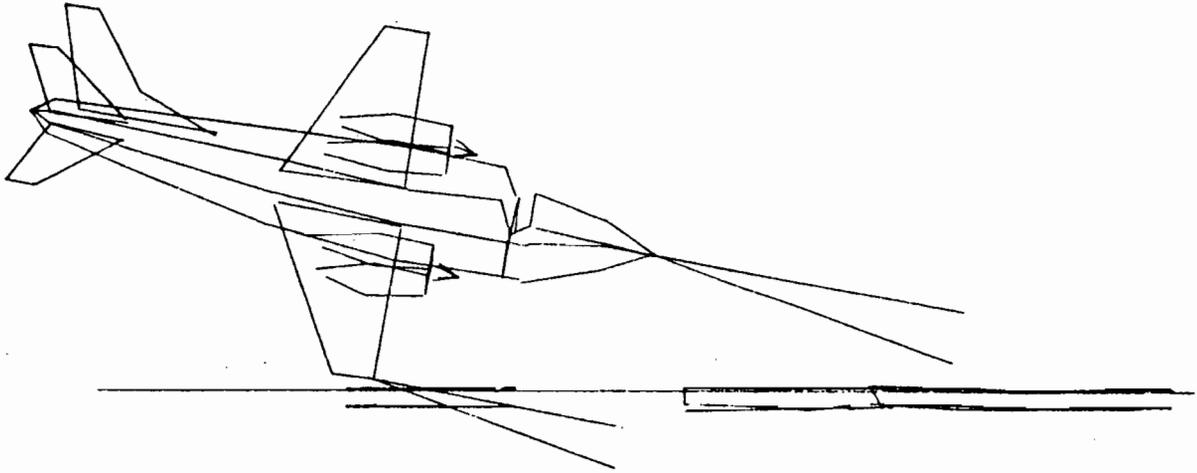
The impact speed of 67 knots was estimated from the airplane's landing configuration stall speed corrected for weight. The impact conditions were derived by matching the airplane components to the ground scars. At initial impact, the pitch attitude was about 10 degrees nose down with a right roll of about 30 degrees. The flight path was about 20 degrees down.

8-1. Side view, right wing down.

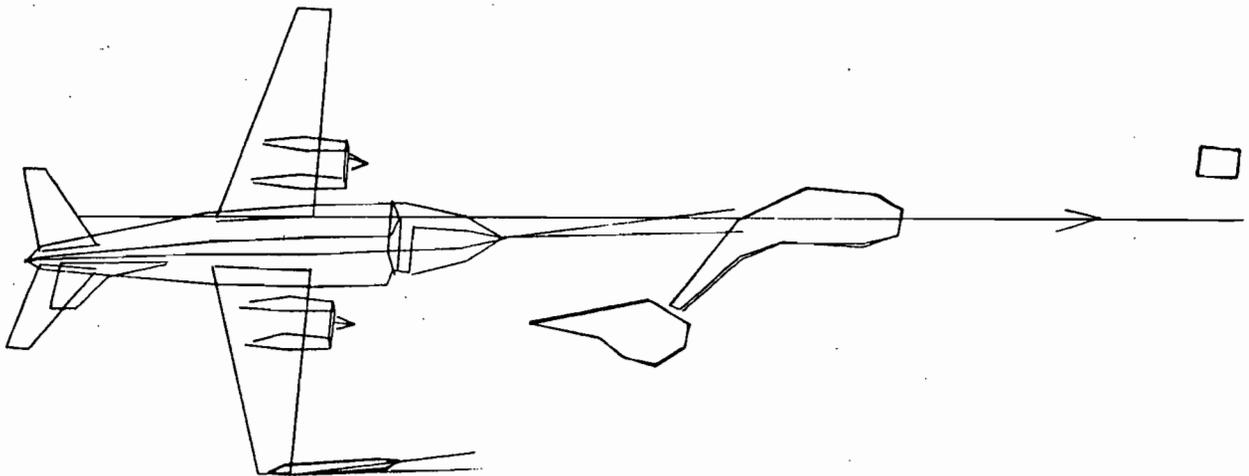
8-2. Top view.

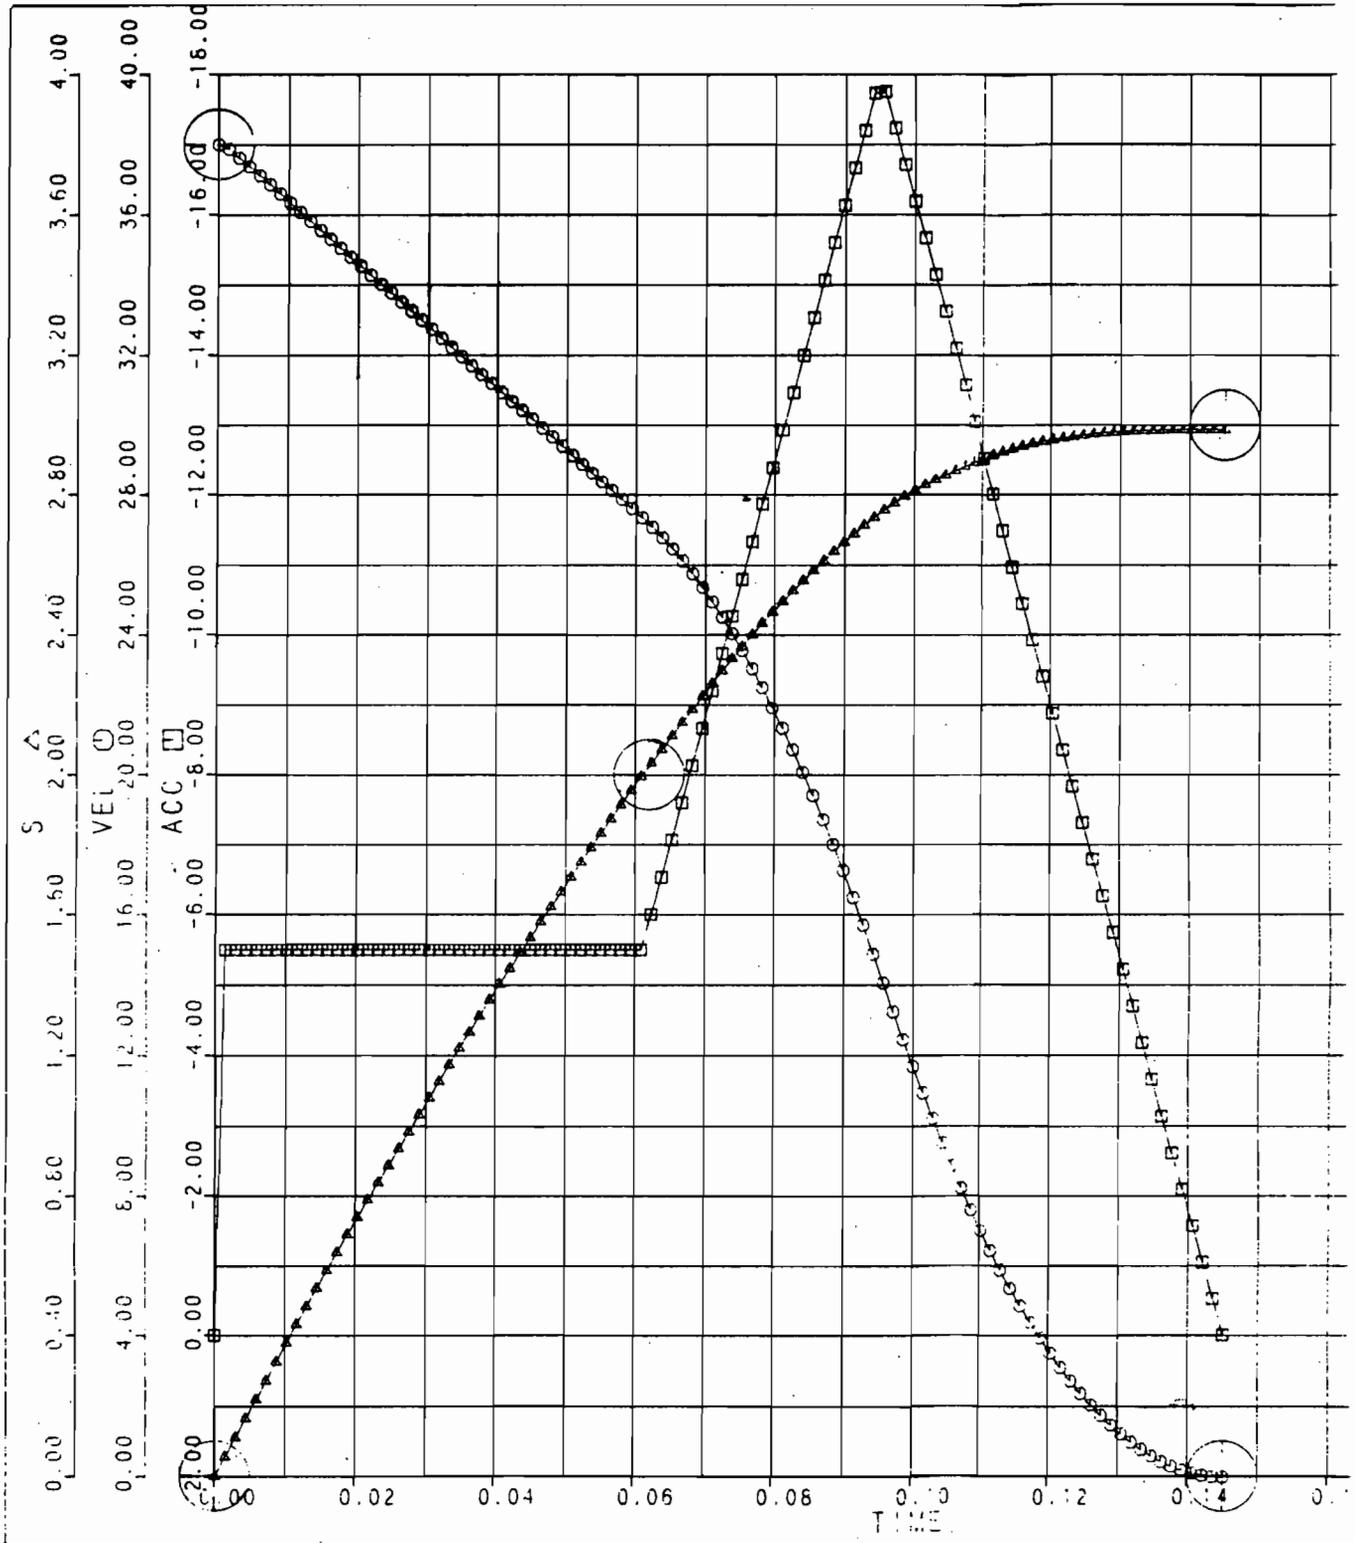
The total crush and stopping distance was about three feet, of which two feet were attributed to the engine nacelle contact and one foot was attributed to the crushing of the fuselage. The vertical impact velocity was calculated as 38 feet per second. The crushing of the nacelle area was estimated to be at an acceleration level of about half that of the fuselage. The minimum peak value would then be around 16 to 18 G's, but it could have been as high as 24 G's (earth axis).

Since there was a long slide, exit velocity estimates were not made. The direction of head movement was used to estimate the longitudinal loads. Evidence showed that the head contacted the panel by moving 30 to 40 degrees down. With the fuselage in a 10-degree pitch down attitude, the head moved down at an angle of 40 to 50 degrees (earth axis). Using the 16 G vertical estimate, the total vector would be in the range of 25 G's. Converting into airplane axis would yield a vertical peak of 12 G's and a longitudinal peak of 22 G's. The horizontal velocity change of 50 feet per second is consistent with a 22 G peak pulse and a duration of 0.14 seconds. Referenced to the airplane axis, the vertical pulse was 12 G's with a velocity change of 21 feet per second. The horizontal pulse was 19 G's with a velocity change of 30 feet per second.

8-3. Crash pulse.

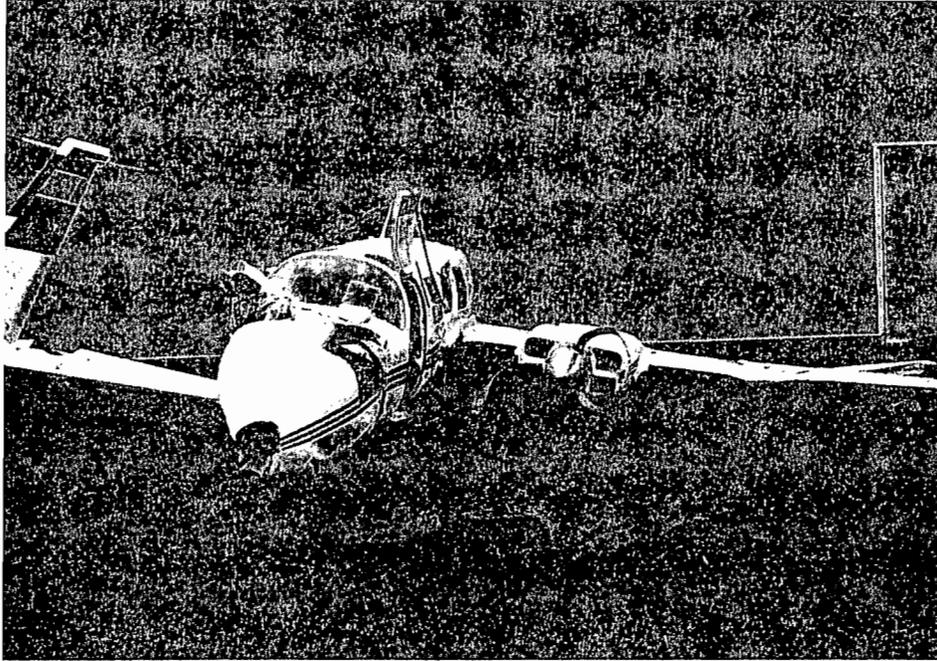
8-4. Wreckage.

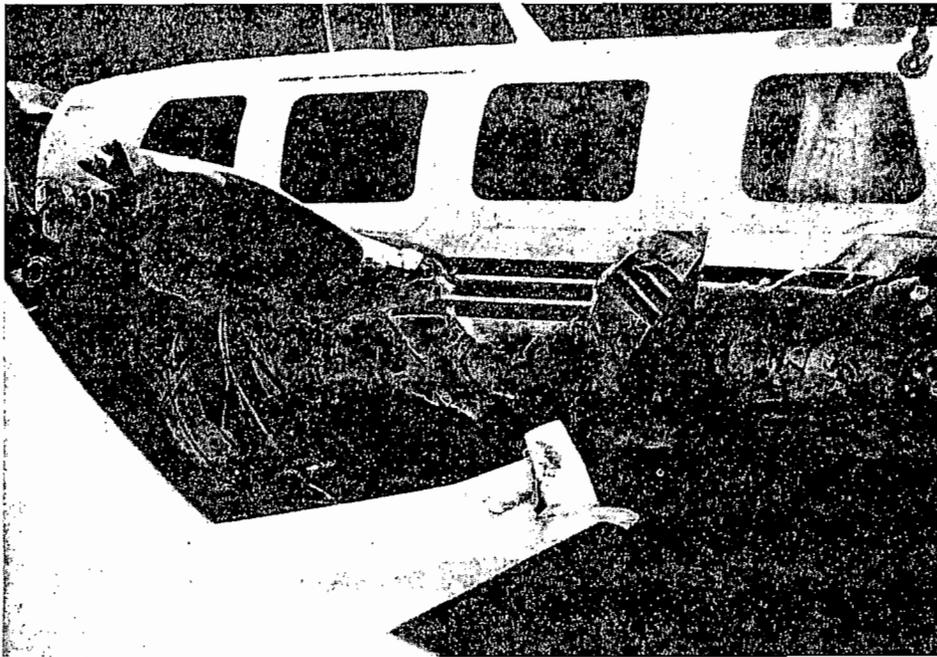
8-5. Wreckage - crush line.

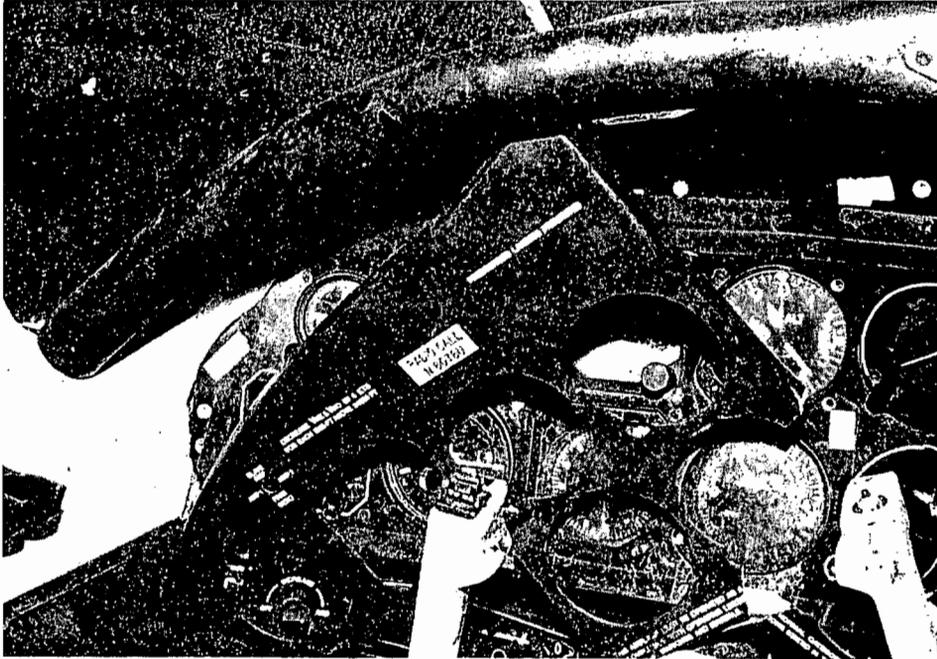
The pilot was not wearing the available shoulder harness. During the impact, his head contacted numerous lights and knobs on the instrument panel and other interior surfaces, fracturing his nose in several places and cutting his right cheek and scalp. In addition, he had a fractured right ankle, sprained left ankle, and back spasms caused by compression of a thoracic vertebra. A shoulder harness could have prevented the serious head injuries. The seat pan of the unoccupied right front seat had a small tear which was easily propagated to the full width of the seat by pulling at the tear with one finger. The pilot's seat pan was torn in similar manner.

8-8. Pilot's head contact area.
