# NATIONAL TRANSPORTATION SAFETY BOARD

## SAFETY REPORT

GENERAL AVIATION CRASHWORTHINESS  
PROJECT: PHASE III - -  
ACCELERATION LOADS AND  
VELOCITY CHANGES OF SURVIVABLE  
GENERAL AVIATION ACCIDENTS

NTSB/SR-85/02

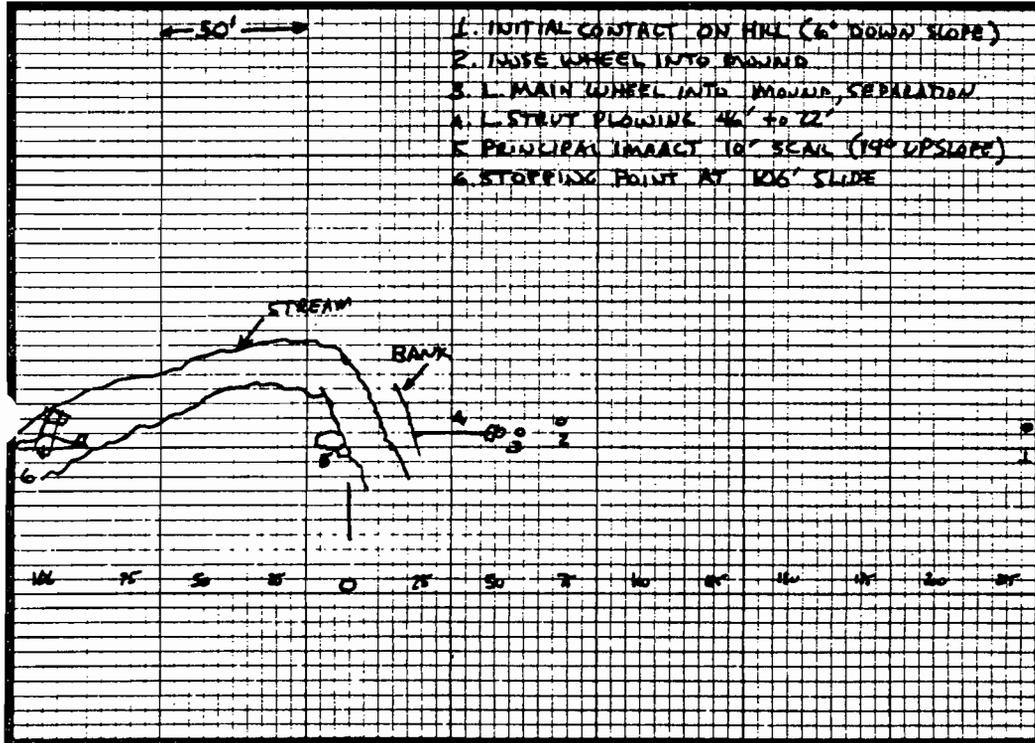
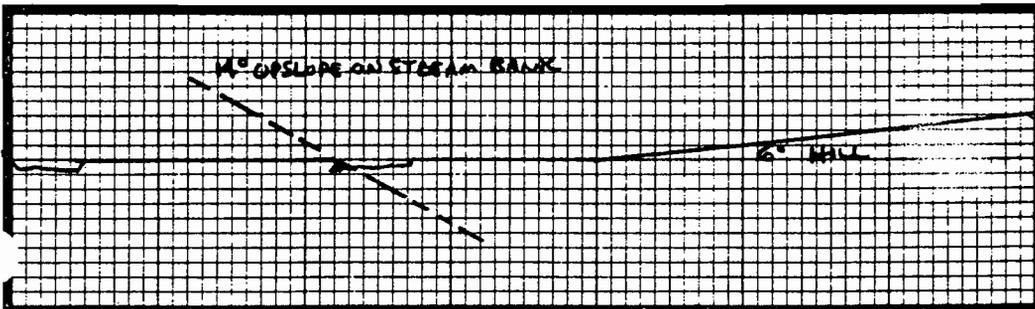
Crash Site Plan/Elevation

This high-wing, single-engine airplane experienced an engine failure after takeoff as a result of fuel contamination. During the ensuing forced landing, the airplane impacted into a creek bank, continued 106 feet further, and ultimately came to rest in the creek. The airplane was destroyed.

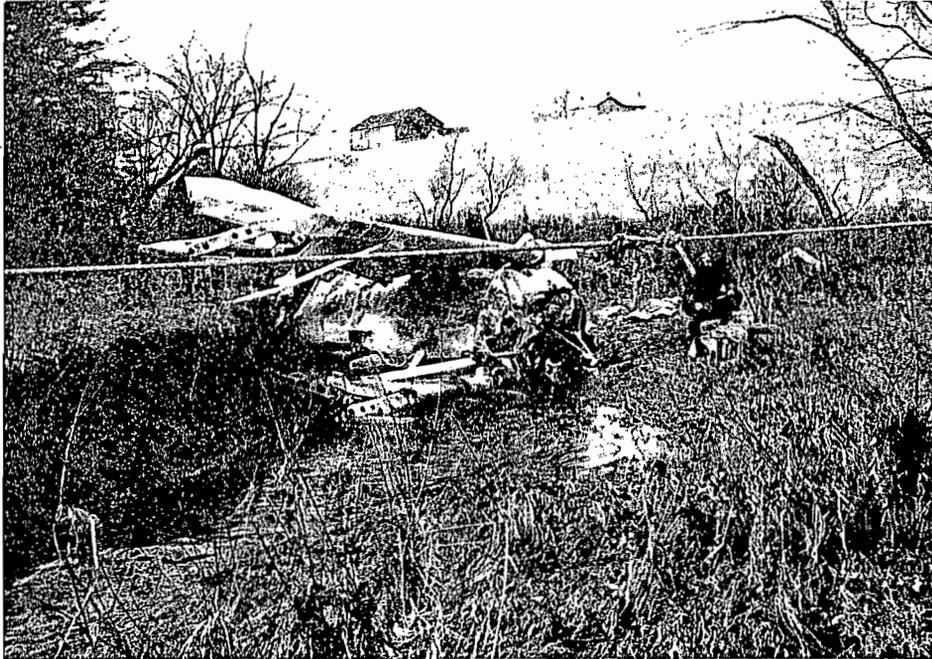
9-2. Wreckage.

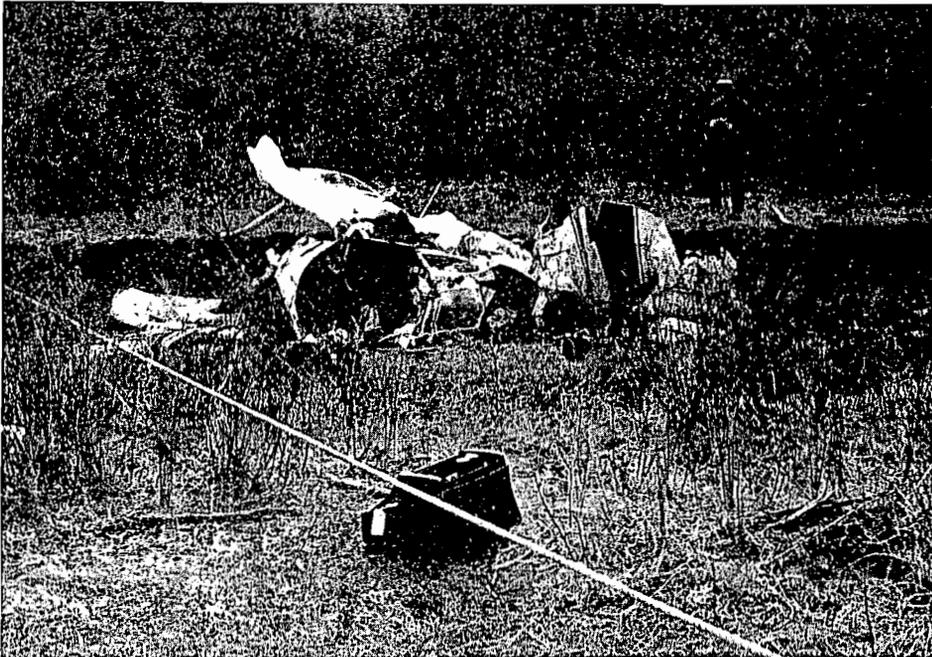
9-3. Wreckage.

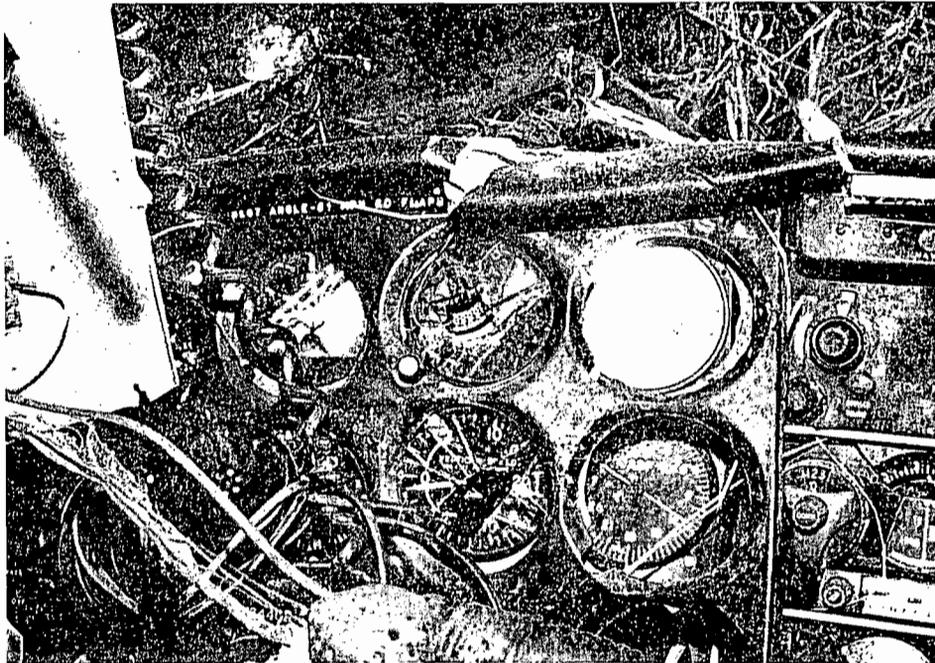
9-4. Pilot's head contact area.

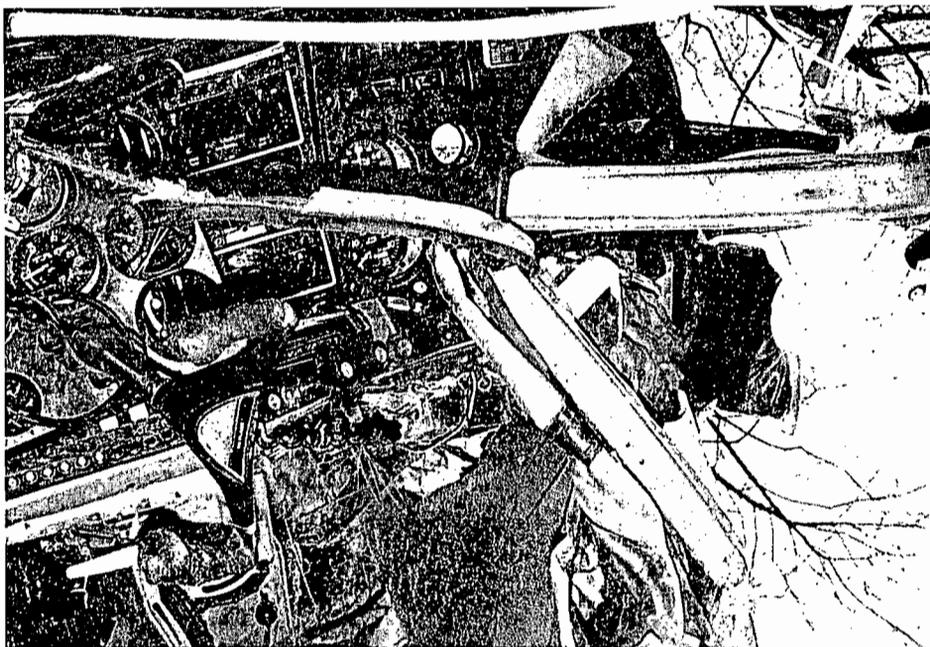
9-5. Area near right front occupant;  
note door post over control column.

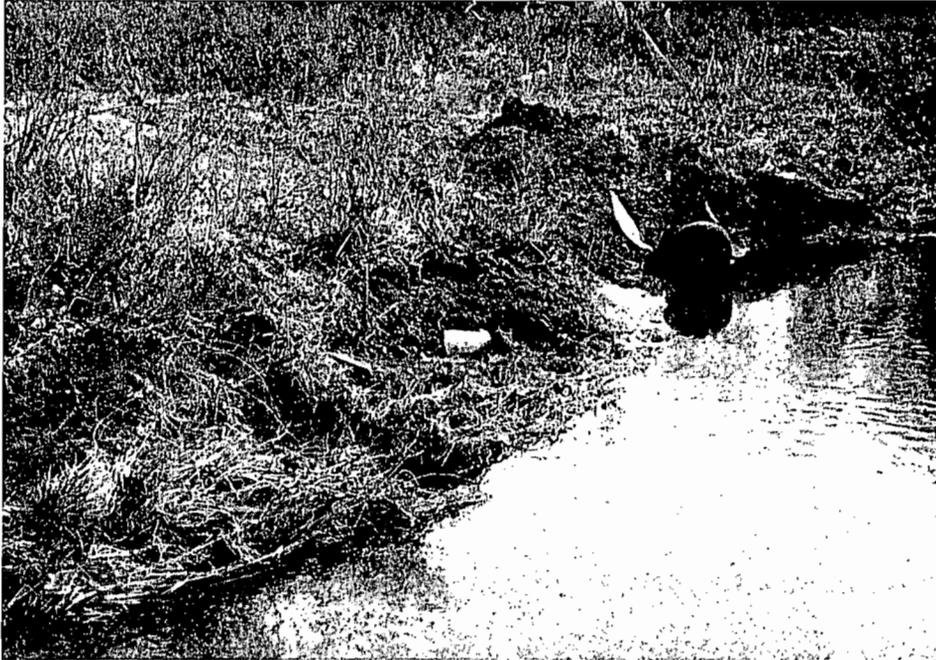
9-6. Principal impact area.

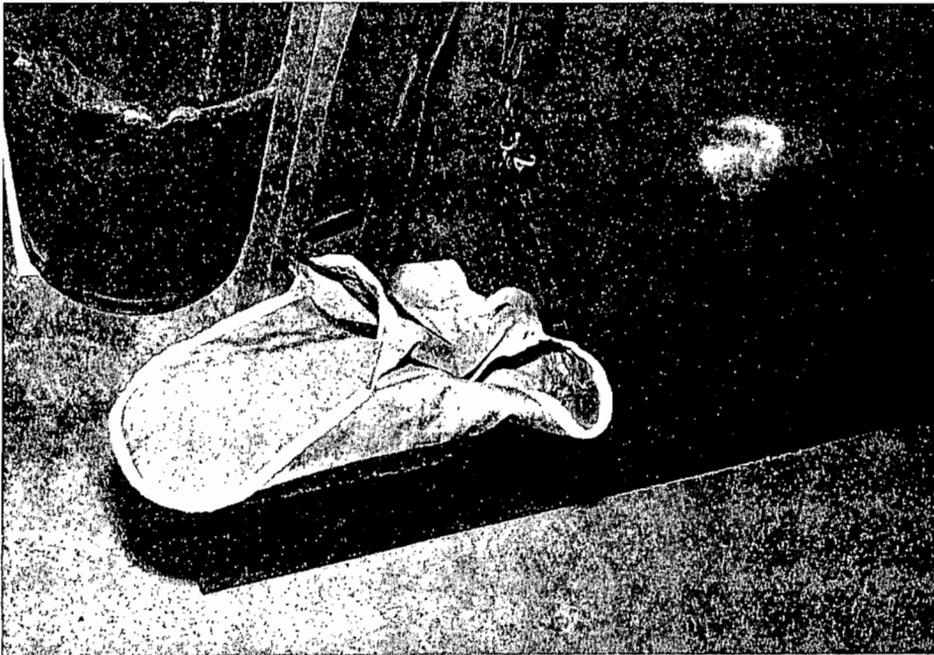
It is believed that 12 G's is the smallest force that would be possible for the noted conditions. If a sliding friction coefficient of 0.8 is used, an acceleration load of 16 G's peak is possible. In this case, the injuries are consistent with the calculated acceleration loads but the damage appears more extensive. This is probably the result of a rolling action that occurred during the slide. A point of interest is that the infant was retained in the papoose-type carrier with straps around the mother. At the end of the sequence, the baby was still in the carrier and the carrier was still attached to the mother, although separation appeared imminent because of the tearing of the carrier.

9-7. Child carrier that retained baby.

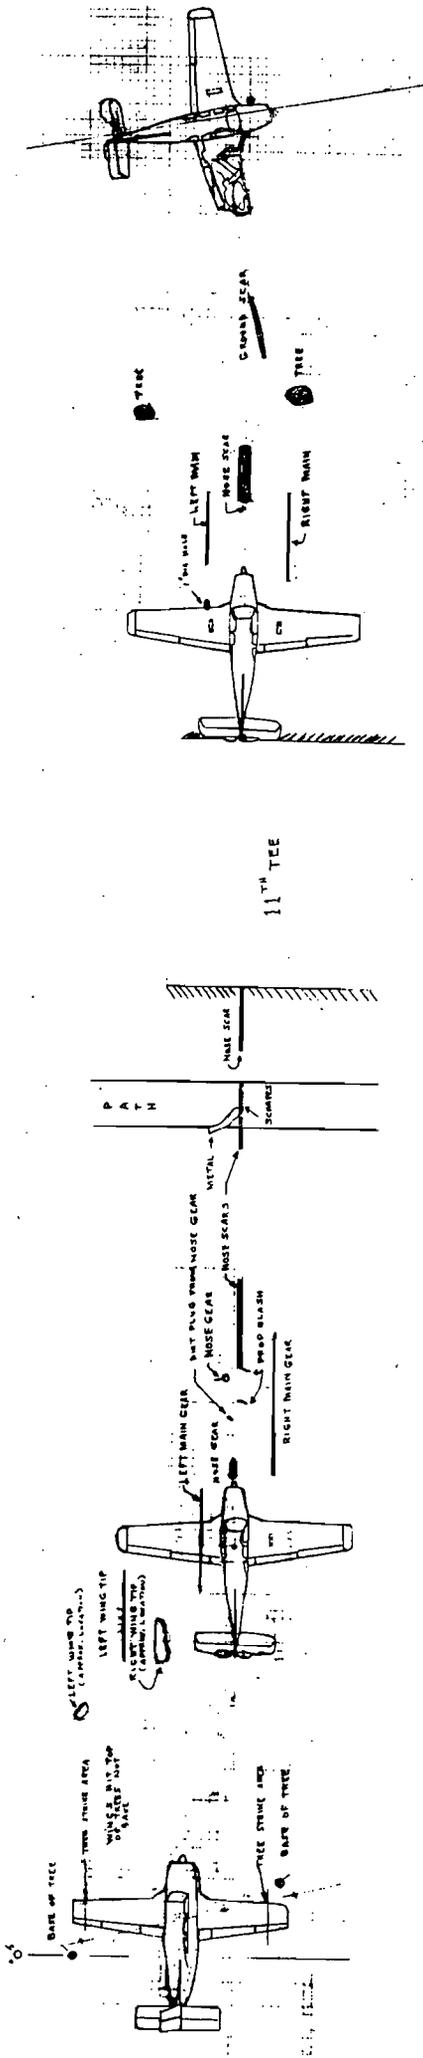
Because the airplane struck several trees and the ground prior to the major impact, it was difficult to determine the actual velocity losses in this accident. However, these small initial velocity losses cumulatively absorbed a substantial amount of energy, a little at a time. The net result was that the major impact was much less catastrophic than it might otherwise have been. The principal impact was at the secondary tree strike where the left wing was sheared in two and the right wing was heavily damaged. The airplane was substantially slowed prior to this impact, and the resultant acceleration loads were calculated at about 3 G's average using a decrease in velocity from 46 feet per second to 32 feet per second over the 5 feet of wing crushing. The average load is considered to be reasonable since an increasing amount of structure was not involved. The relative lack of occupant injury was also considered.

10-1. Flight path and impact depiction (top view)..

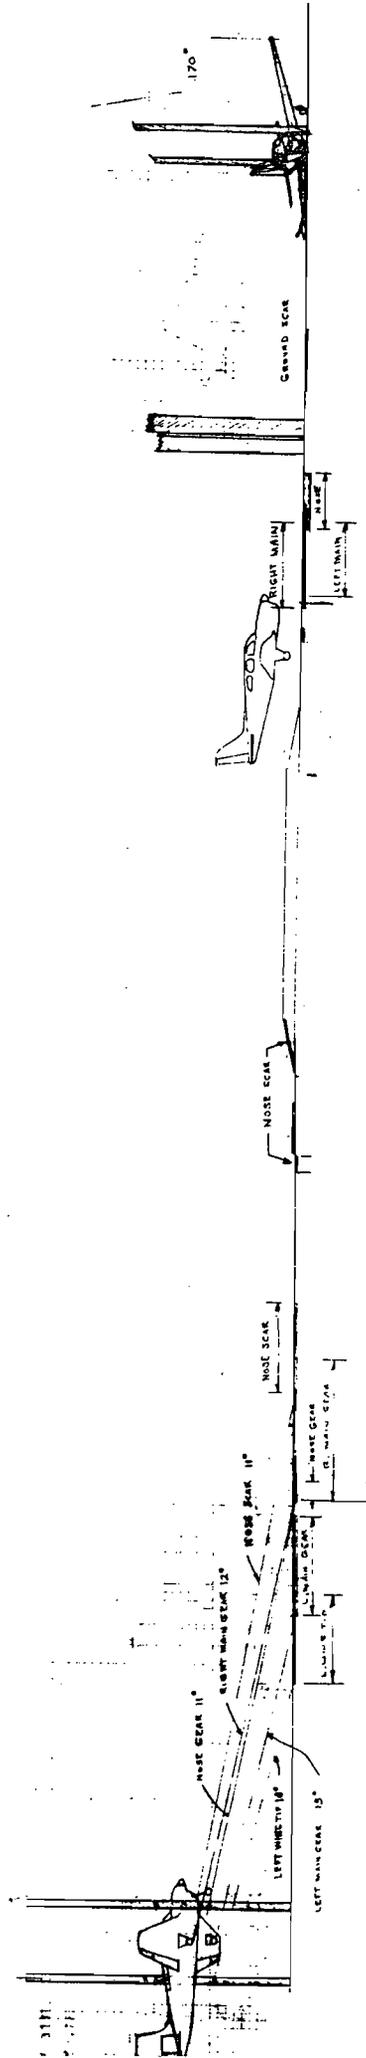
10-2. Flight path and impact depiction (side view).

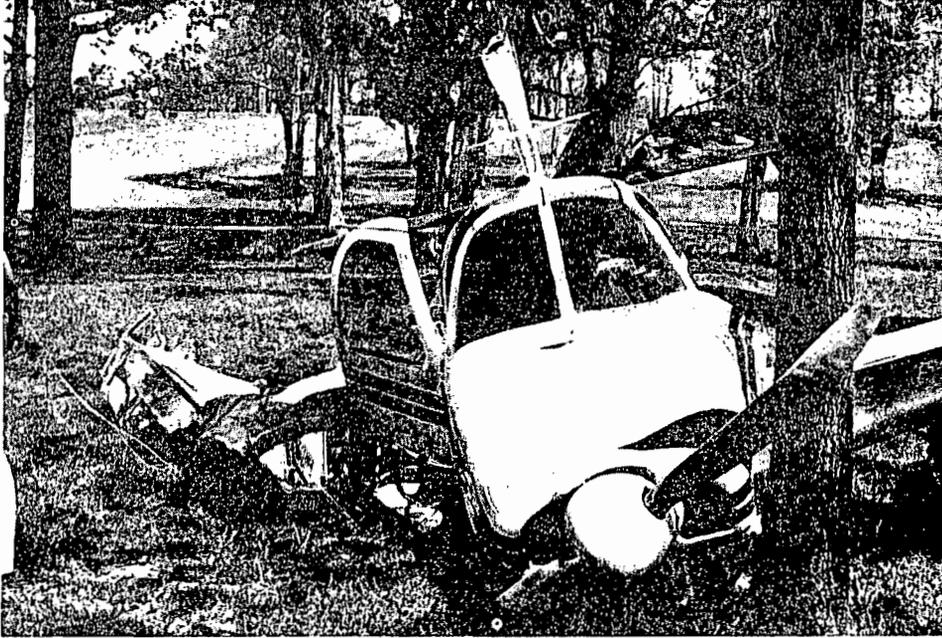
10-3 Wreckage.

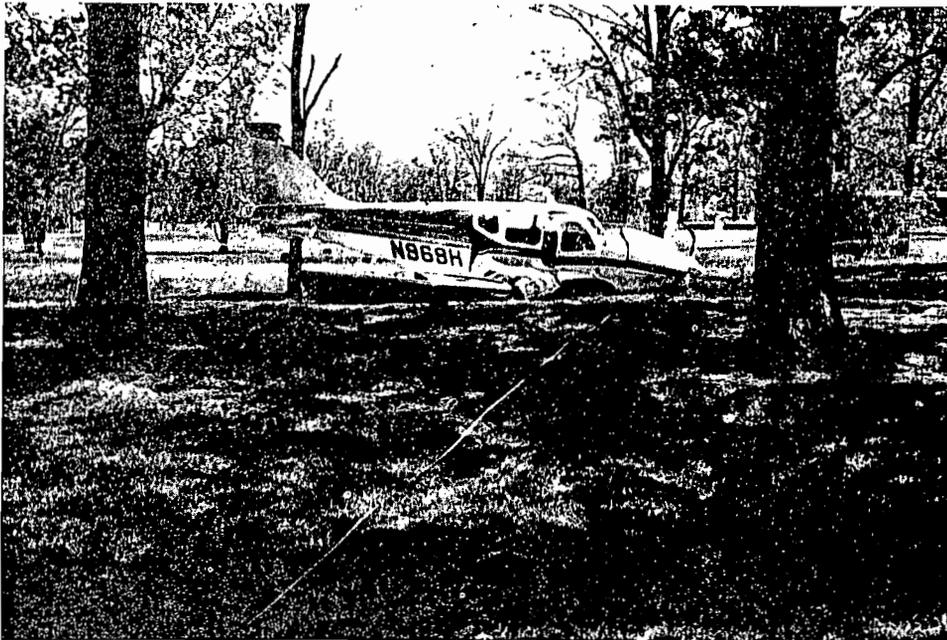
10-4 Wreckage.

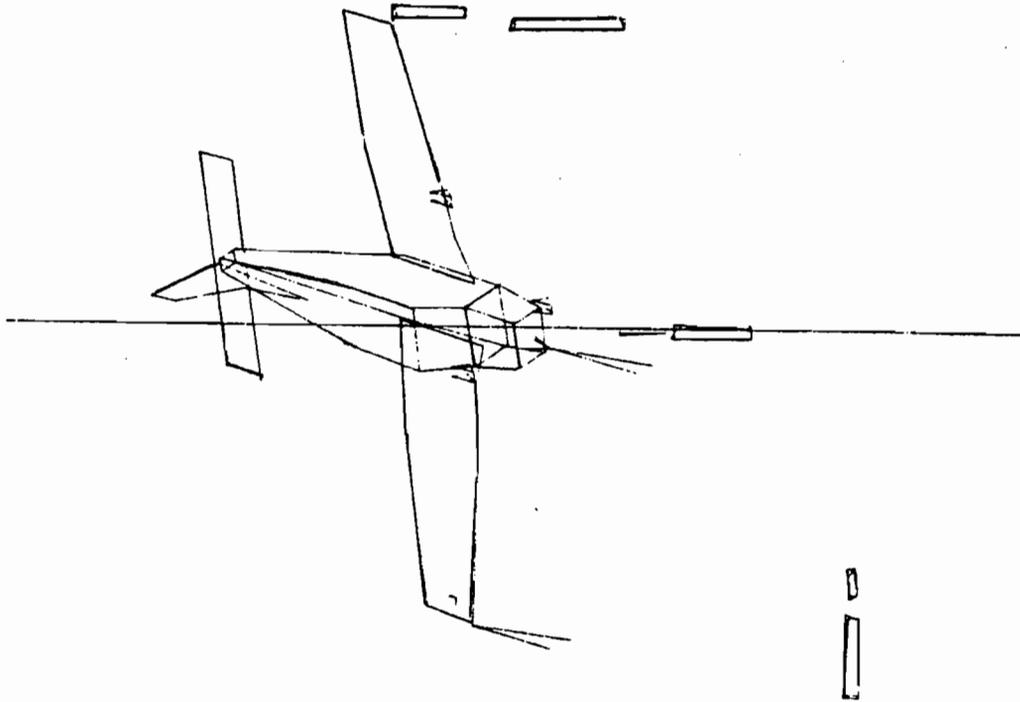
The airplane drawing was rotated through the impact sequence and it appeared that the total stopping distance at the principal impact was seven feet (5 feet of ground scar and about 2 feet of airplane motion). Slowing from 77 to 32 feet per second in 7 feet would result in a 22 G peak horizontal load over a period of 0.127 seconds.

11-1. Top view depiction of airplane at impact.

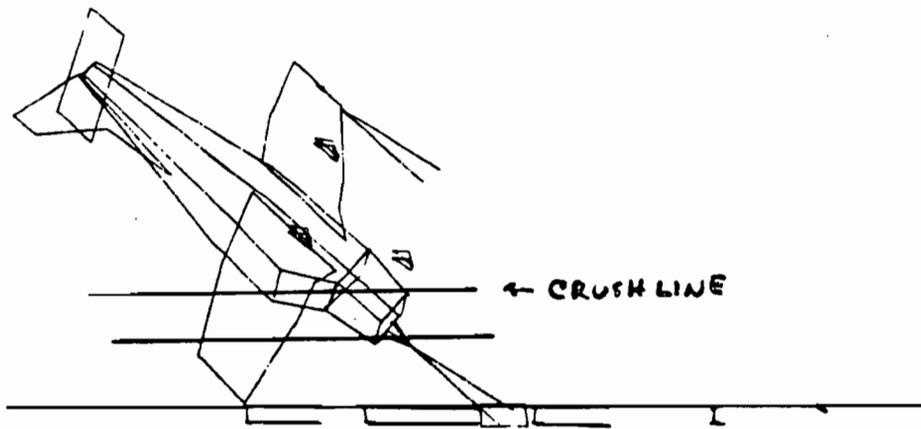
The resultant vector sum of the loads is nearly aligned with the fuselage, again indicating primarily longitudinal loads (airplane axis) to the occupants. The longitudinal loads would be about 30 G's peak for a 60 feet-per-second velocity change.

11-2. Side view depiction - airplane almost inverted.

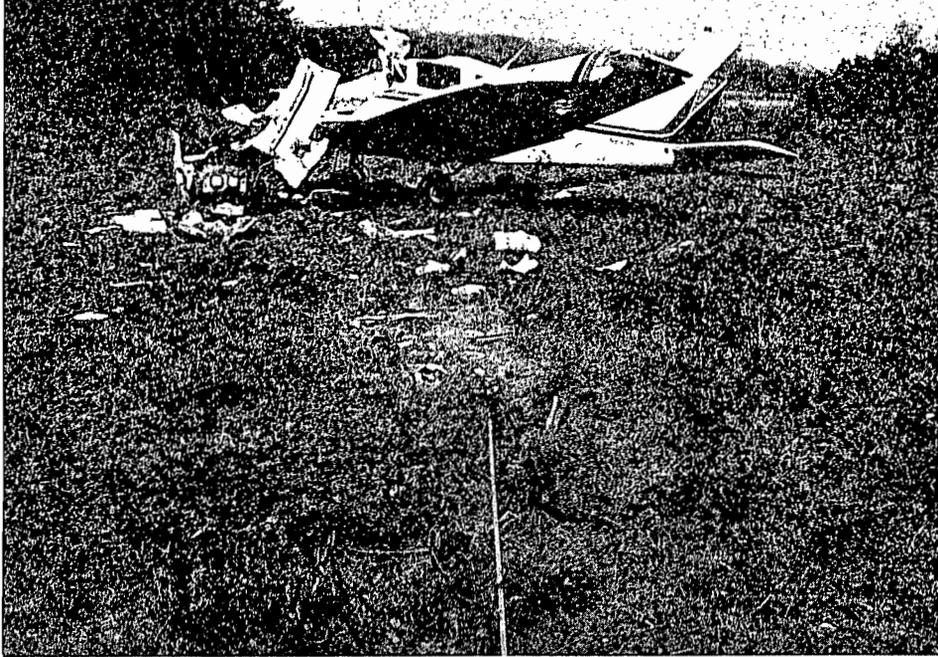
11-3. Wreckage.

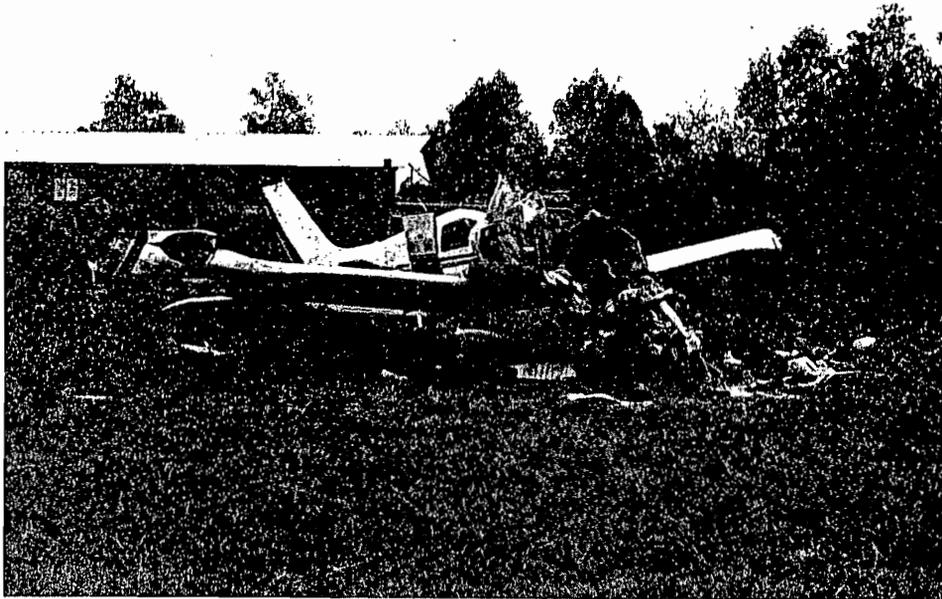
11-4. Wreckage.

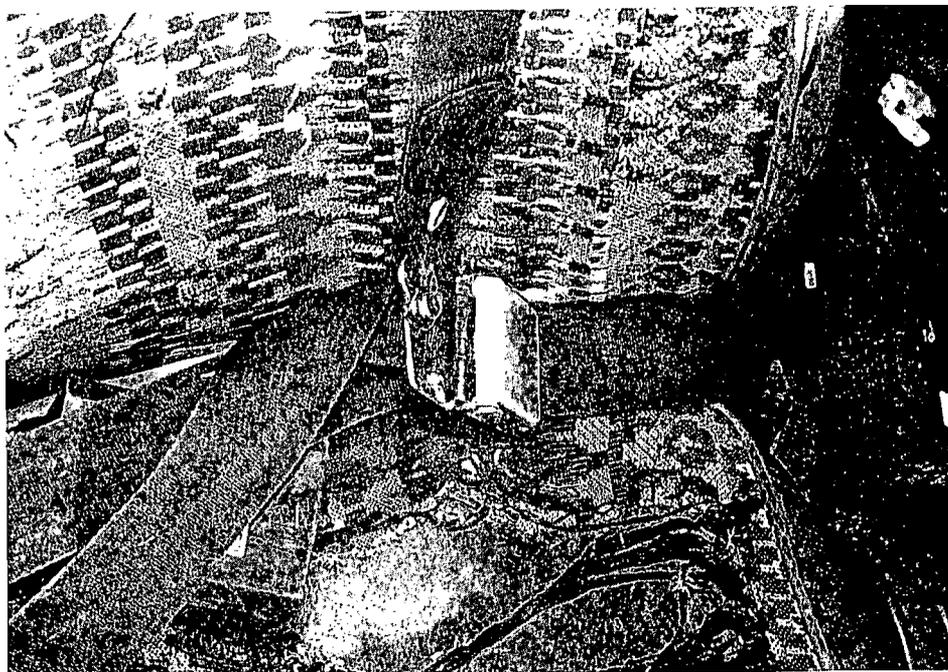
11-5. Shoulder harness worn.

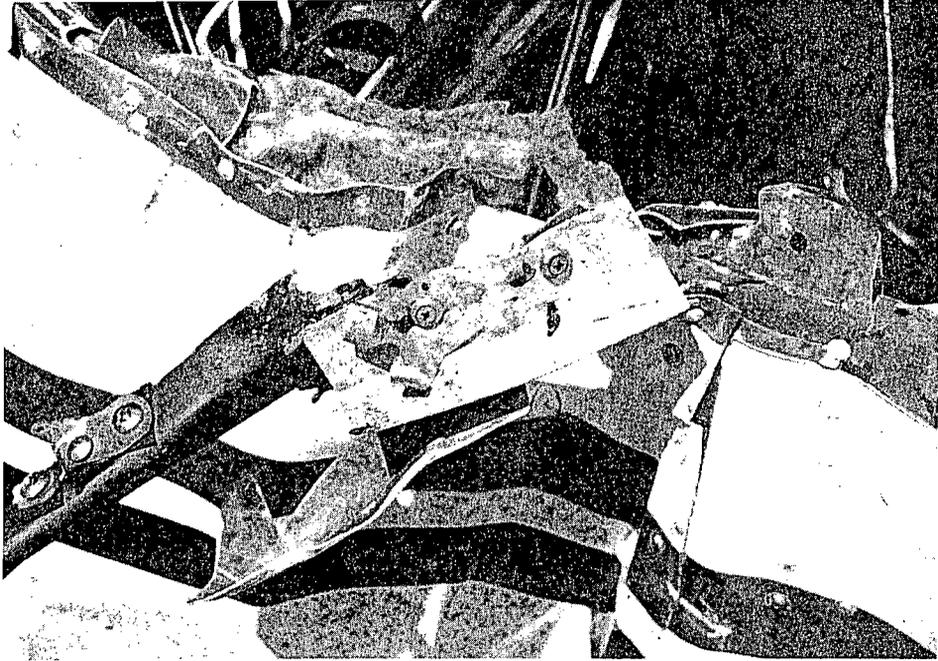
The fatally injured pilot, who had a shoulder harness but was not wearing it, was subjected to multiple extreme traumatic injuries as a result of his head impacting the instrument panel. He received multiple skull fractures, rib fractures, facial lacerations, and other injuries. Even though the cockpit roof was crushed, the pilot's injuries all resulted from contact with the instrument panel and the sidepost. His injuries might have been substantially less serious with the use of a shoulder harness. His three passengers were all seriously injured. The right-front passenger, who was wearing a shoulder harness, had a fracture-dislocation of the left forearm and a fracture of the scapular process as well as multiple facial lacerations. The right-rear passenger suffered a facial fracture and mesenteric tear (possibly as a result of seatbelt loads) which required resection of the small bowel. Injuries which may have been the result of excessive loads on the seatbelt could have been less severe with the use of a shoulder harness. The left rear passenger, who was also wearing a seatbelt, received multiple fractures of her right arm and other flailing injuries. In addition, she sustained a blowout-type rupture of the small bowel and multiple facial lacerations. Her abdominal injuries probably were the result of seatbelt loads, and if so, could have been prevented or made less severe by shoulder harness usage.

11-7. Pilot head strike area.

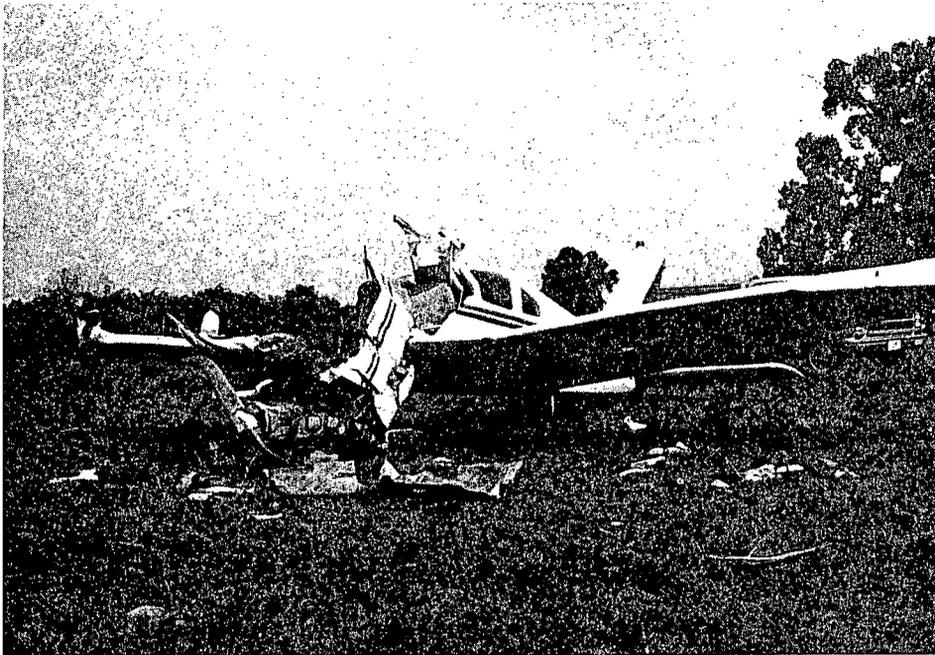
11-8. Circled area is pilot head strike area.

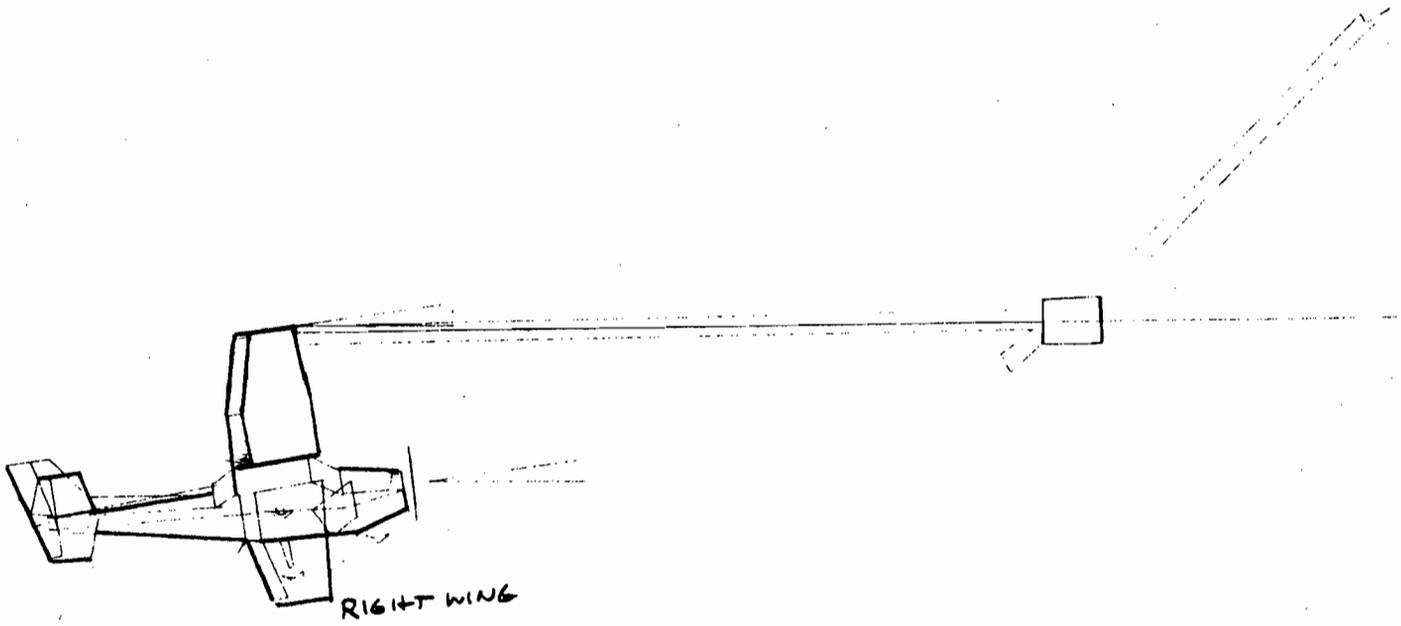
The exit velocity from the initial ground impact could not be determined because of the long slide and significant secondary impact into the side of the ditch. As a result, accurate reconstruction of the acceleration loads could not be made. The impact velocity of 55 knots was calculated by using the landing configuration stall speed corrected for weight and bank angle. The roll angle progressed from 60 degrees left wing down to 120 degrees of left roll. The pitch attitude changed from about level to 60 degrees nose-down. The impact angle was about 17 degrees.

12-1. Top view and side view  
(left wing down).

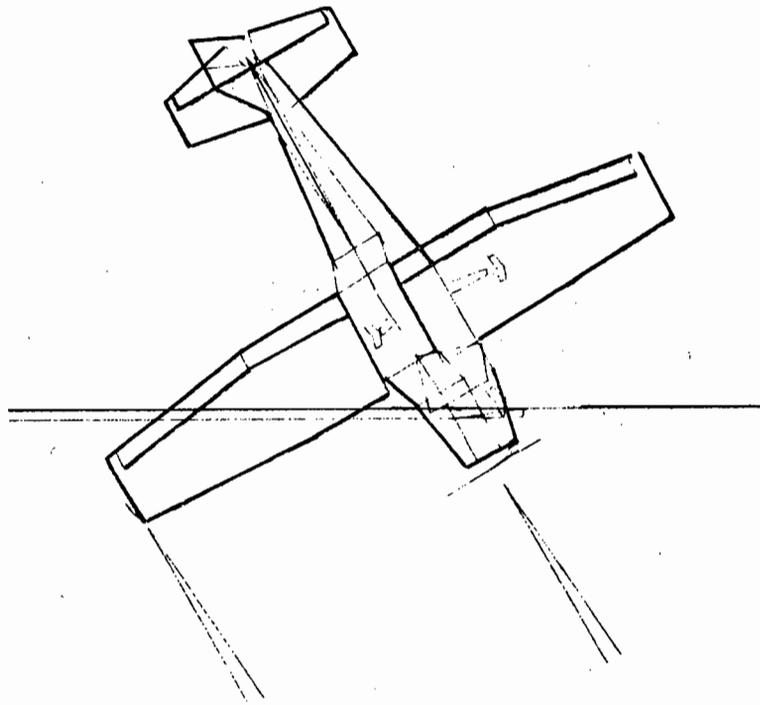
12-2. Side view - fully stroked position.

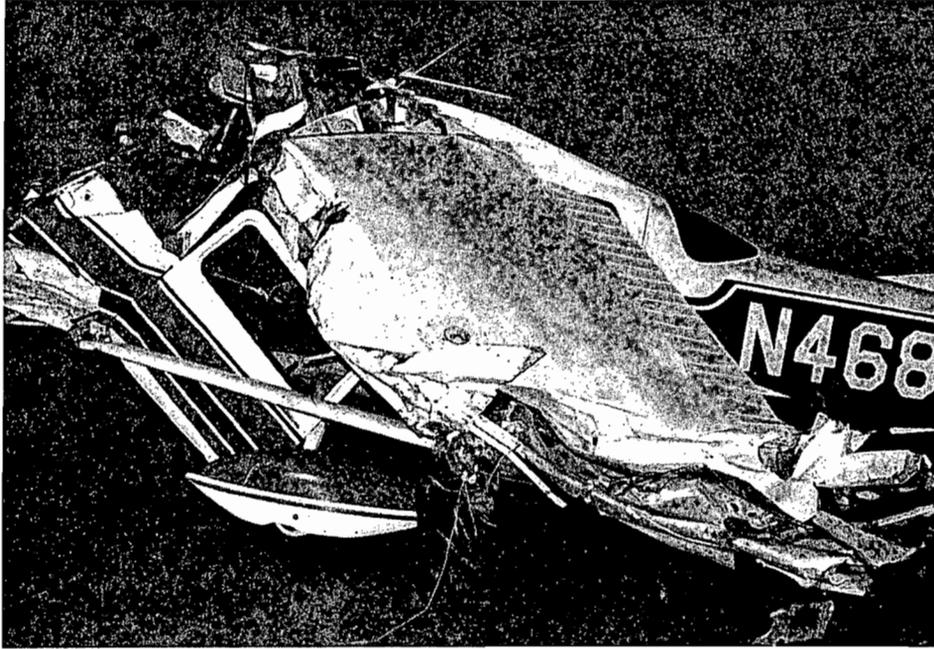
12-3. Wreckage.

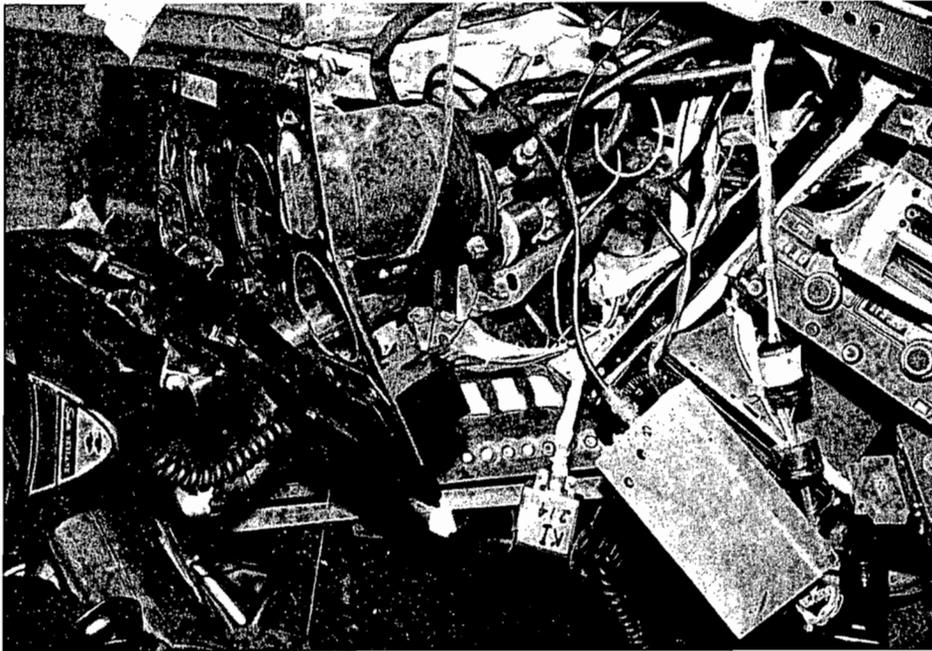
The pilot sustained multiple facial lacerations and a loss of consciousness, resulting in disorientation for several days following the accident. He also received a fractured ankle. A shoulder harness may have prevented his head injuries.

12-4 Pilot's area.

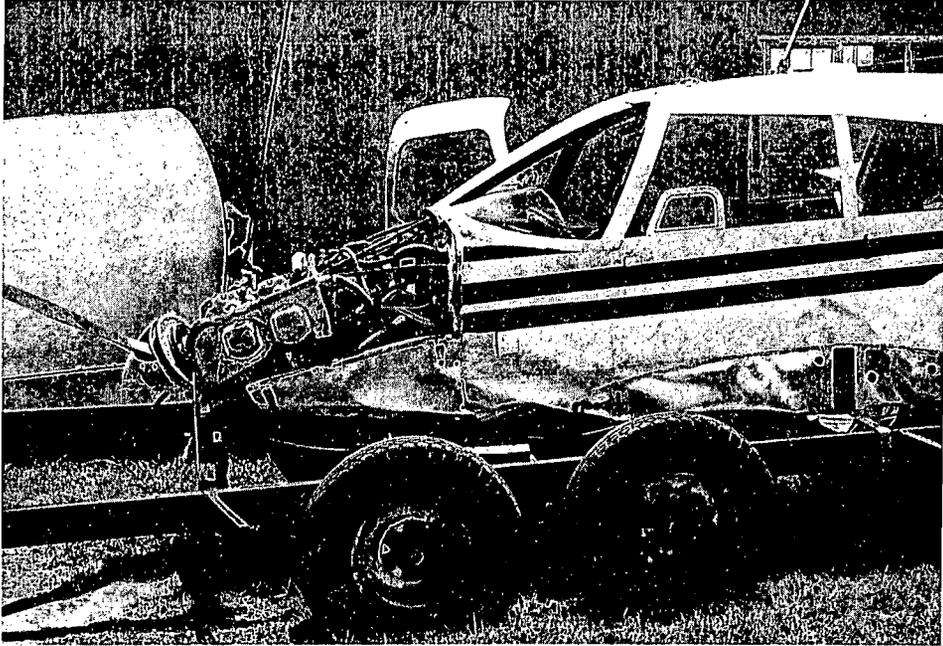
The vertical acceleration loads transmitted to the occupants were dictated by the effects of the gear and by the three inches of fuselage crush that could be measured. It was estimated that either the gear could slow the airplane down an equivalent of 8 feet per second or that the gear would break off and absorb no energy. If the gear did slow the airplane, it would slow the airplane from 14.8 feet per second to 12.5 feet per second. The peak vertical loads in these cases would have ranged from 15 to 20 G's. These loads are those imposed on the airplane. If the occupants' seats collapsed, the load to the occupants could be greater due to the secondary impact with the cockpit floor. The horizontal load was believed to have been small because occupants did not contact the instrument panel.

13-1. Wreckage - Crush line.

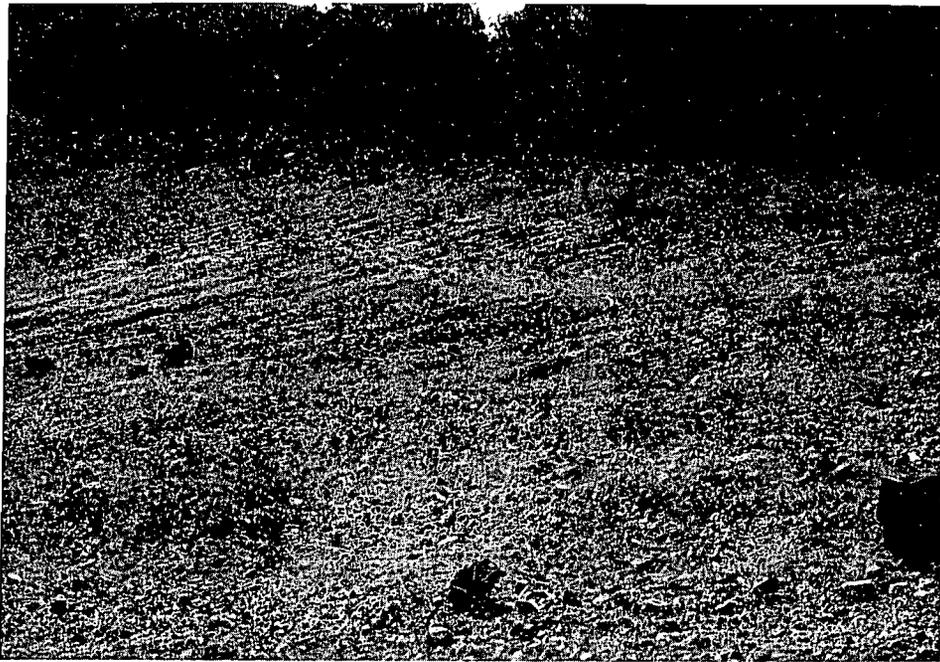
13-2. Impact points, general terrain.

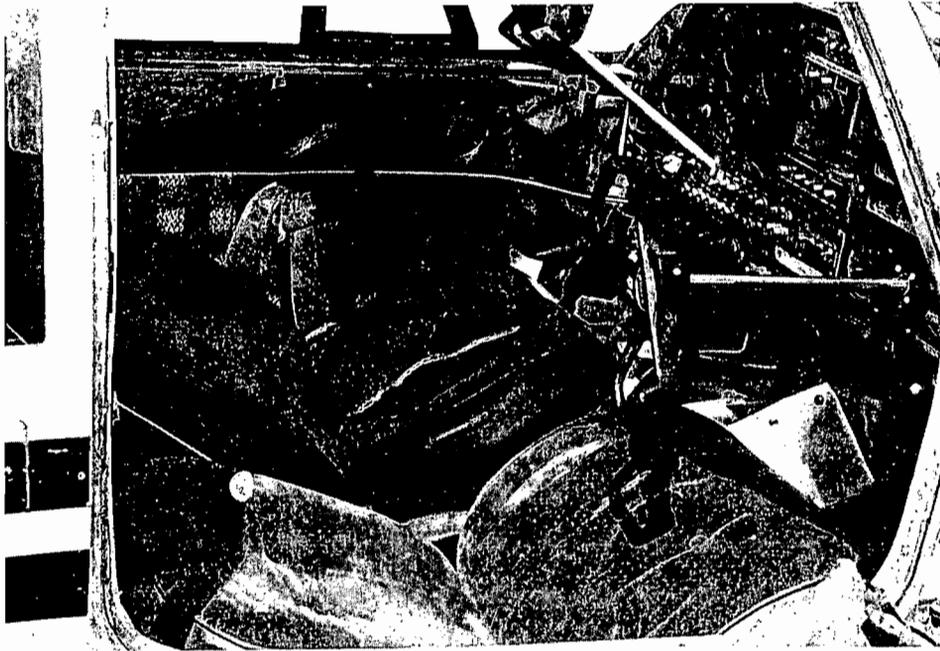
The pilot received compression fractures of the cervical spine and two fractured ribs. The cervical spine injuries probably resulted when the seat pan split, allowing the pilot to impact the floor. The passenger received fractured ribs, a perforated chest, and a severely sprained ankle. The exact injury sources for this passenger could not be determined.

13-3. Seats rotated down to floor.

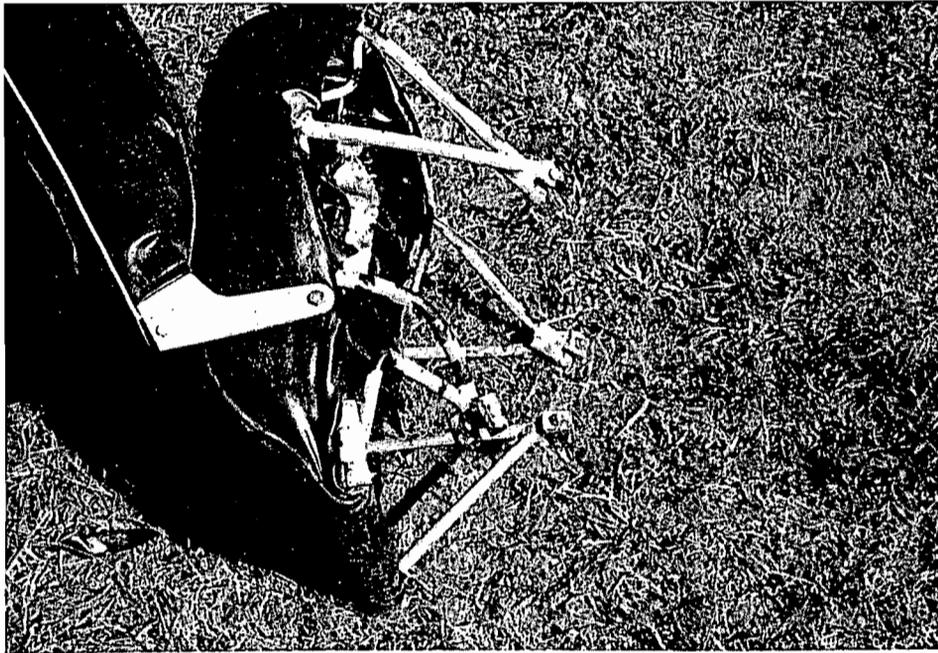
13-4. Pilot's seat - No stabilization between front and rear seat feet.

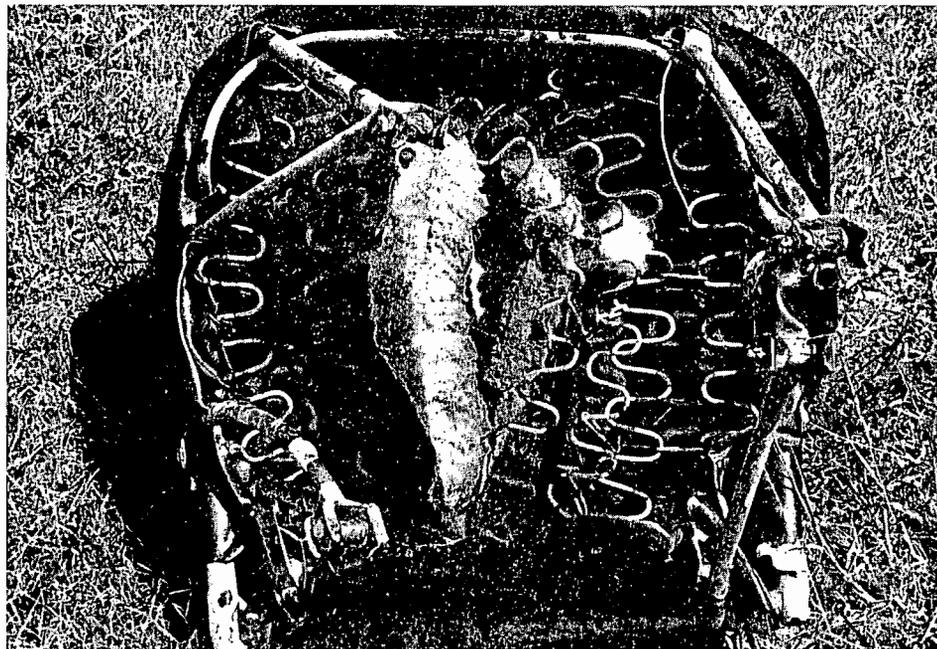
13-5. Springs pushed out of place.

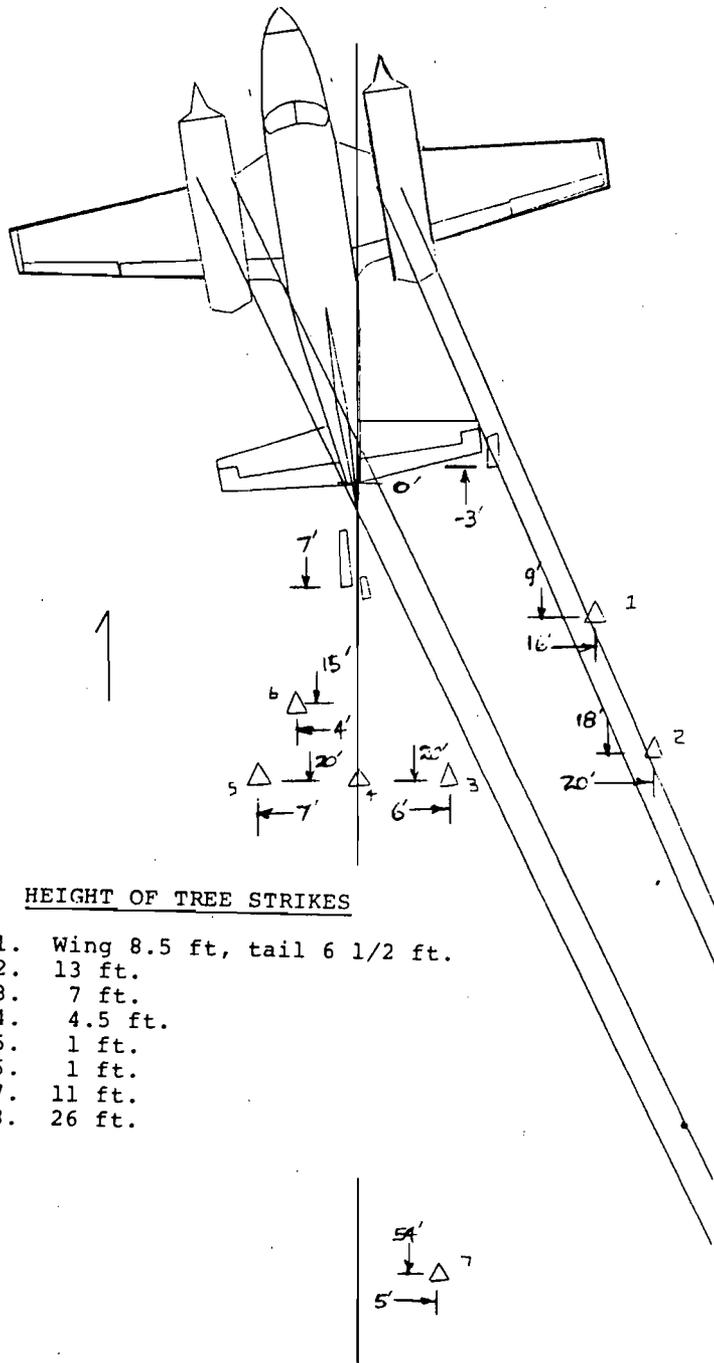
HEIGHT OF TREE STRIKES

1. Wing 8.5 ft, tail 6 1/2 ft.
2. 13 ft.
3. 7 ft.
4. 4.5 ft.
5. 1 ft.
6. 1 ft.
7. 11 ft.
8. 26 ft.

14-1. Final flight path through trees.

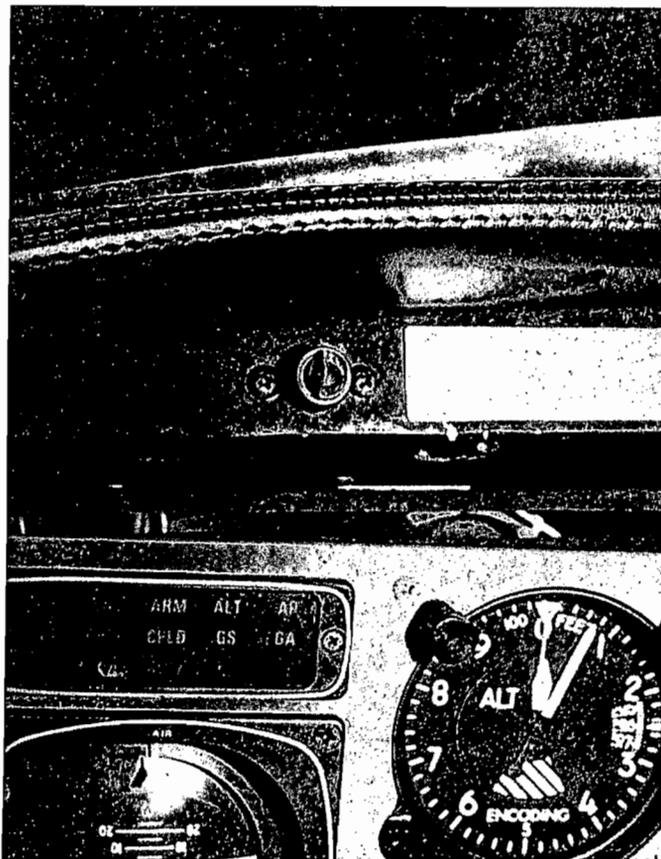
Acceleration loads could not be calculated because the multiple tree strikes and fragmenting of the structure precluded an accurate estimate of the impact velocity. However, the passenger had less than one inch of stroking distance because of the solid understructure in his seating area. The occupant contacted the understructure hard enough to leave a permanent dent in its metal cover.

14-5. Pilot's head contact area.

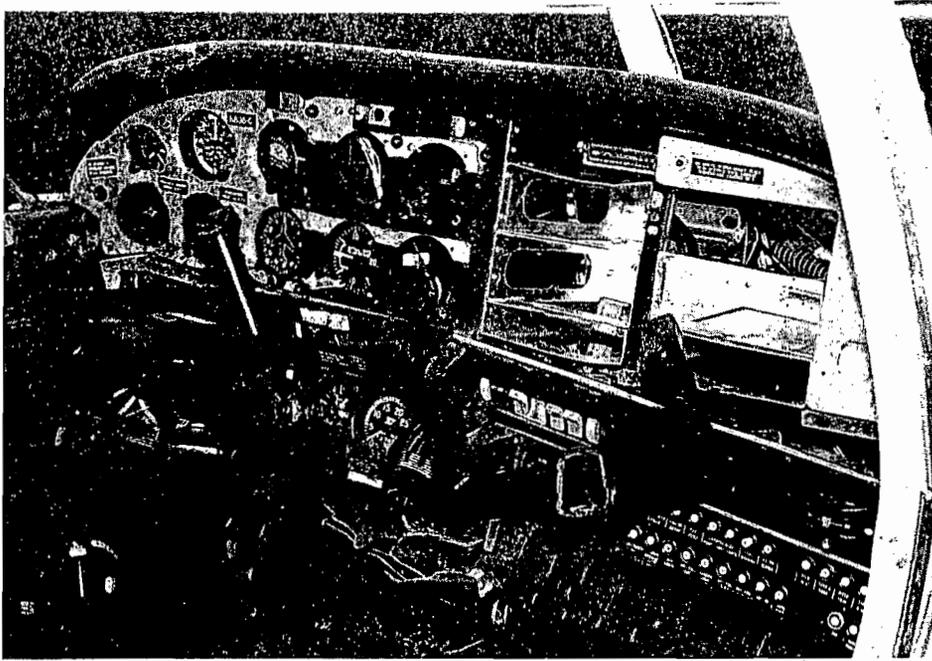
The occupants' seats were of an energy absorbing type. The seats were deformed and offered a significant amount of protection to the occupants. Both the pilot and his passenger were wearing lapbelts and shoulder harnesses and they remained in a snow-covered field for up to two hours before being rescued and transported to a hospital. The pilot received extensive lacerations of his face and a broken nose, broken ankles, and fractures of the third, fourth, and fifth ribs. The passenger also received multiple traumatic injuries, including extensive scalp lacerations, with the scalp peeled off the skull for a considerable distance. He also had a depressed skull fracture, fractures of both legs, and multiple bruises. In spite of the protection offered by the shoulder harnesses, both the pilot and the passenger impacted portions of the instrument panel as well as the side windows and side posts. Without shoulder harnesses, these impacts would probably have been fatal.

15-3. Pilot contact area.

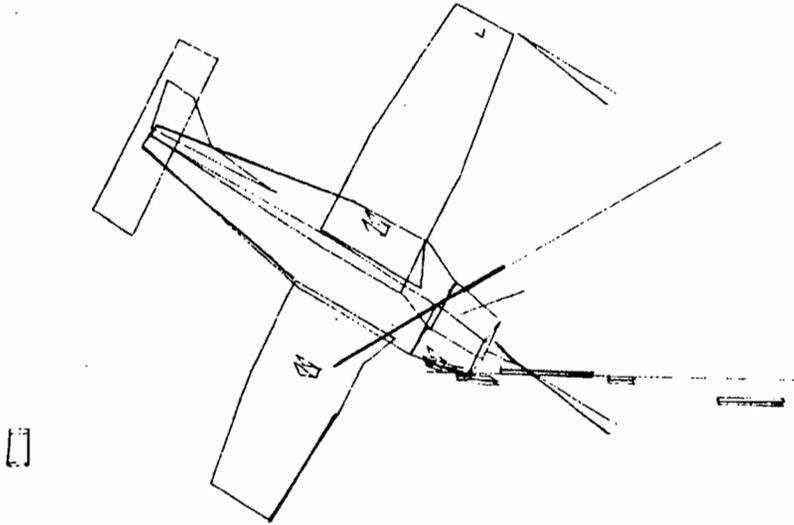
The airplane impacted the ground in a 30-degree nose-down pitch attitude with a 45-degree right roll. By the time the fuselage was fully crushed to the ground, the pitch attitude had increased to about 40 degrees. The airplane then slid 45 feet down an 18 percent slope. The initial impact speed was estimated to be 55 knots based on a flaps-up stall speed of 58 knots, corrected for weight, and adding 5 knots for acceleration to the ground after the stall.

16-1. Impact angle (side and rear view).
