# NATIONAL TRANSPORTATION SAFETY BOARD

## SAFETY REPORT

GENERAL AVIATION CRASHWORTHINESS  
PROJECT: PHASE III - -  
ACCELERATION LOADS AND  
VELOCITY CHANGES OF SURVIVABLE  
GENERAL AVIATION ACCIDENTS

NTSB/SR-85/02

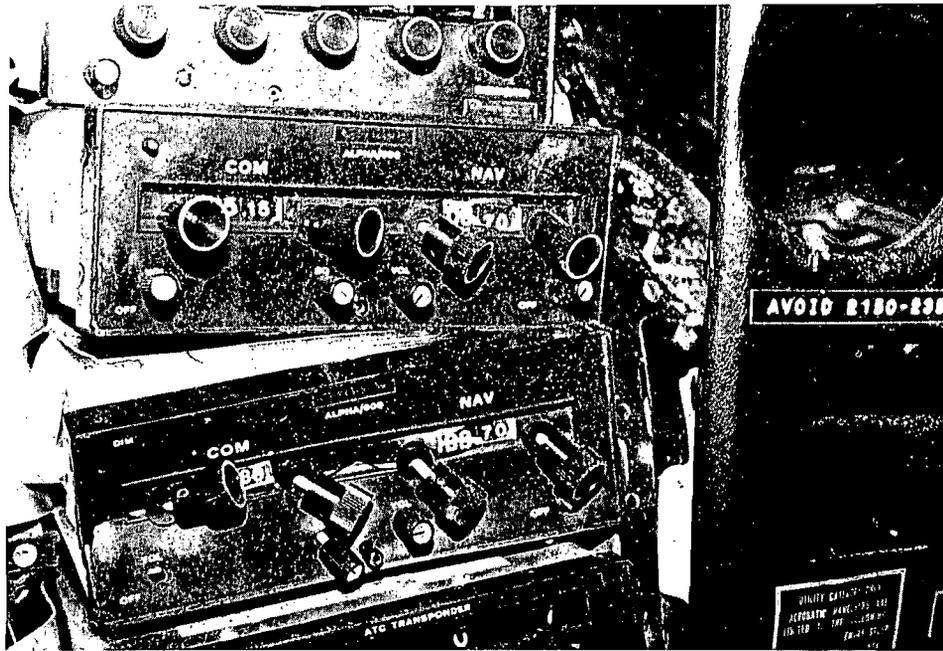
Although the pilot was killed, this accident was fully survivable. During the impact, his body and extremities contacted the instrument panel and control column. His chest was crushed and he received multiple brain contusions. There was no evidence of loading to the lapbelt which would be indicative of aft movement of the instrument panel. Passengers were seated in the copilot seat and in the right-rear seat, directly behind the copilot seat. Both passengers were seriously injured. At the time of impact, both were wearing lapbelts. The passenger in the right-front seat received lacerations to her face, ear, and left knee, caused primarily by impacts with the door post. She was unconscious when found and was not breathing because of an obstructed airway. She also fractured her right foot and coccyx. The legs of her seat bent to the right while the back frame and seat pan bent downward. The passenger occupying the right-rear seat received fractures of the lumbar vertebrae, and was also unconscious. The seat attach fittings separated.

16-5. Head impact area.

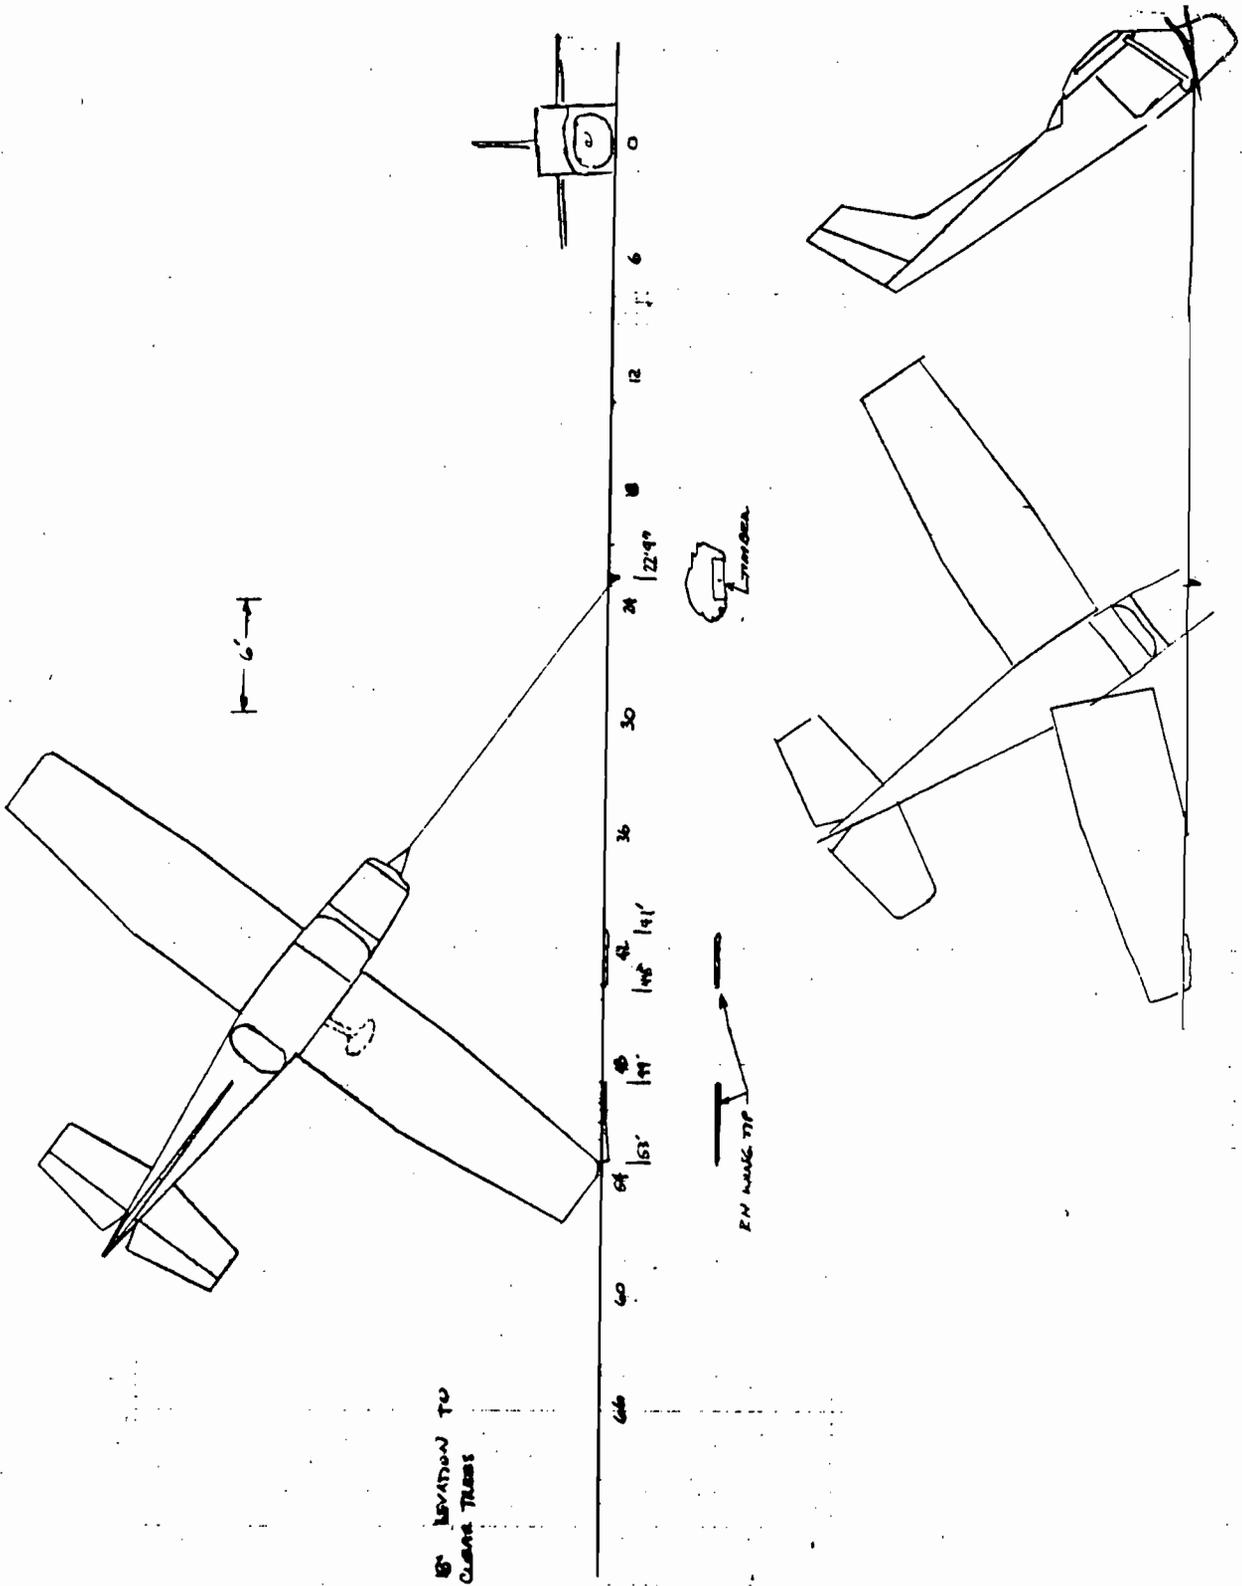
The airplane impacted the ground right wing first. By matching ground scars and airplane components, the attitude was reconstructed at 37 degrees nose-down with about 90 degrees right roll. An estimated impact speed of 41 knots was based on a landing configuration stall speed of 42 knots corrected for an estimated 60-degree roll, a weight of 2,000 pounds, and power on. It was assumed that the wing would create a ride down effect of 1 G acceleration for 19 feet, or a velocity change from 69 feet per second to 59 feet per second. The vertical velocity change would then be from about 30 feet per second to zero. A 23-foot slide and cartwheeling at a friction coefficient of 0.5 would create a 27 feet-per-second exit velocity. Therefore, the horizontal velocity change was estimated to be from 51 feet per second to 27 feet per second.

17-1. Impact angle.

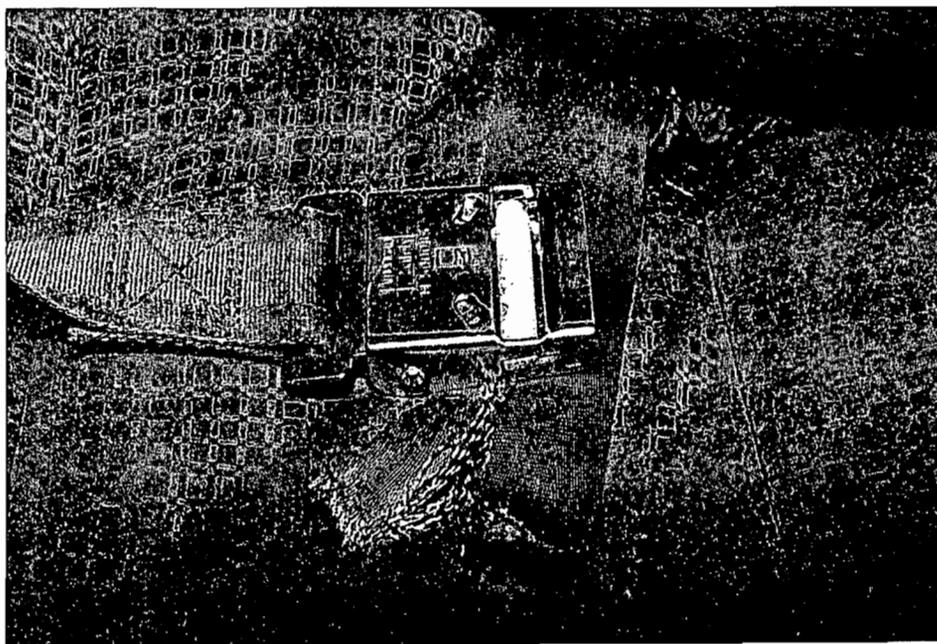
17-5. Buckle cam cut through webbing.

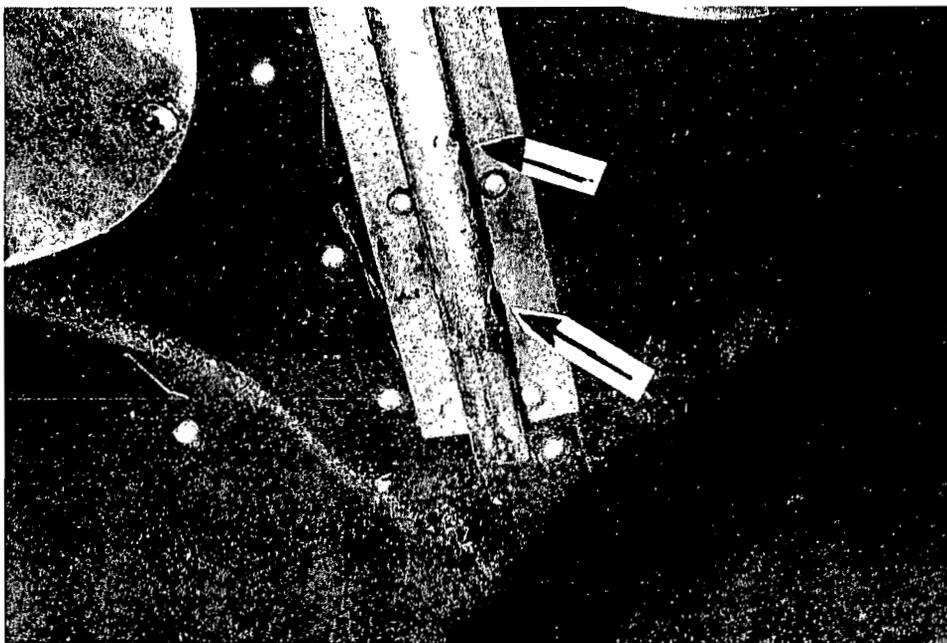
18-4. Tracks torn out.

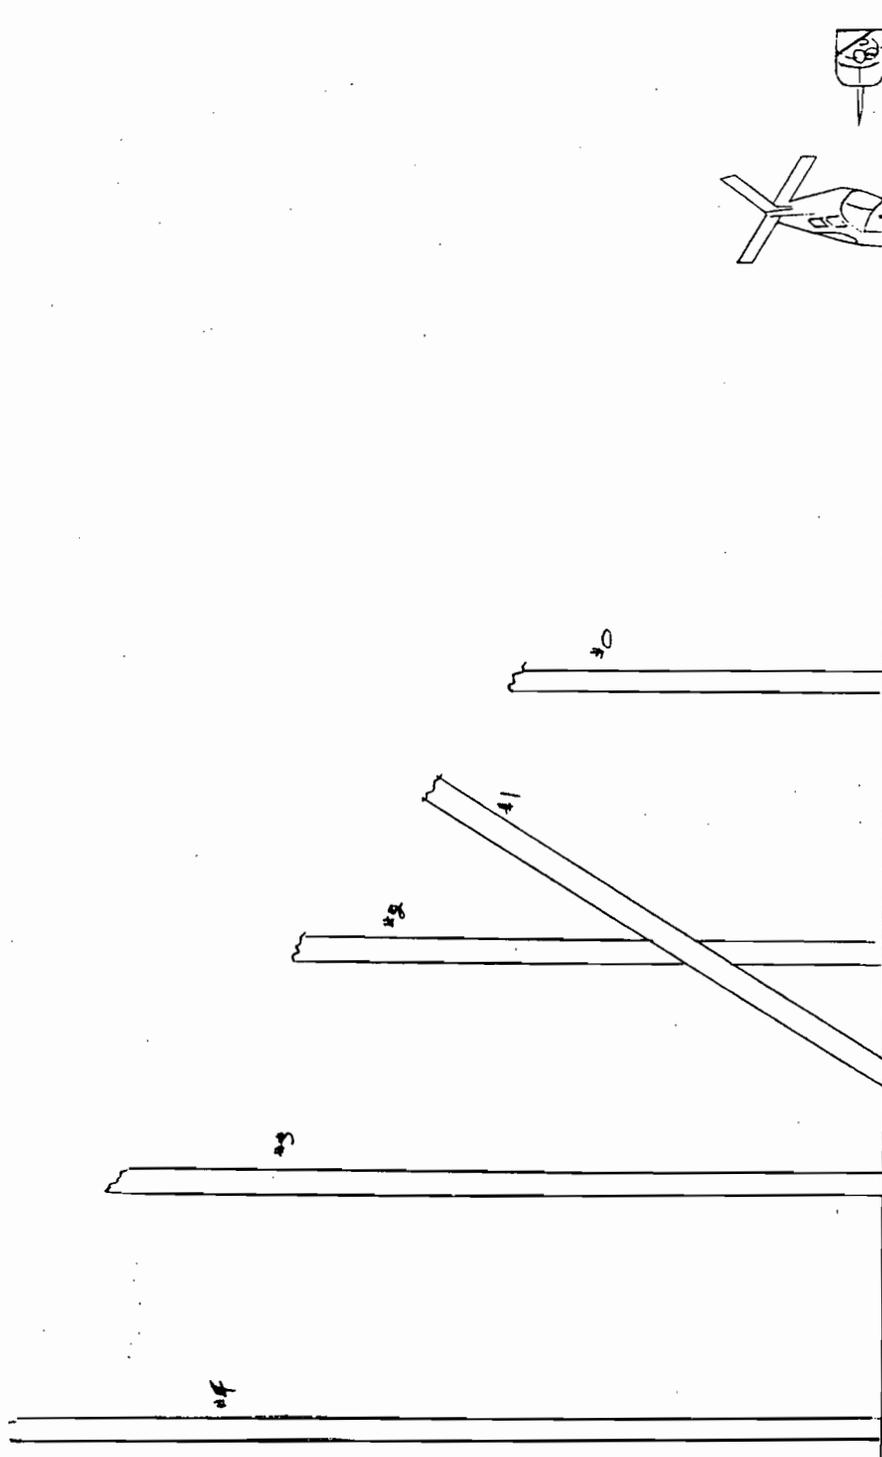
The flight path angle of 39 degrees was reconstructed from the tree strikes and the ground scars. A minimum vertical velocity of 46 feet per second was assumed, based on the 34-foot drop. The total velocity of 74 feet per second was based on the 46 feet per second velocity and the 39-degree impact angle. The airplane moved only 12 feet after impact with the movement being a rolling motion so no corrections were made for the slide. It is assumed that most of the energy was dissipated during the principal impact because of the low energy slide out. The crush to the fuselage was measured at 2.7 feet. Therefore, the peak acceleration loads were calculated to be about 63 G's, using the 74 feet per second velocity change and the 2.7 feet stopping distance.

19-1. Impact angle.

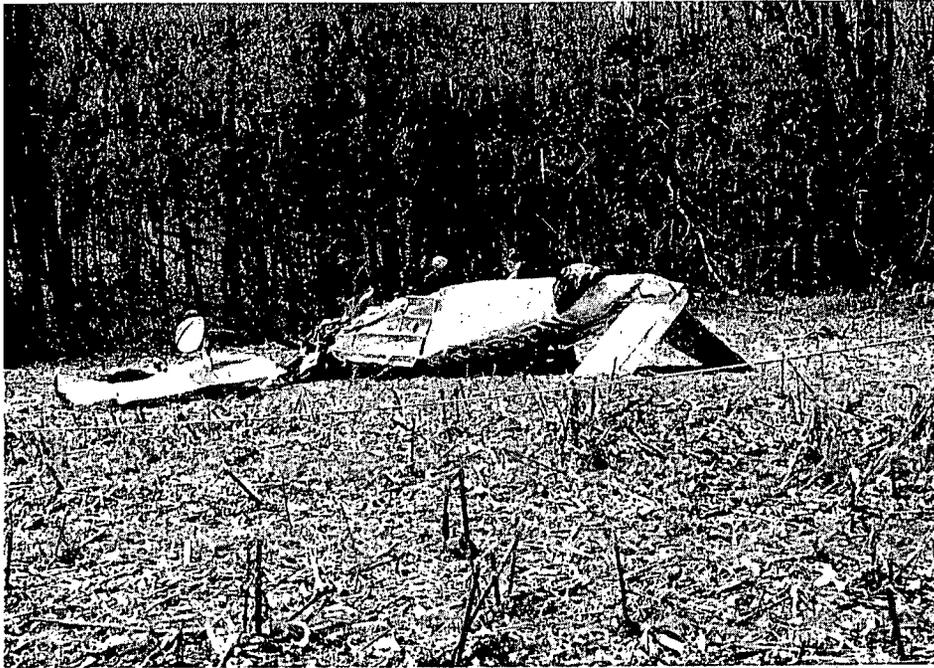
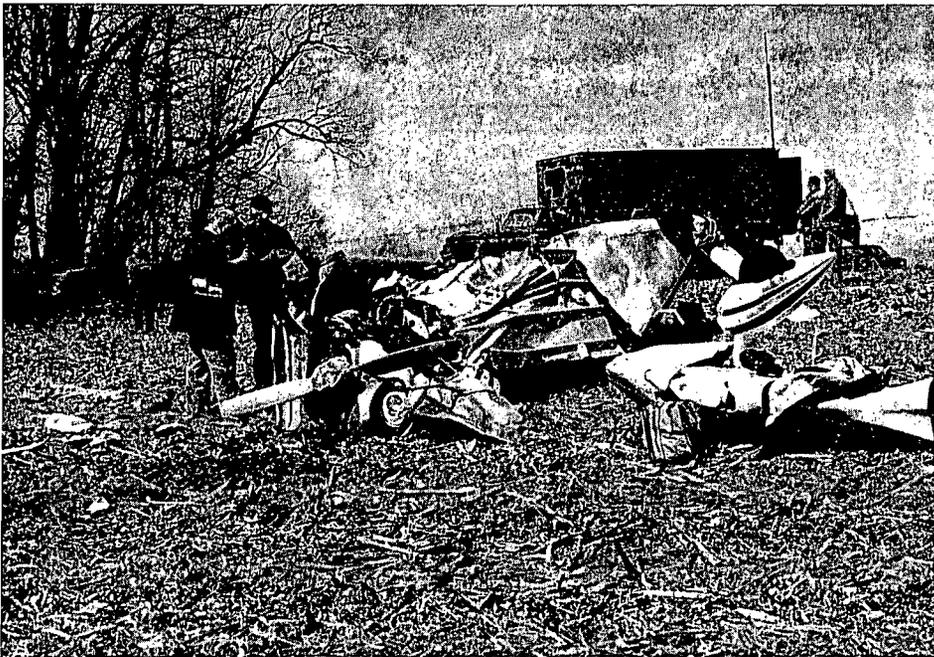
19-2. Wreckage-crushline.

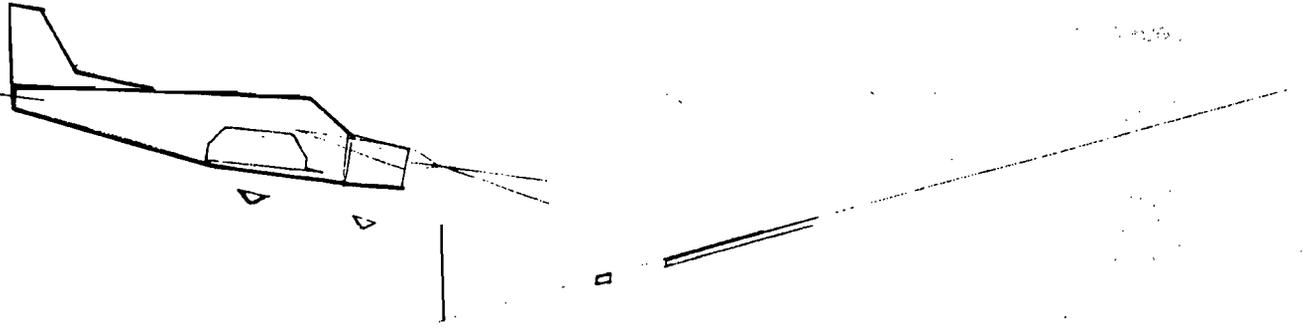
The vertical velocity would have been between 36 and 44 feet per second and the horizontal velocity was about 77 to 80 feet per second. A slide of 29 feet, a slope of 23 percent, and a friction coefficient of 0.7 would yield an exit velocity of 42 feet per second.

20-1. Impact angle.

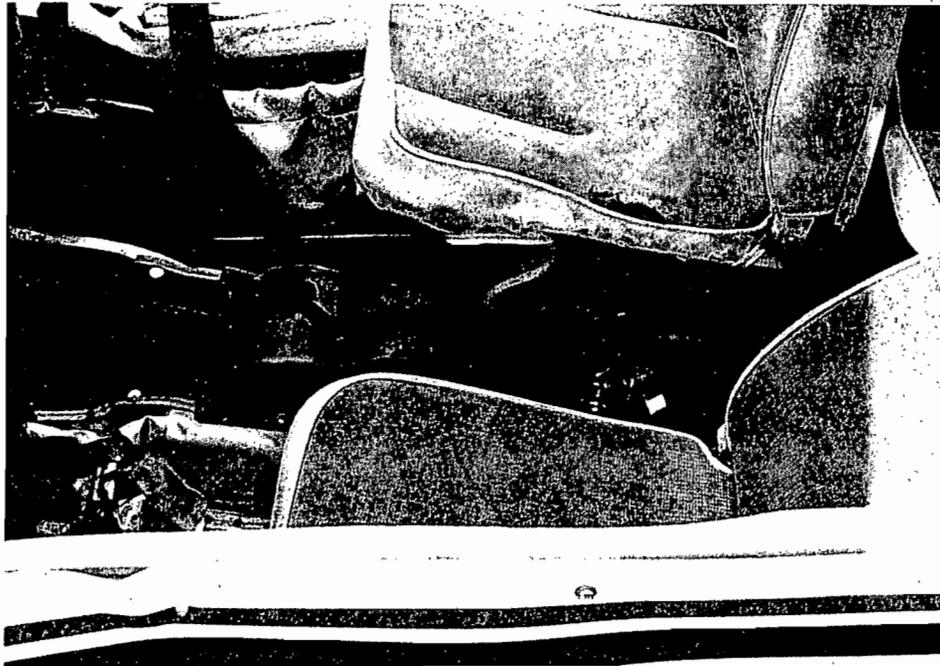
20-3. Energy absorbing seat in place.

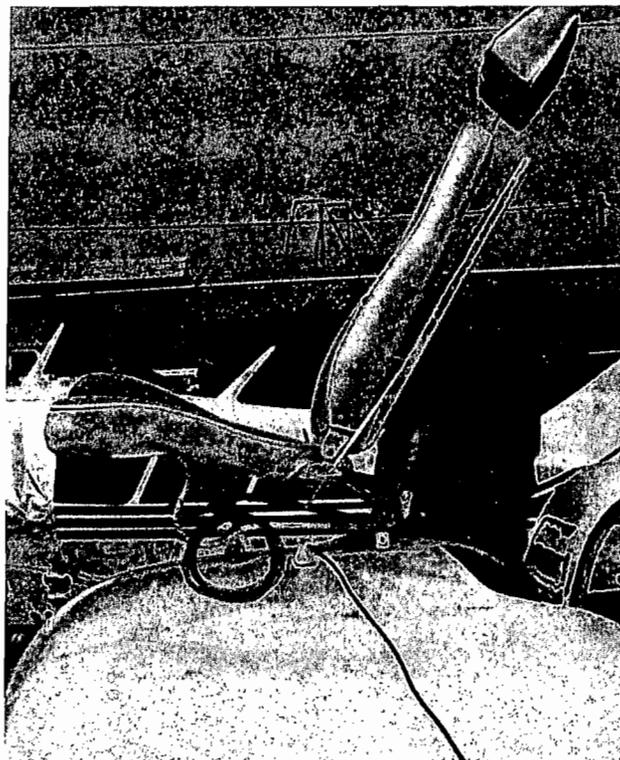
The airplane was equipped with energy absorbing seats. The pilot's seat stroked, absorbing energy which protected the pilot from higher vertical loads. Had the shoulder harness been worn, the pilot probably would not have received head injuries and may have been seated in a more upright position, thus preventing the flexion injuries to his back.

20-4. Partially stroked energy absorbing seat.

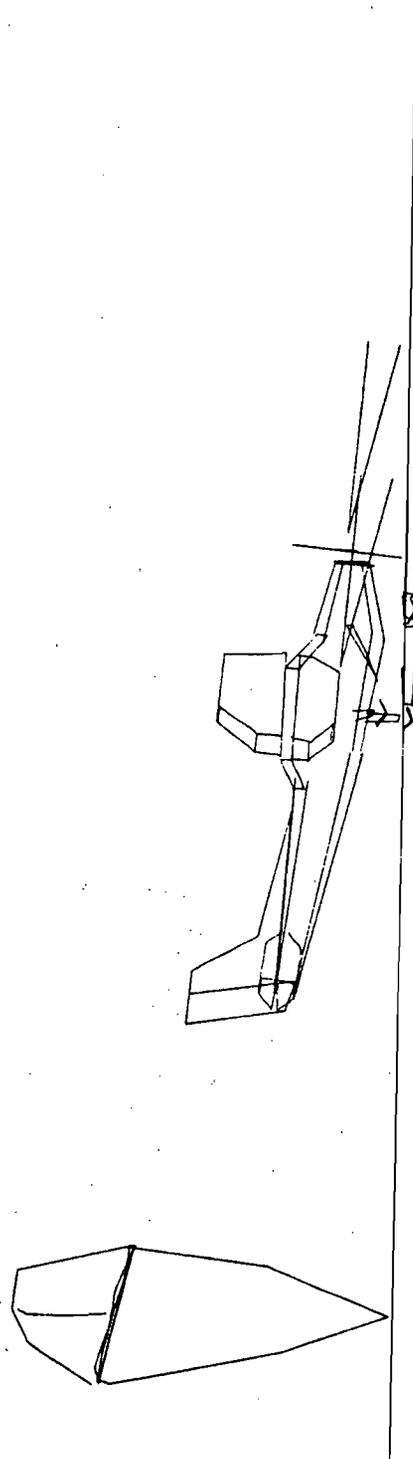
The airplane hit the ground with about a 17-degree impact angle, based on a 14-degree flight path angle and a 3-degree upsloping terrain. The impact speed was assumed to be about 48 knots, based on the published stall speed of 43 knots and corrected for the weight and flaps up configuration. The vertical velocity was calculated at 24 feet per second and the horizontal velocity was 78 feet per second. After impact the airplane slid up a 36 percent slope for about 30 feet. The sliding resistance was estimated at 1.06, based on the 36 percent slope plus a 0.7 friction coefficient. The velocity change during the slide would have been from about 64 feet per second to zero.

21-1. Impact angle.

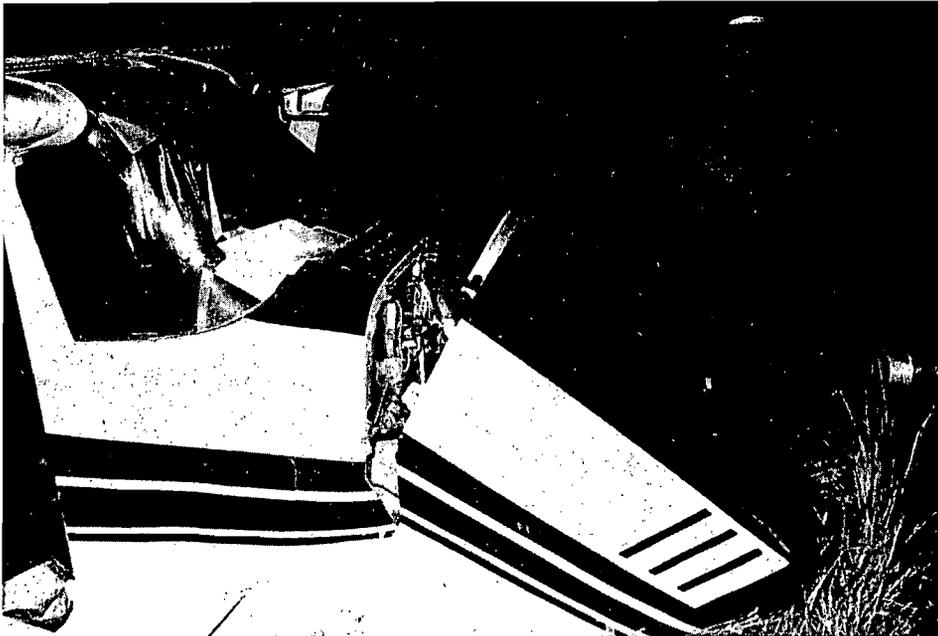
21-3. Nose cone dented forward.

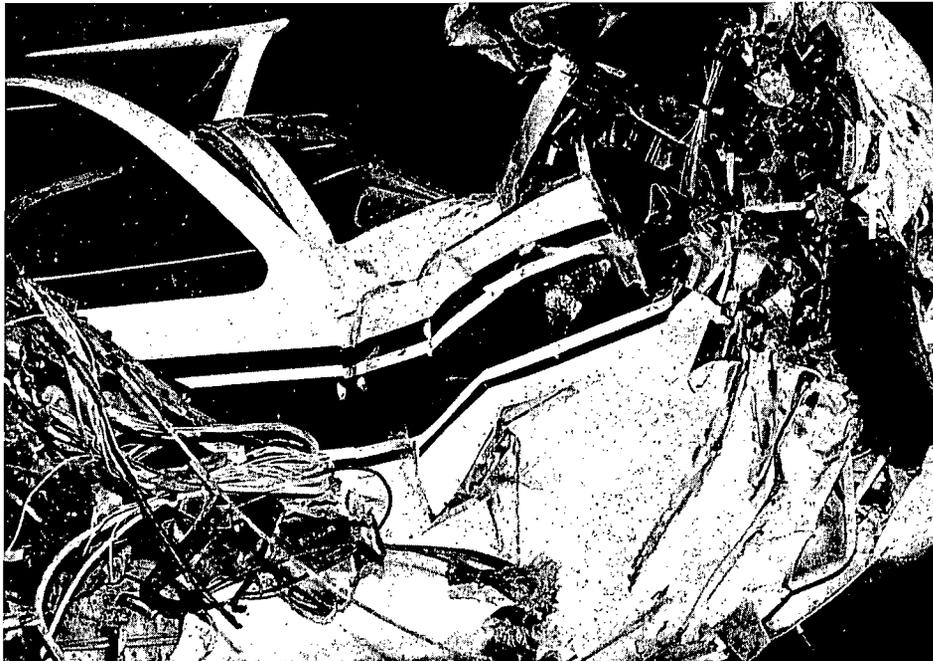
22-2. Crushline.

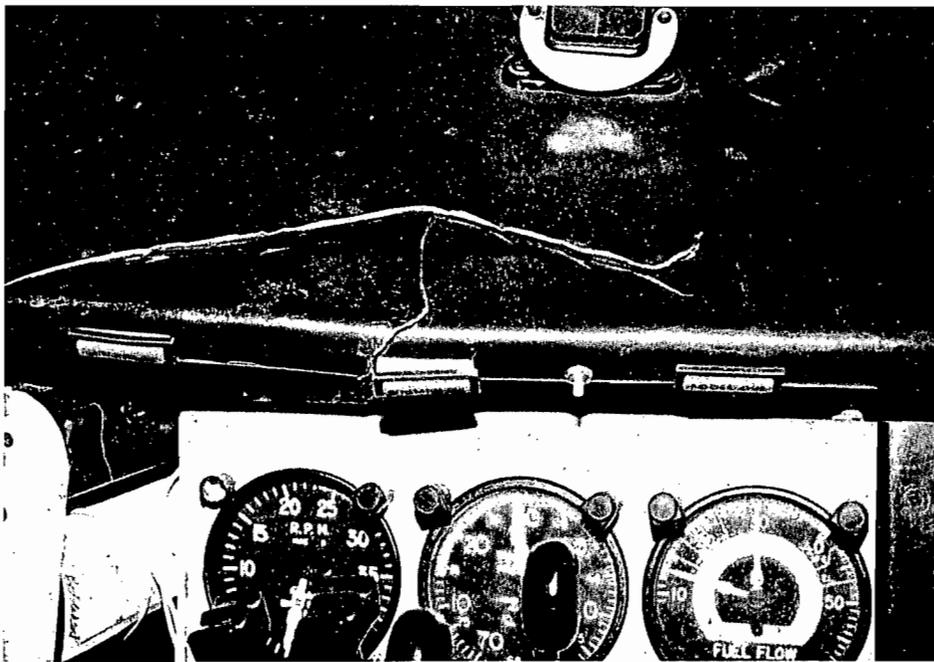
The four occupants of the airplane received serious injuries. The uncertificated pilot and the passenger occupying the copilot seat both moved forward into the instrument panel and glareshield. They also moved down in their seats, impacting the structure under the seat. The pilot seat pan was torn when it contacted the center seat track. Both front seat occupants received head injuries that consisted of lacerations and abrasions of the scalp and forehead. The pilot also received a lacerated eye, fractured right orbit, severe crush to the right side of his face, and abrasions of the chest. Passengers occupying the second row of seats received less serious injuries. The passenger occupying the seat directly behind the copilot seat received a superficial laceration of the forehead which did not need suturing. The passenger seated directly behind the pilot's seat received multiple abrasions of the back, abdomen, and legs. At the time of impact, all four occupants of the airplane were using their lapbelts. The airplane was not equipped with shoulder harnesses.

22-4. Pilot's head contact area.

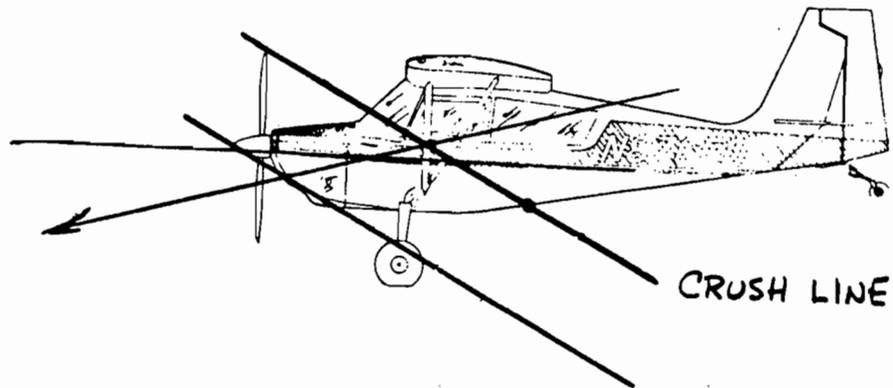
The airplane impacted the ground with a 45-degree impact angle and a 30-degree nose-down attitude. The speed was estimated at about 50 knots, based on a 44-knot stall speed and allowing for some acceleration into the ground. The crushing extended about 5 feet aft, which would have caused very high acceleration loads to the front seat occupant as the crushline progressed through his position. The rear seat occupant would have had the advantage of the 5 feet of ride-down so that his acceleration loads could have been far less severe. The average acceleration load would be about 22 G's and the peak would be about 44 G's. It is believed that the actual load would be less than the peak because the crushing did not involve an increasing amount of structure throughout the crush distance. A 30 G acceleration was assumed, based on the lack of acceleration injuries to the rear seat occupant. The 30 G value must be considered a gross approximation.

24-1. The 45-degree impact angle.

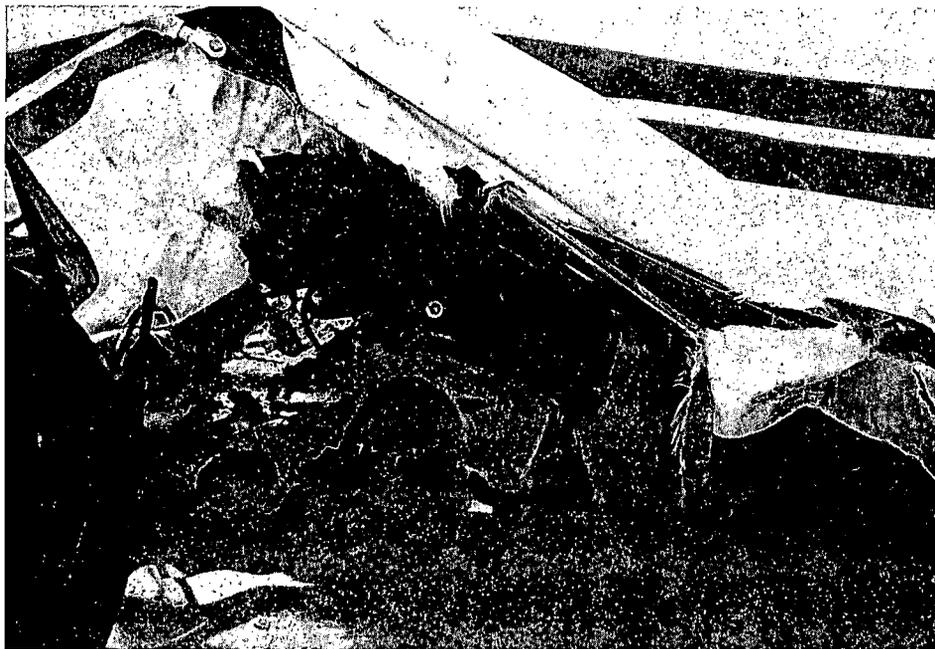
24-4. Crushline.

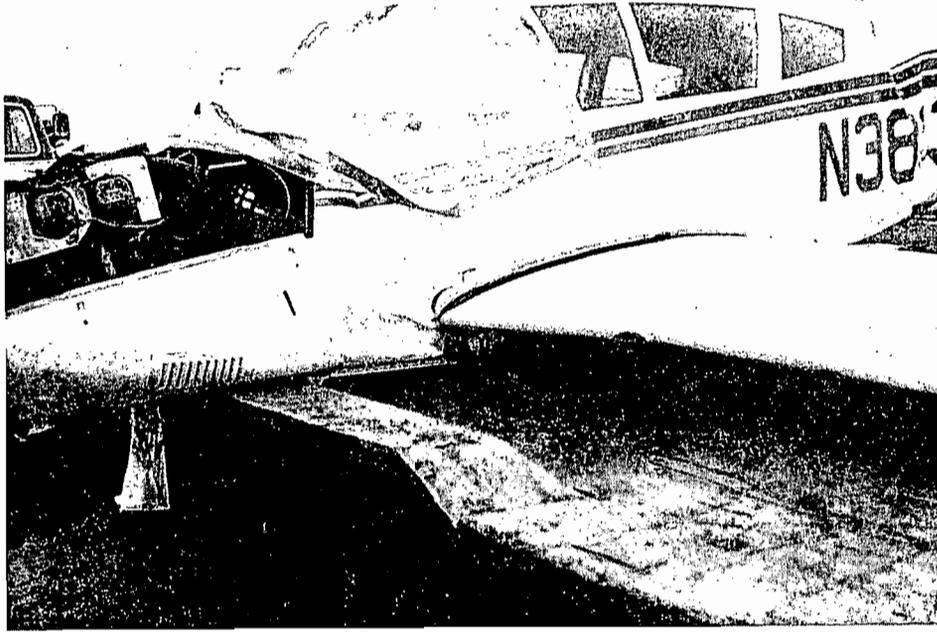
25-1. Wreckage.

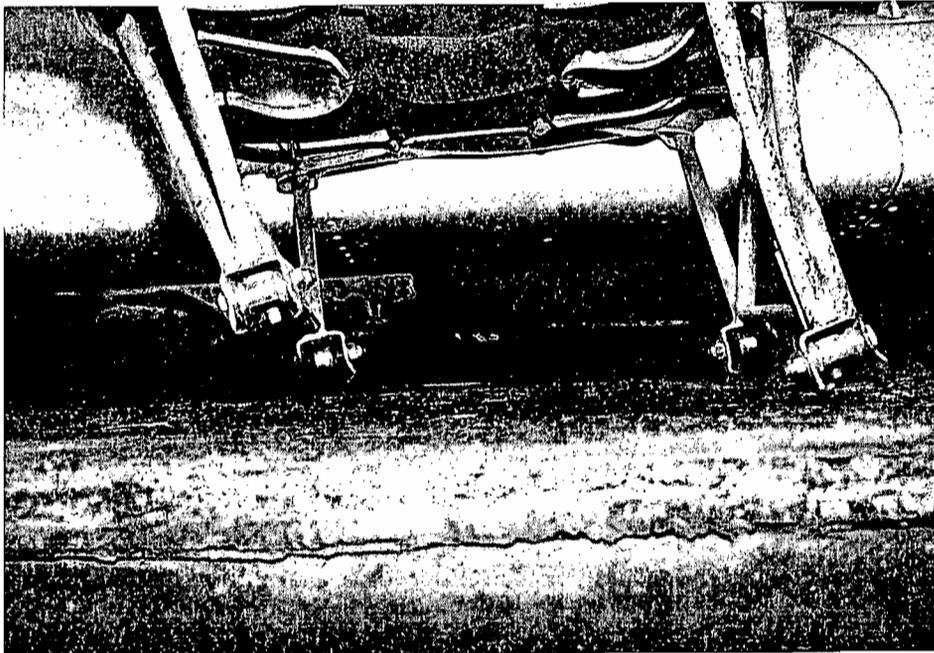
25-2. Seat loaded sideways which spread seat feet.

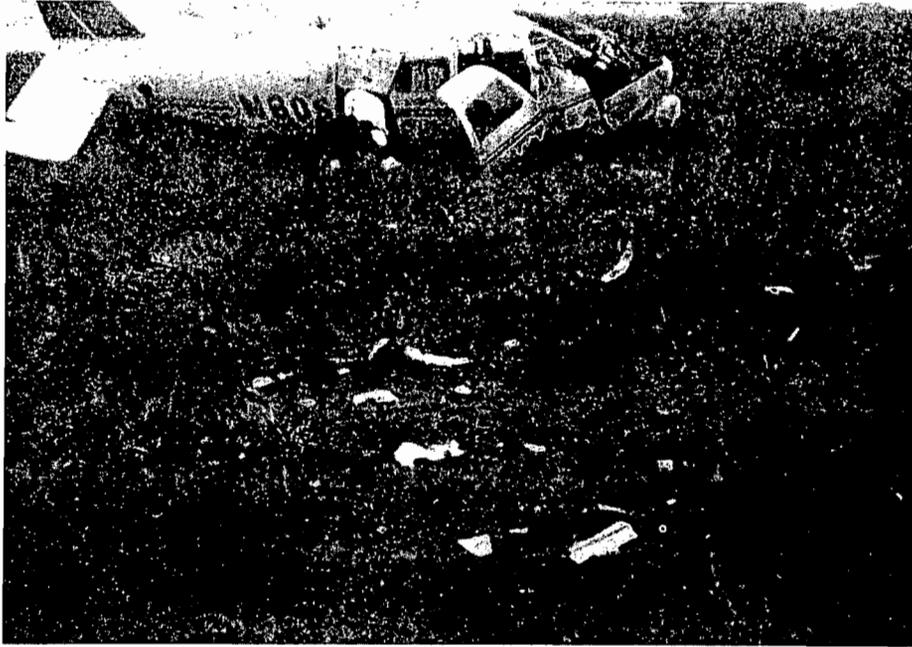
26-1. Wreckage.

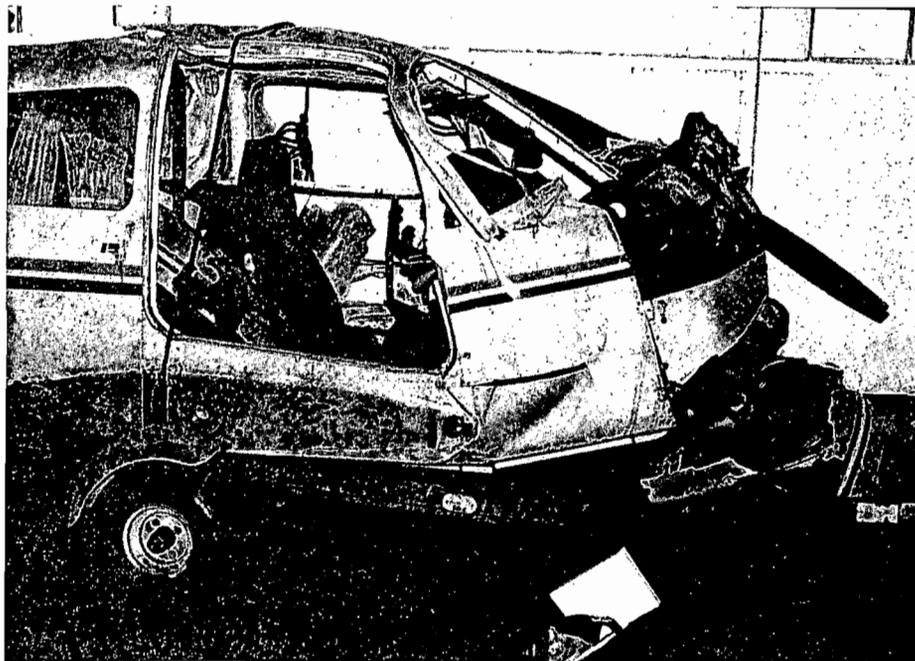
At impact, the occupants moved forward. The two occupants in the front seats impacted into the control yokes and instrument panel. The pilot hit the glareshield; the right front passenger's injury was caused by his contact with the radio group. Both front seats were stroked about 1 inch. The passengers seated in the second row impacted the seat backs directly in front of them. The rear seat occupant sustained lower back injuries and there was evidence of vertical loading on the seat where the seat pan is only several inches above the floorboard. The floorboard under the right rear seat was bent down from occupant loading.

26-2. Cockpit area.

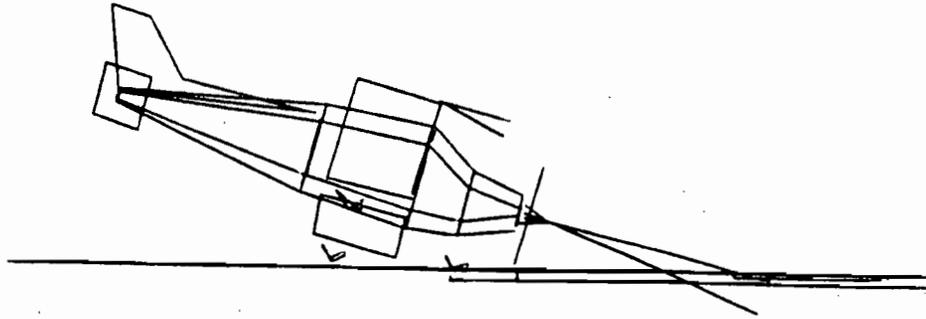
The crushline on the fuselage indicated that the nose of the airplane was 20 degrees nose-down relative to the ground. By matching ground scars and airplane components, the impact angle was reconstructed as about 25 degrees and the roll angle as about 15 degrees. The published 51-knot stall speed at 2,350 pounds was corrected for a 2,000 pound weight, yielding a calculated speed of 48 knots. A 34 feet-per-second vertical velocity and a 1-foot crushing distance would yield a 36 G peak vertical acceleration. Adding another foot of stopping distance because of the stroking seat would lower the peak acceleration to 18 G's. The passenger apparently had the full advantage of the seat because his seat was almost fully stroked. The heavier pilot appeared to fully stroke his seat and probably bottomed out on the floor, thus creating far greater acceleration loads to himself. His seat was not capable of dissipating the extra energy because of the additional weight.

27-1. Impact angle.

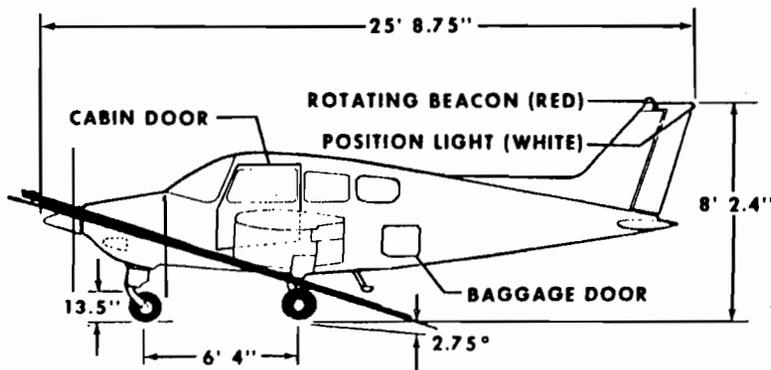
27-2. Crushline.

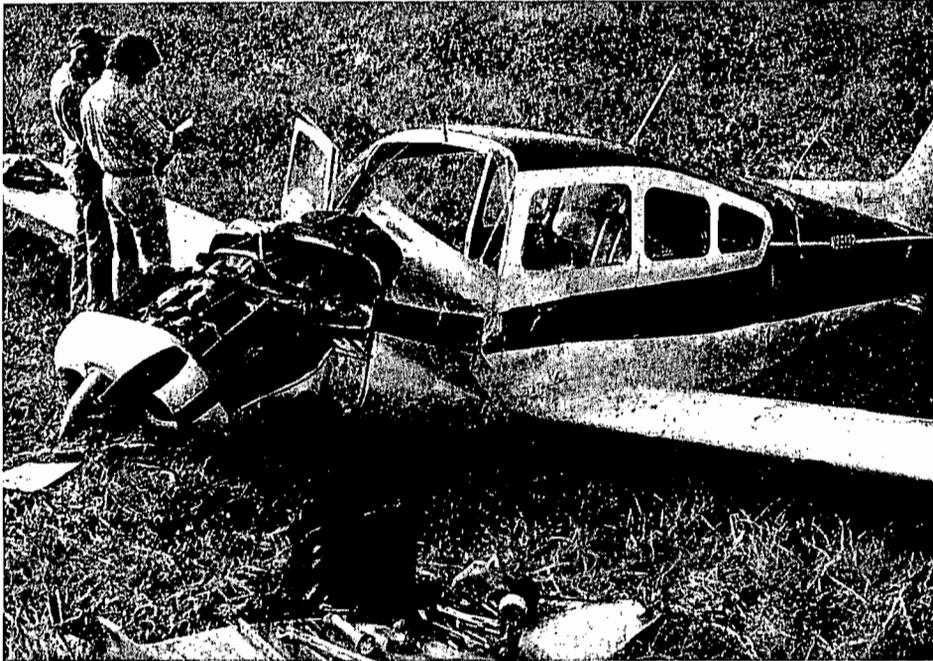
27-3. Wreckage.

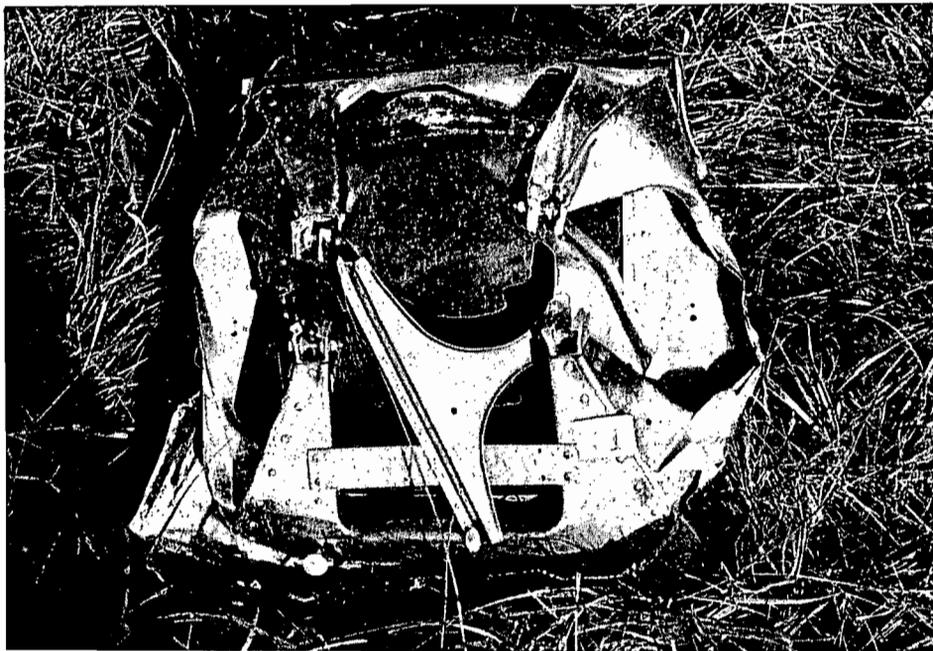
Both occupant seats incurred damage. The pilot's seat was partially separated from the seat track. The seat pan was distorted downward, and the back frame was collapsed rearward. The seat track was bent. The copilot's seat, which was occupied by the passenger, was similarly damaged except that the back frame, which collapsed on the pilot's seat, remained intact. The pilot's seat was fully stroked to the floor and the copilot's seat was almost fully stroked. It is believed that the energy absorbing nature of the seats protected the passenger by preventing him from slamming into the floor. The pilot did not receive this same protection because his extra weight (energy) exceeded the capabilities of the seat. For additional information concerning the effect of weight on energy absorption, see the section regarding Vertical Pulse and Velocity Change in the main body of this report.

27-4. Crushed seat - spread seat feet.

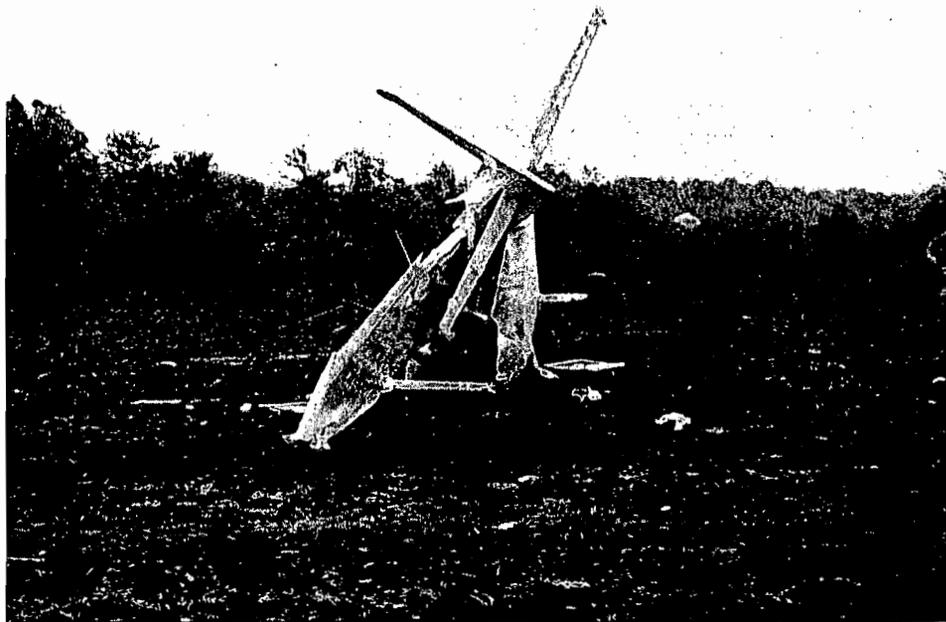
28-1. Wreckage.

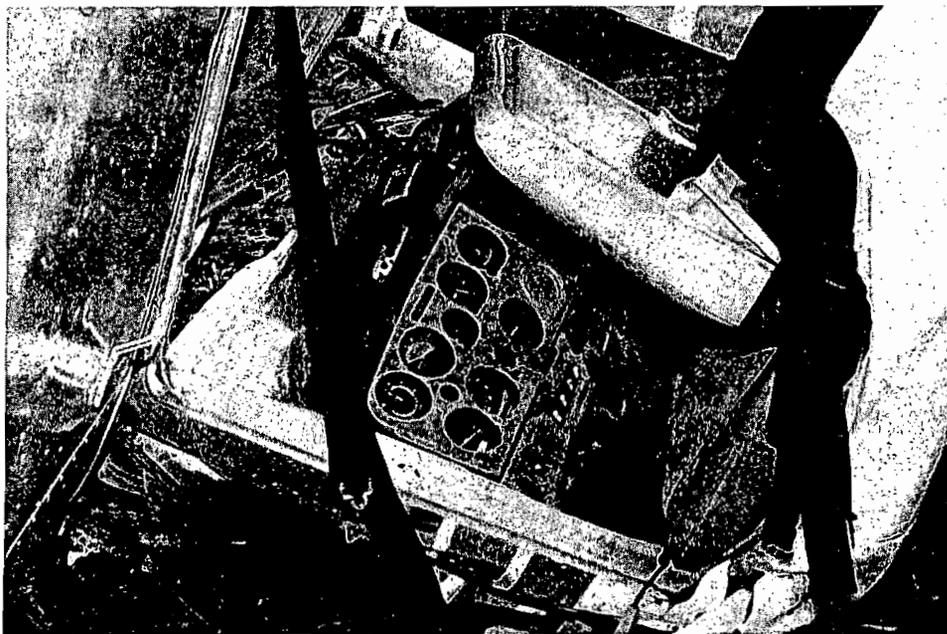
At impact, both occupants impacted into the instrument panel and control yokes. Both control yoke columns snapped. The pilot's seat, occupied by the student pilot, showed downward distortion to the seat pan frame and the seat bottom enclosure. The copilot's seat, occupied by the examiner, showed no visible damage.

28-2. Cockpit area.

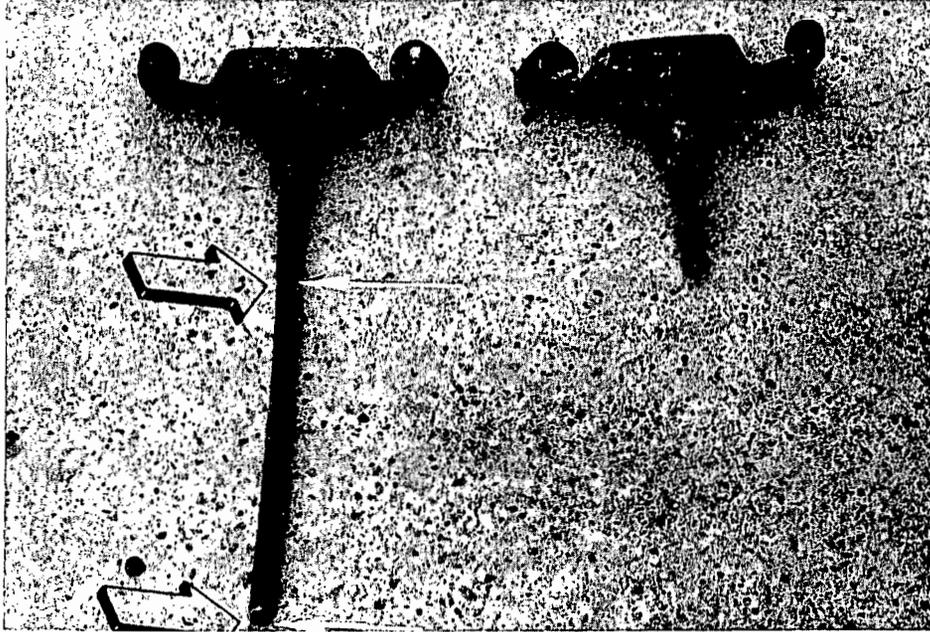
The student pilot was critically injured while the FAA-designated examiner riding in the right front seat was killed. Although the airplane was equipped with both lapbelts and shoulder harnesses, the student pilot was wearing only the lapbelt. Her most serious injuries included lacerations of the skull, a concussion, fractures of the ribs and extremities, and an avulsed liver. The examiner used both the shoulder harness and lap belt. His injuries were similar to the student pilot's injuries, however, the control column caused a penetrating wound to the chest which resulted in a lacerated heart.

28-3. Control column length that penetrated copilot.

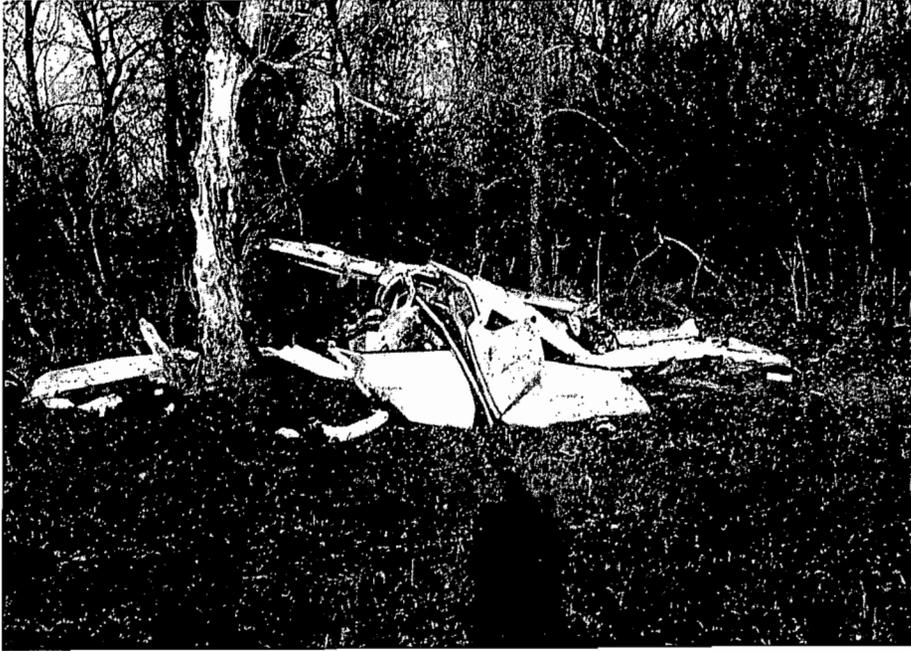
29-1. Wreckage.

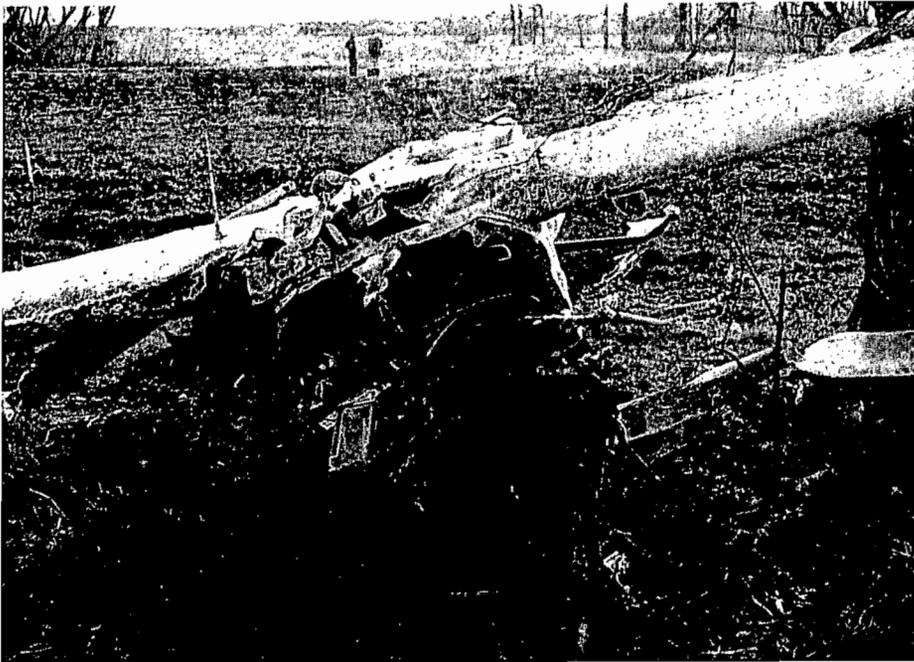
29-2. Wreckage.

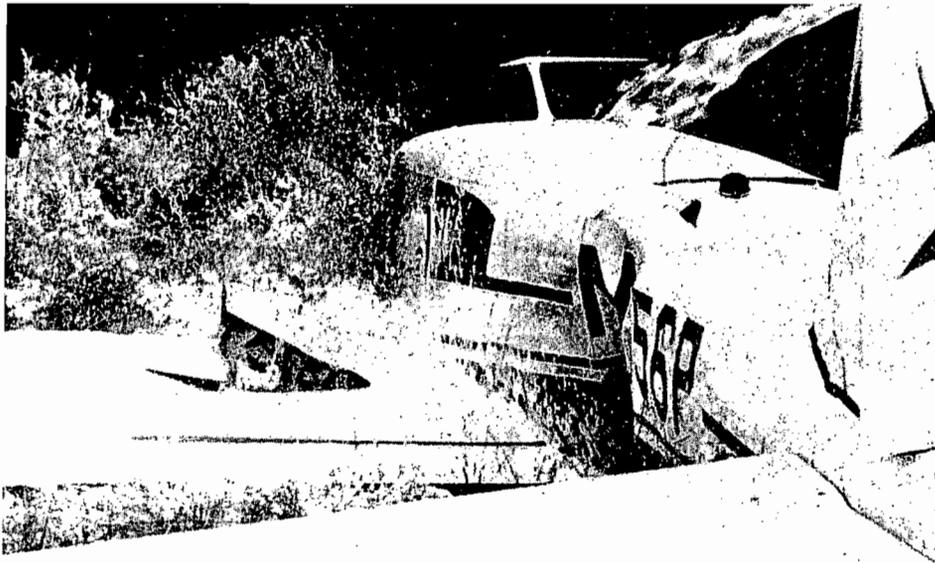
30-1. Wreckage.

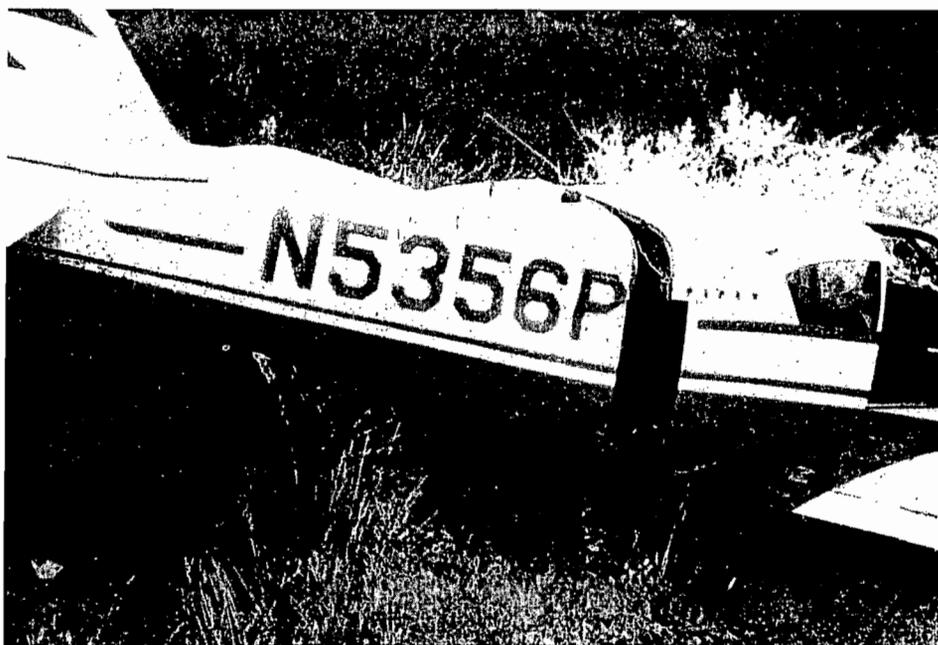
30-2. Wreckage.
