# NATIONAL TRANSPORTATION SAFETY BOARD

## SAFETY REPORT

GENERAL AVIATION CRASHWORTHINESS  
PROJECT: PHASE III - -  
ACCELERATION LOADS AND  
VELOCITY CHANGES OF SURVIVABLE  
GENERAL AVIATION ACCIDENTS

NTSB/SR-85/02

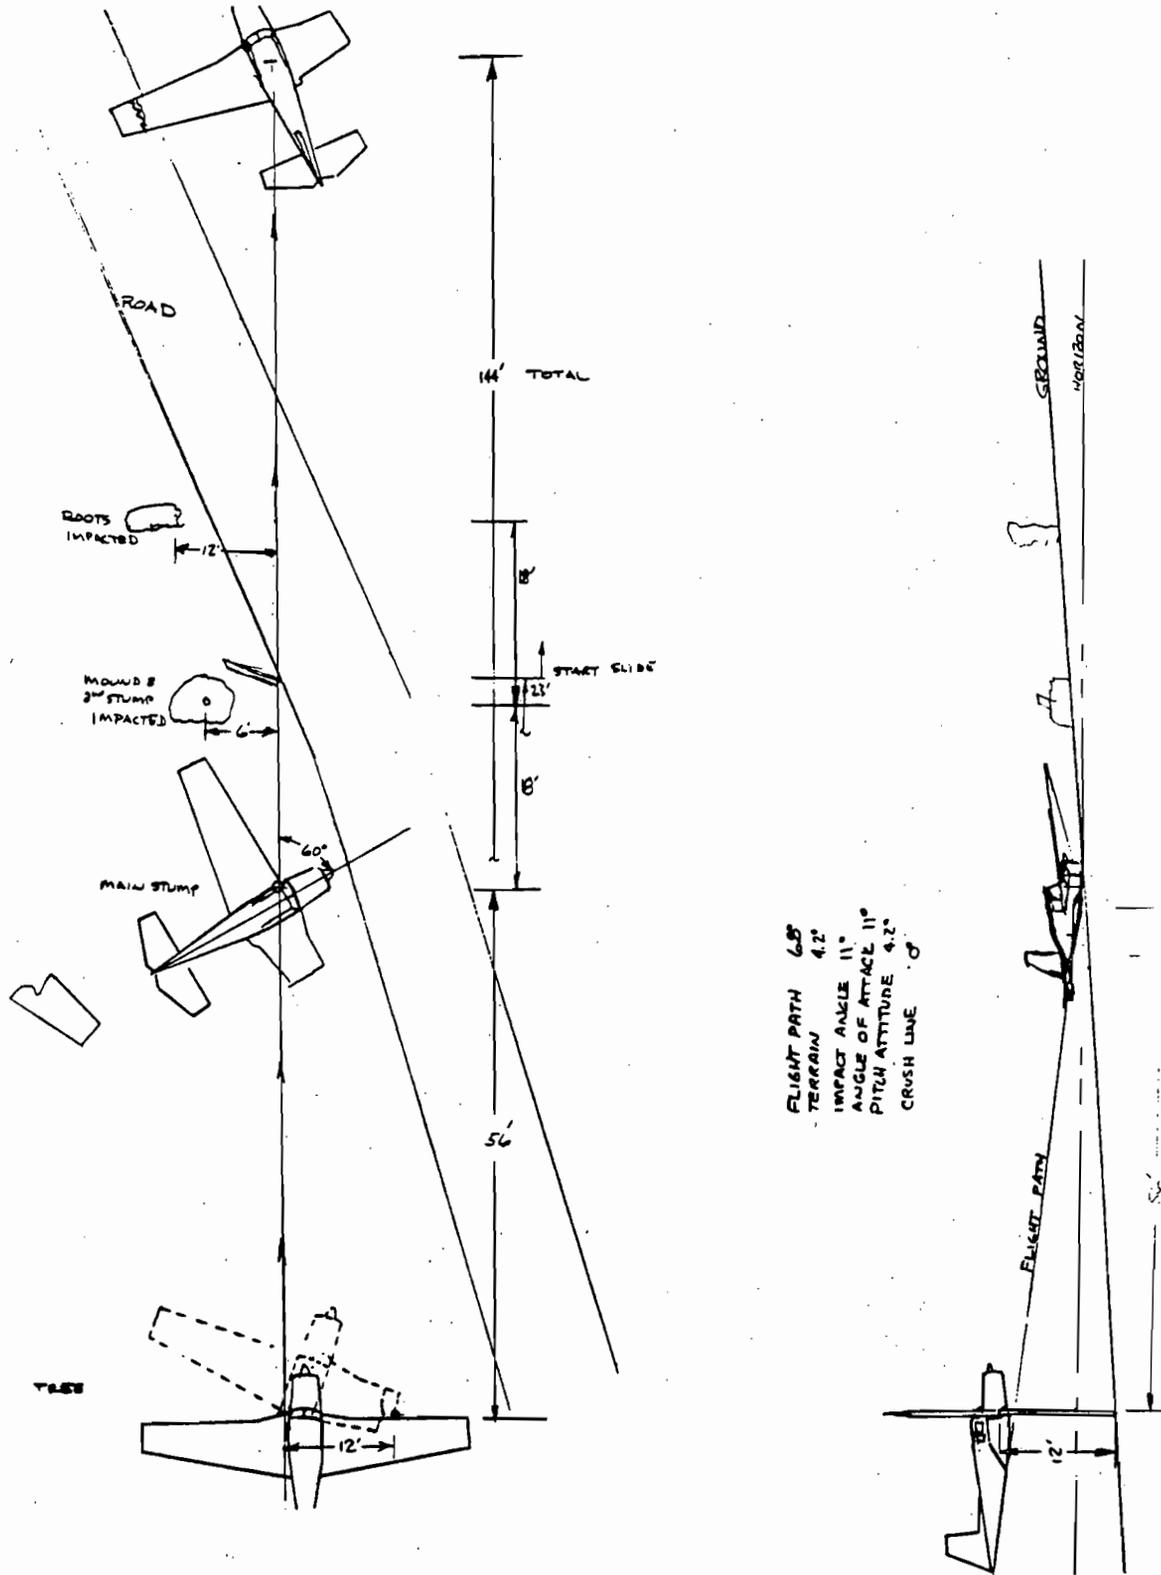
31-1. Final flight path.

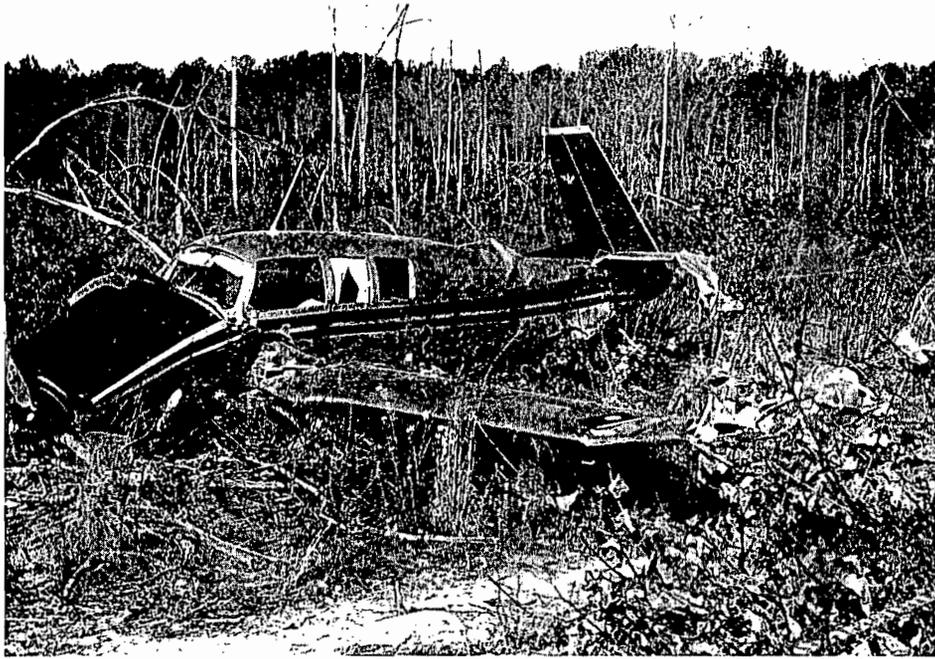
31-2. Wreckage - Area where tree stump penetrated fuselage.

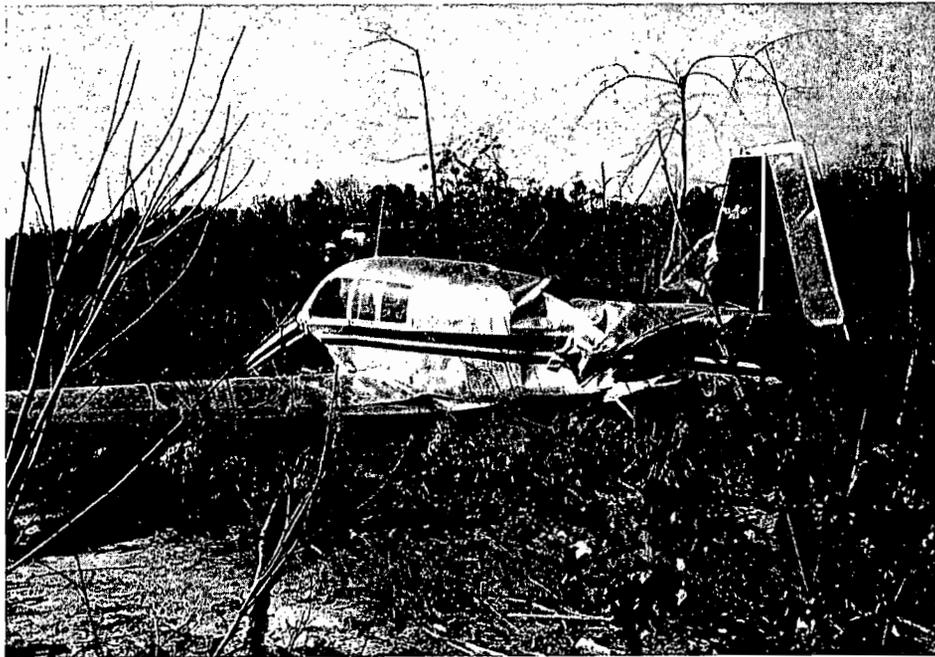
31-3. Wreckage.

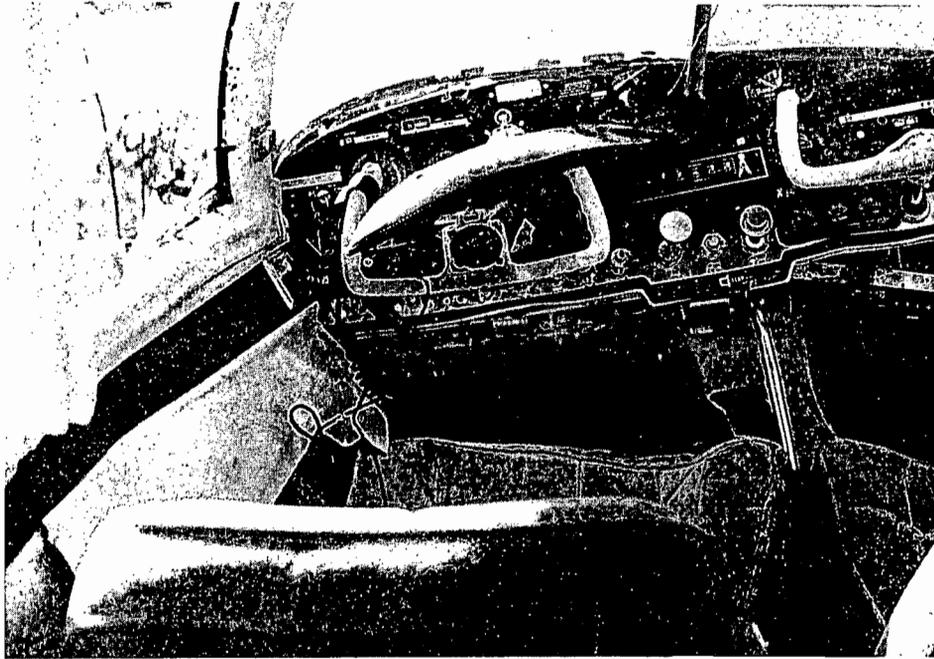
31-4. Sidewall pushed in on pilot's side by tree stump.

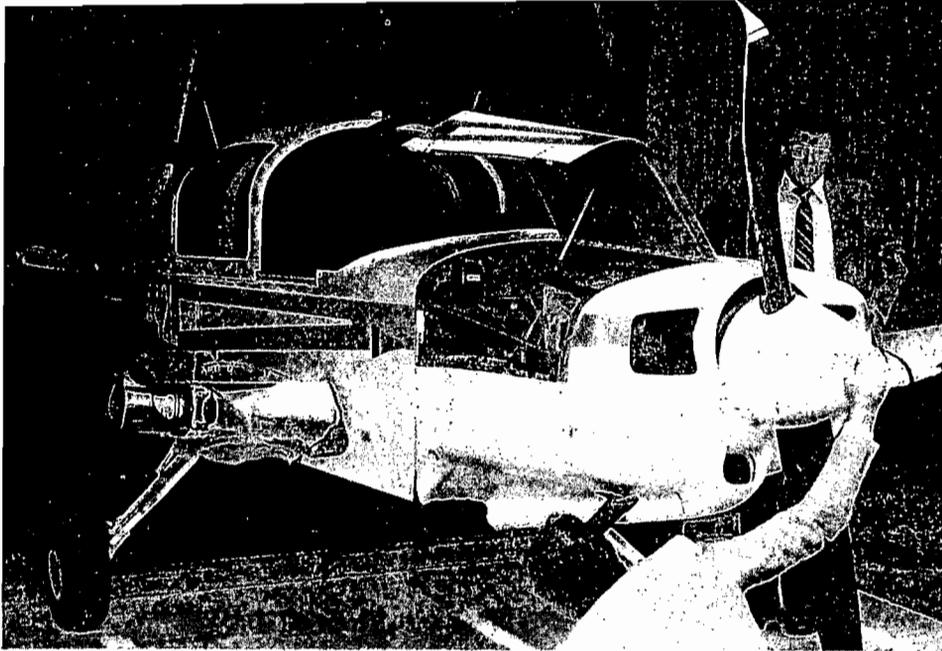
32-1. Wreckage.

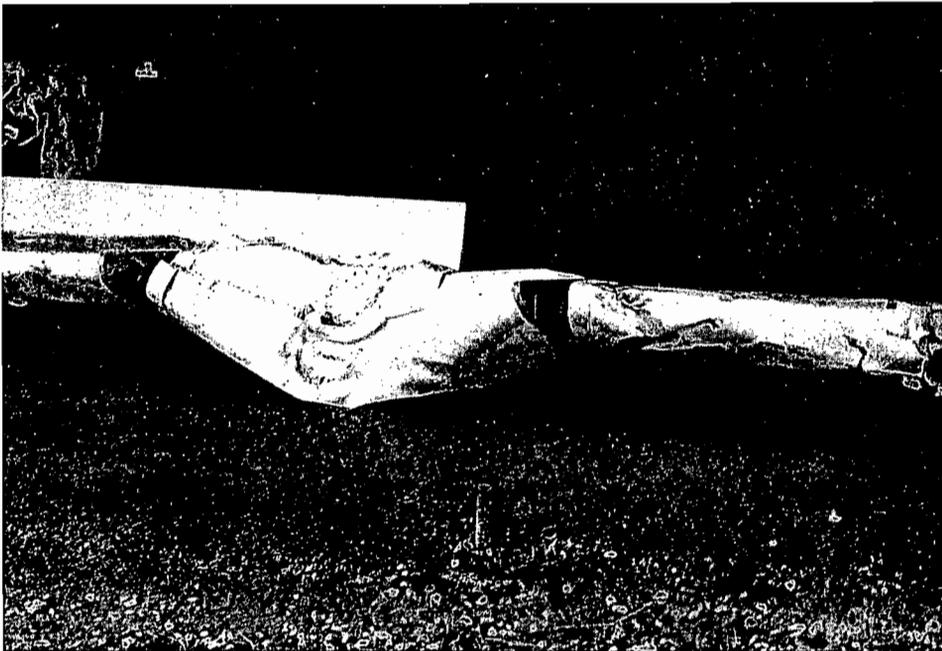
The airplane flew into a number of 6-inch diameter trees, breaking the trees and shearing one wing. Seven trees were contacted sequentially over a total of 12 feet. The loading was primarily longitudinal, and the pulse was assumed to be an average pulse because of the sequential tree strikes. At an impact speed of 52 knots, the average acceleration load was calculated at 10 G's. There were probably higher spikes, but the loading would not have approached the peak loads of a triangular pulse.

32-2. Tree strike to wing.

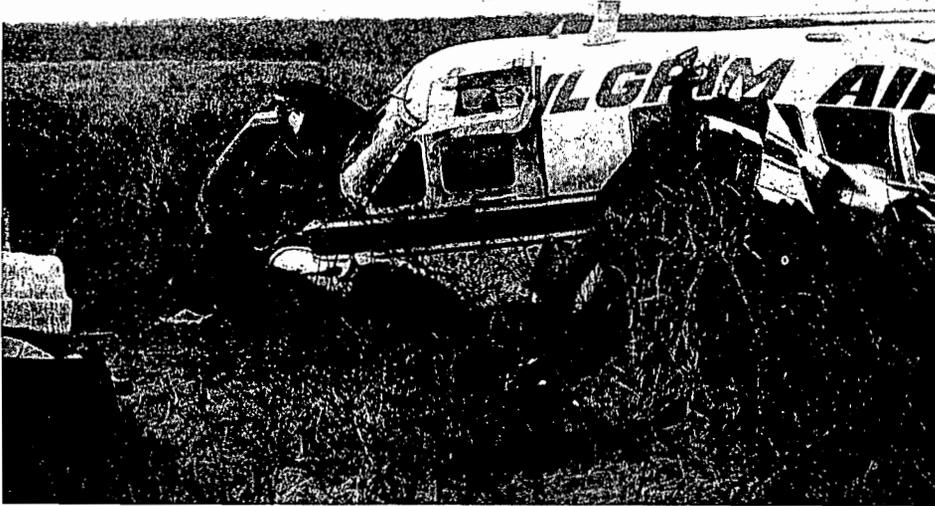
Photographs taken at the accident site show the crushline and general fuselage damage. The crushline in the photographs and the three-view drawing were consolidated into a separate drawing in which the plane of the crushline was rotated to the horizontal position. Parallel lines, labeled 1 through 5, were drawn to represent the crush levels at which different parts of the structure became involved during the crash (photograph 33-5). The airplane attitude, measured directly from the drawing, showed a roll angle of 21 degrees left wing down and a nose-down pitch attitude of 9 degrees.

33-2. Left side crushline.

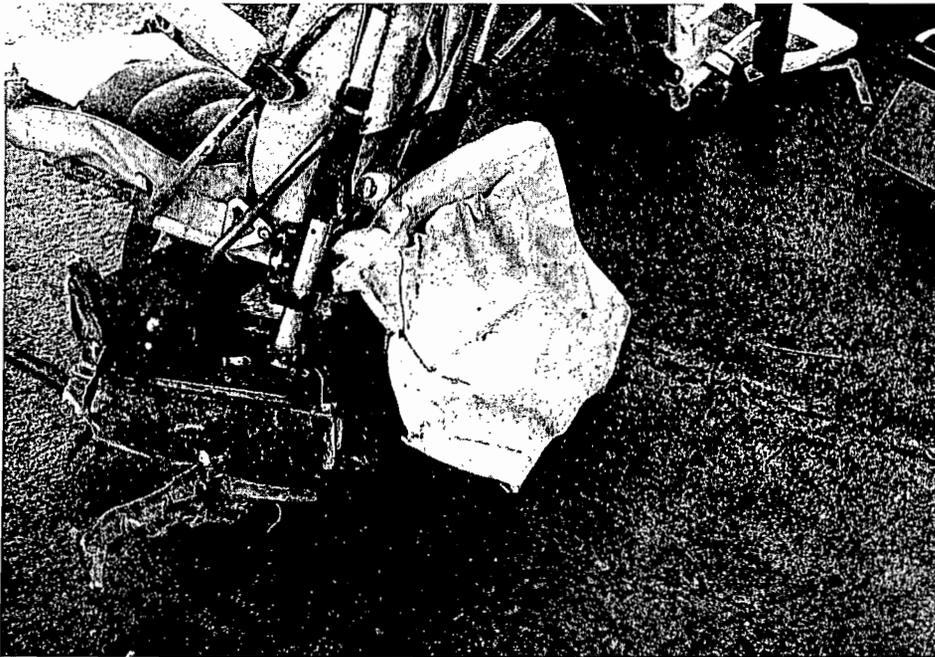
33-3. Pilot's seat in area that was totally fragmented.

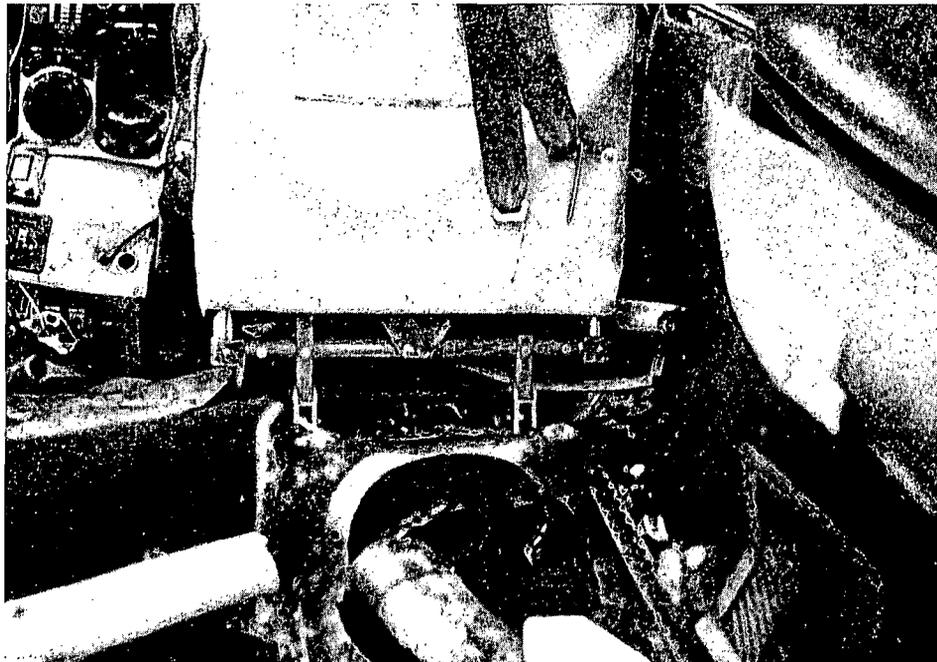
33-4. Copilot's seat in undamaged area.

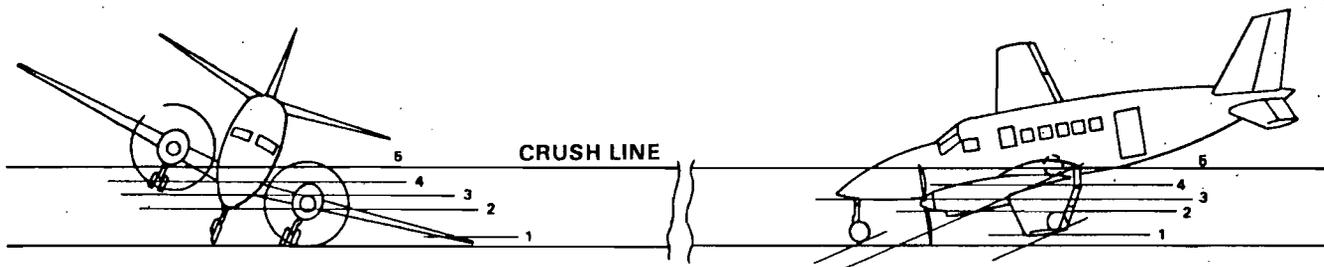
33-5. Drawing showing crushline.

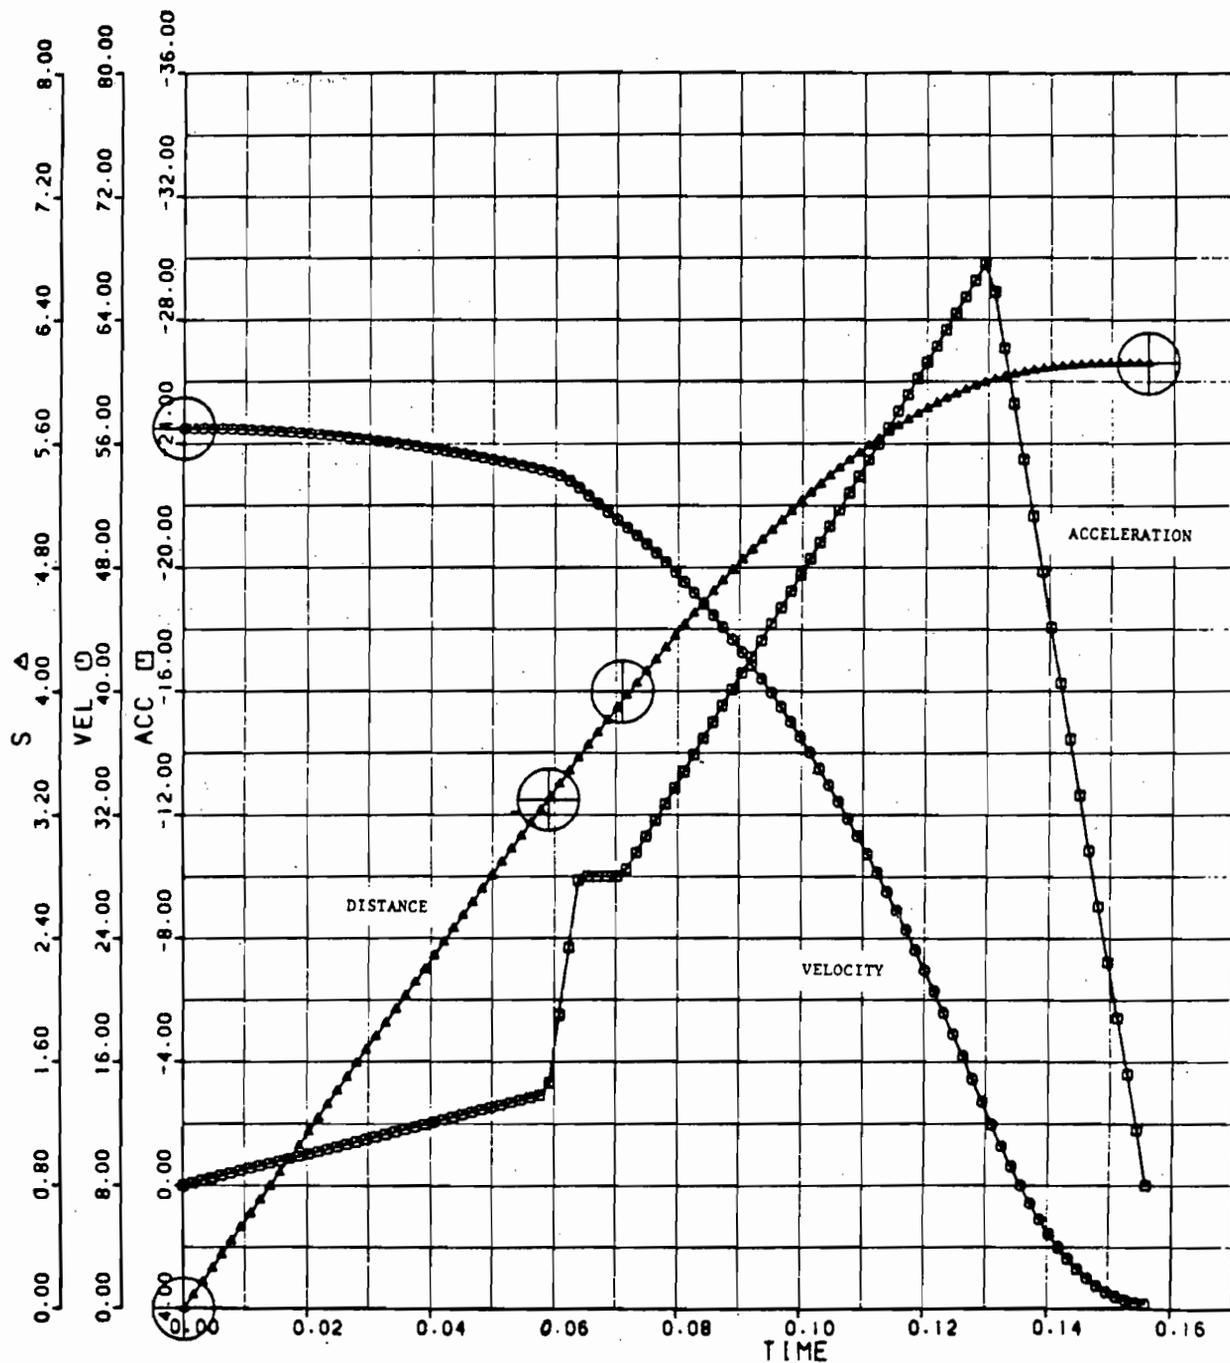
33-6. Shaped crash pulse.

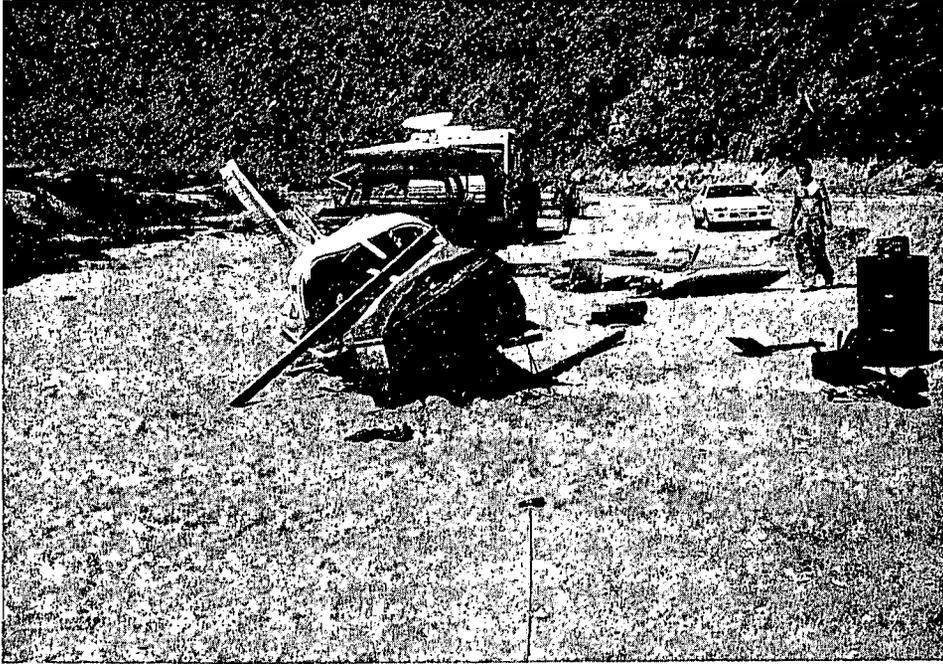
34-1. Wreckage.

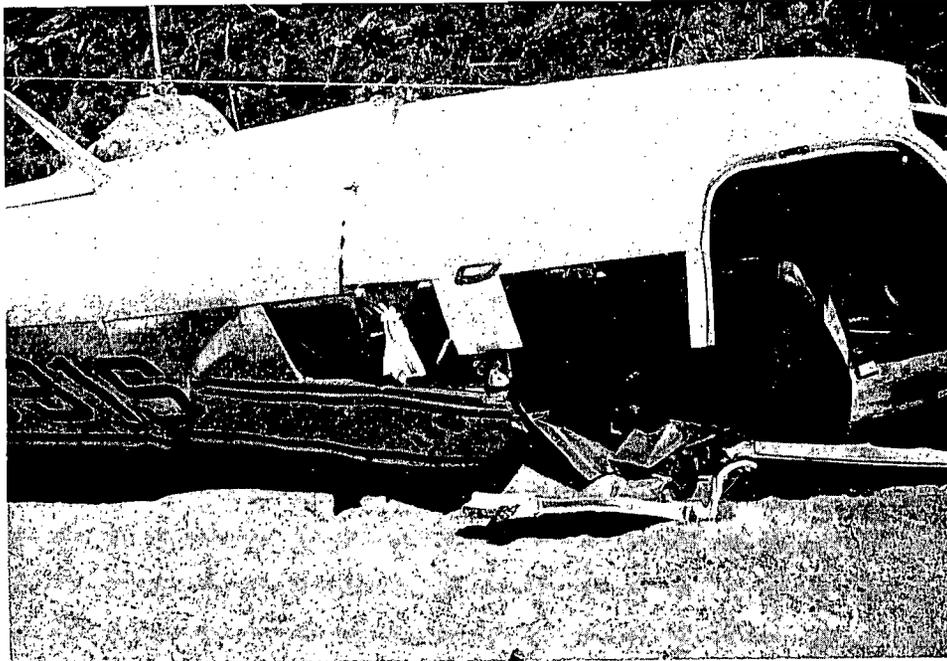
34-2. Crush area.

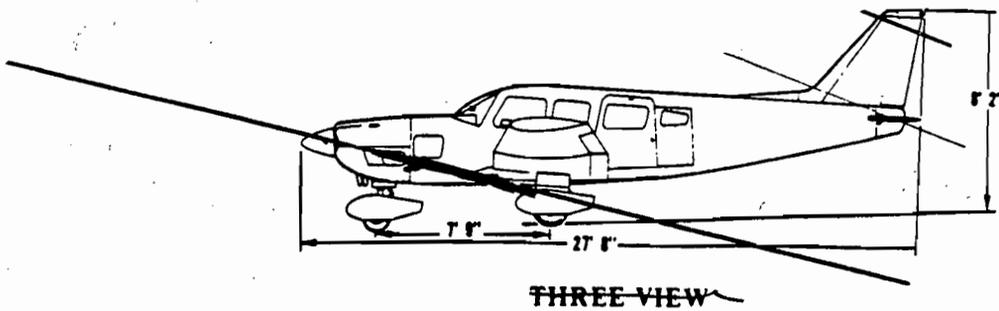
The airplane had a crushline indicating that the attitude at impact was at least 10 degrees nose-down. The flaps were down, so the angle of attack was estimated at about 12 degrees. Adding the angle of attack and the pitch attitude would result in an impact angle and flight path angle of 22 degrees. The gross weight stall speed is 55 knots; based on witness descriptions; a bank angle of about 45 degrees was assumed for the calculation of the 65-knot stall speed, which was also assumed to be the impact speed.

34-4. Crushline.

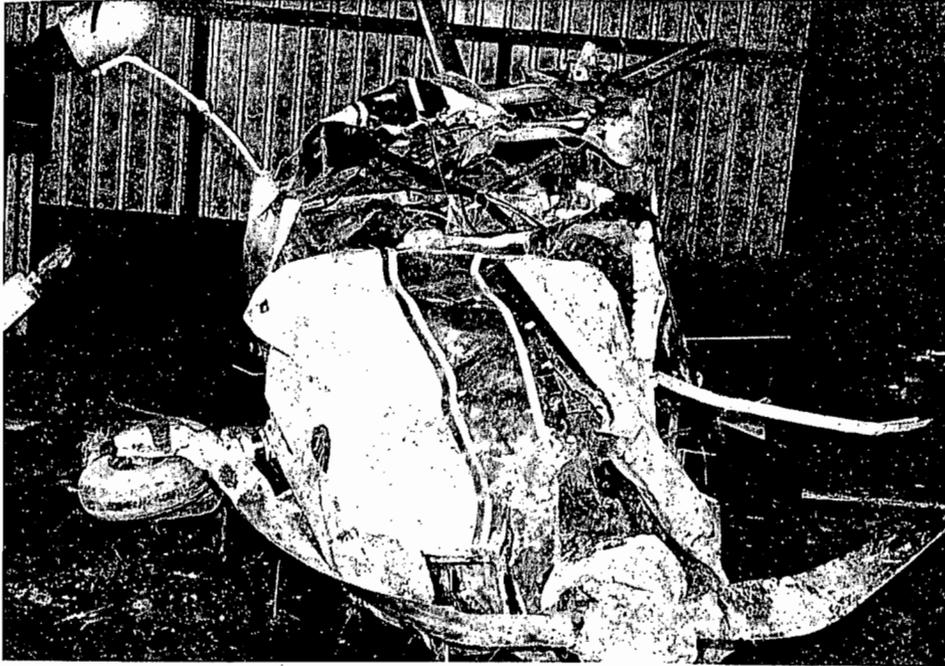
35-1. Wreckage.

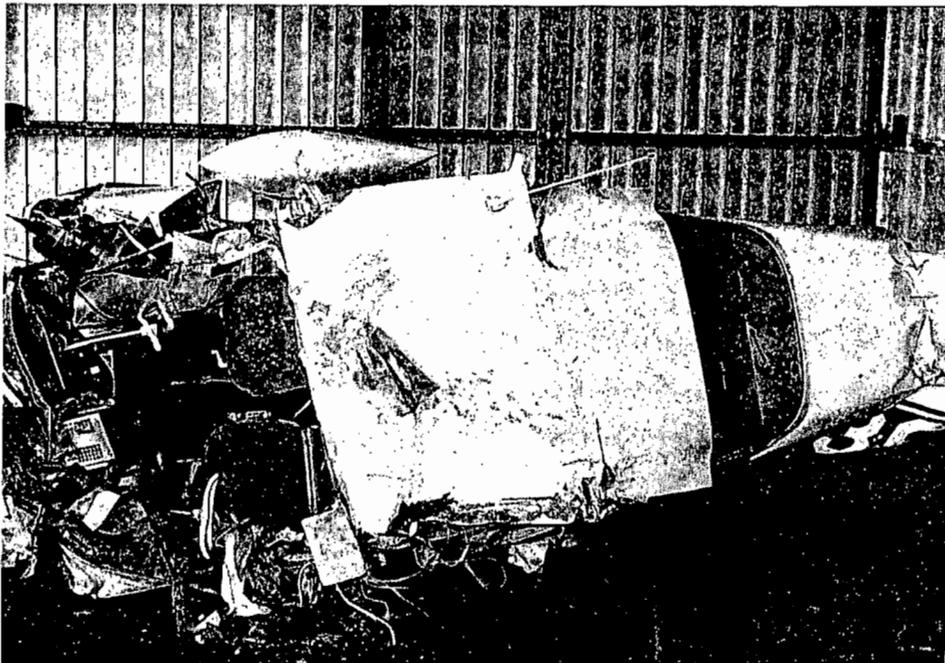
35-2. Wreckage.

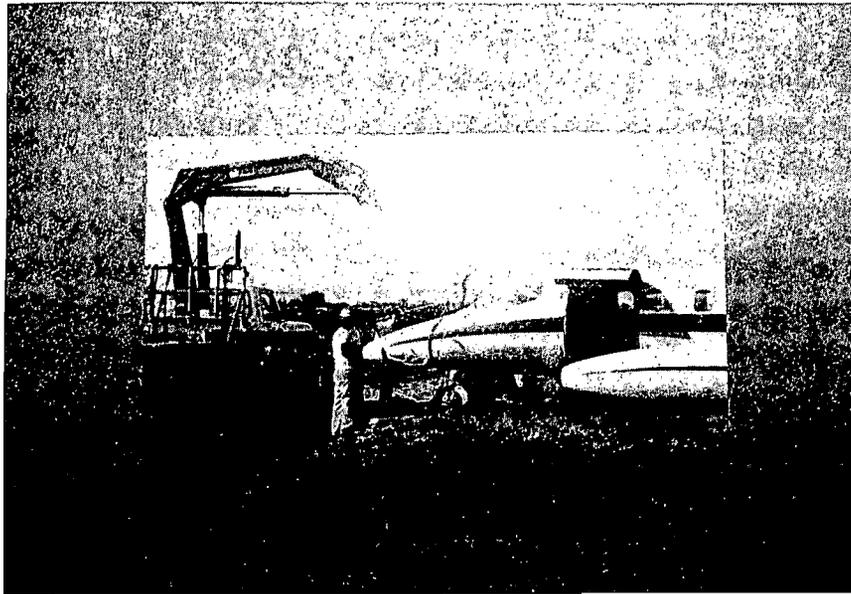
36-1. Wreckage.

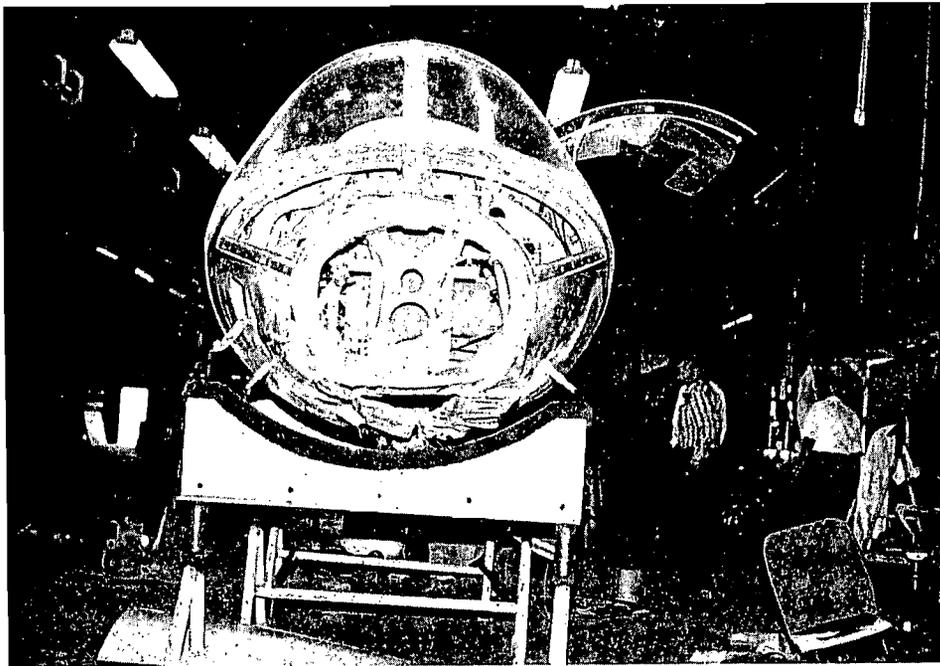
36-2. Crush to nose area.

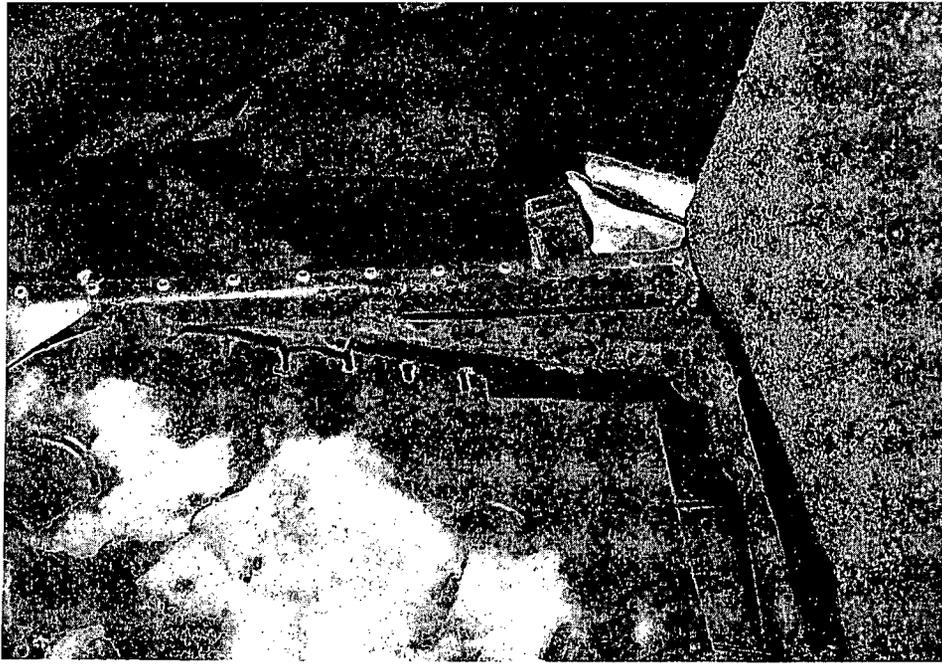
36-3. Incrementally torn seat pan.

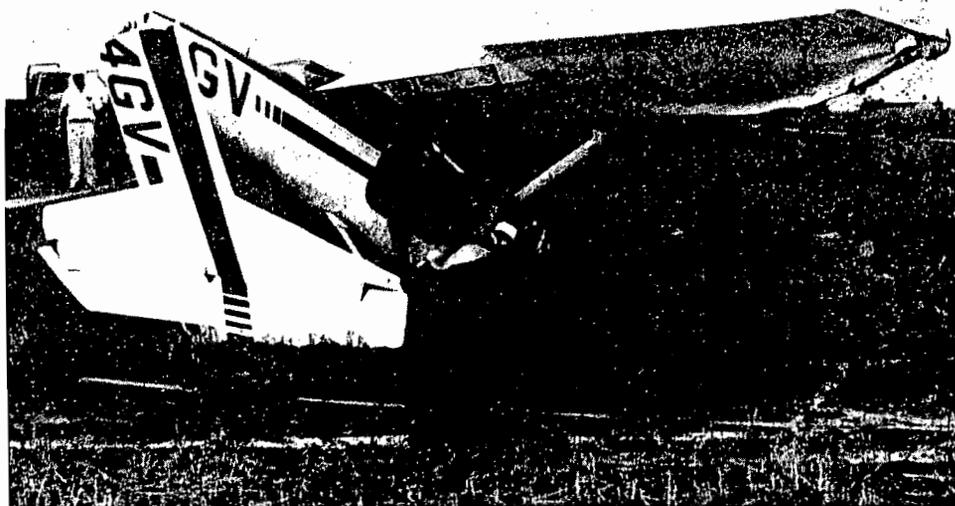
37-1. Wreckage.

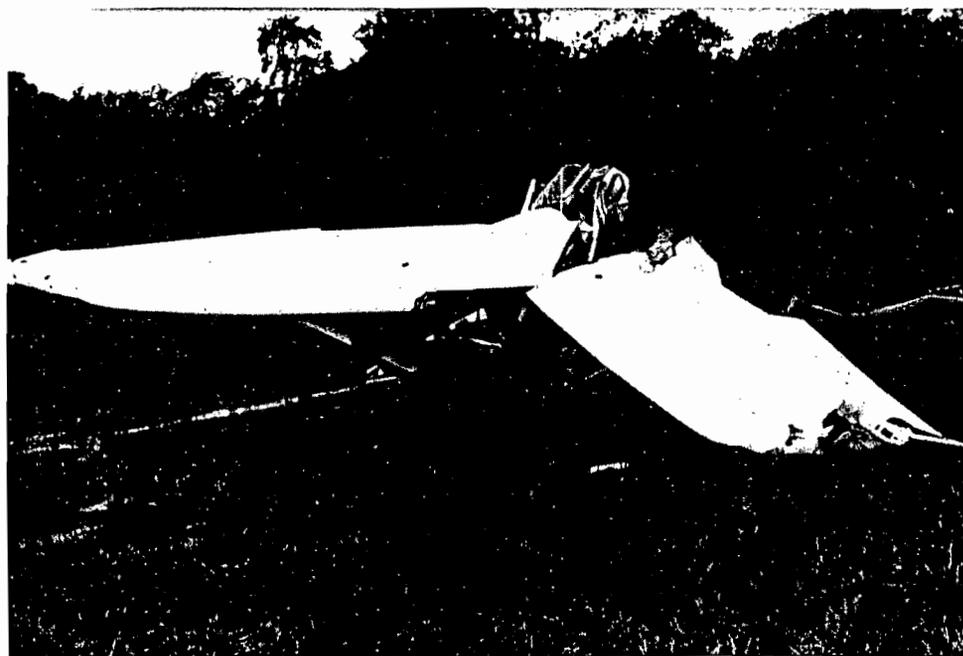
37-2. Wreckage.

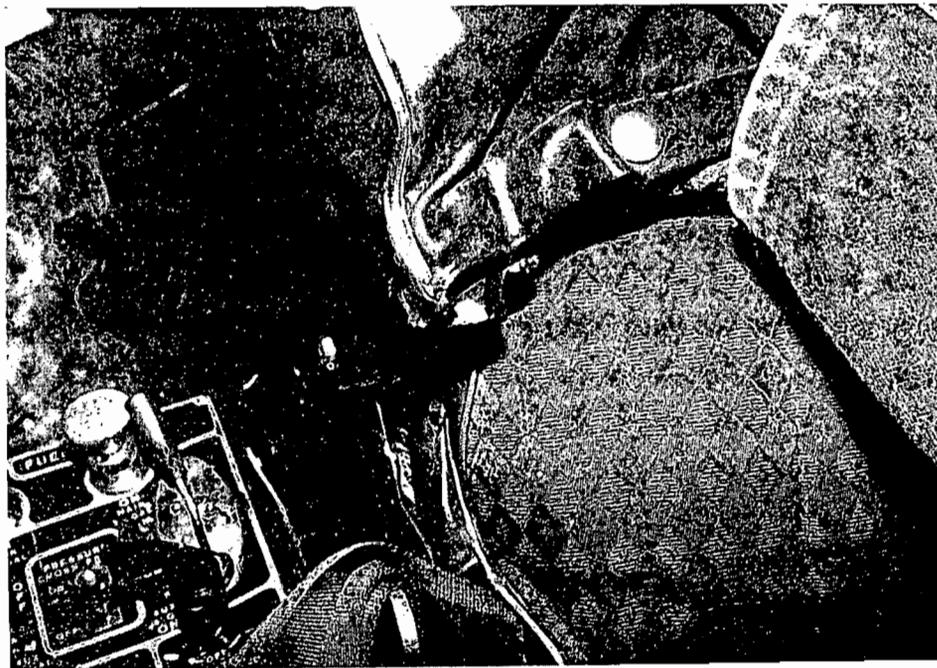
38-3. Head strike area of rear seat occupant.

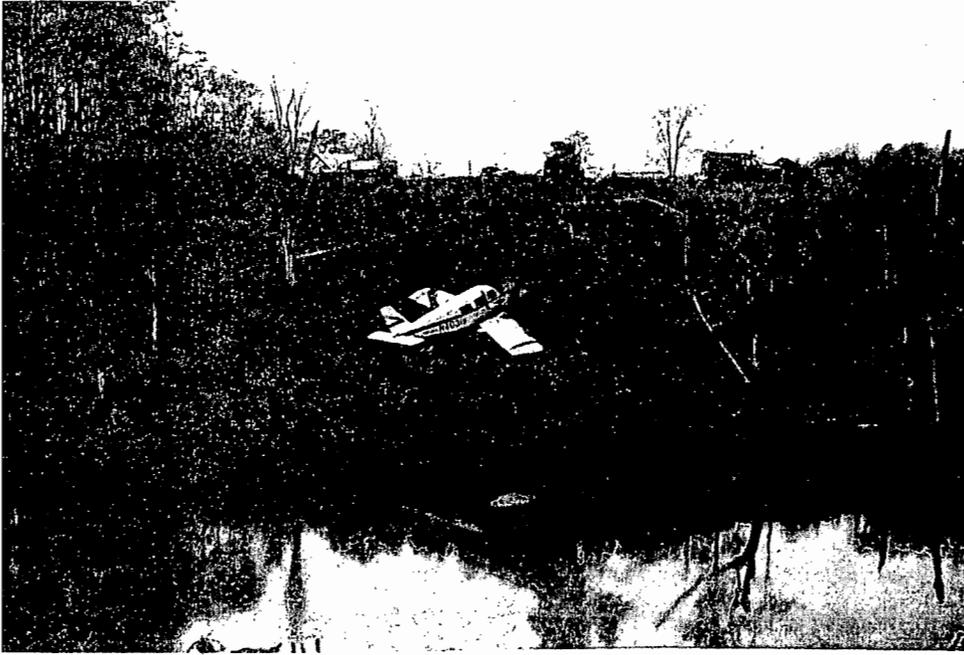
39-1. Wreckage.

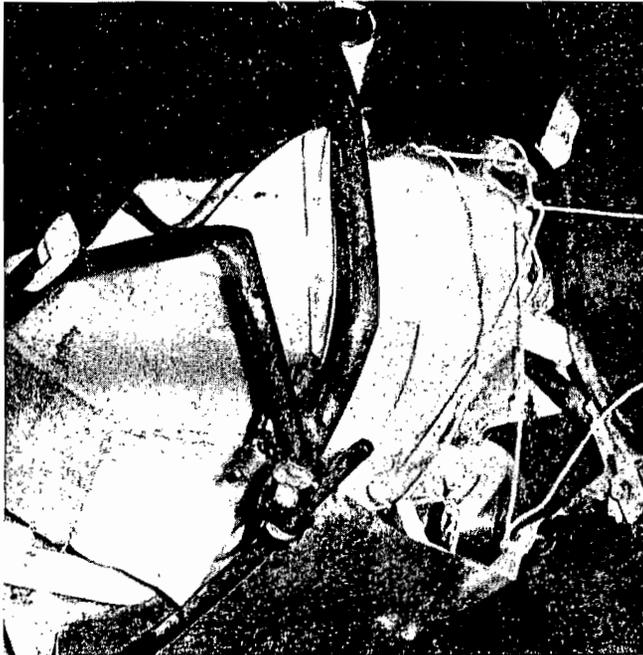
39-4. Bottom of seat pan.
